# STRENGTHENING HERITAGE TUNNELS TO ENHANCE THE RESILIENCE OF WELLINGTON'S TRANSPORT NETWORK

## ABSTRACT

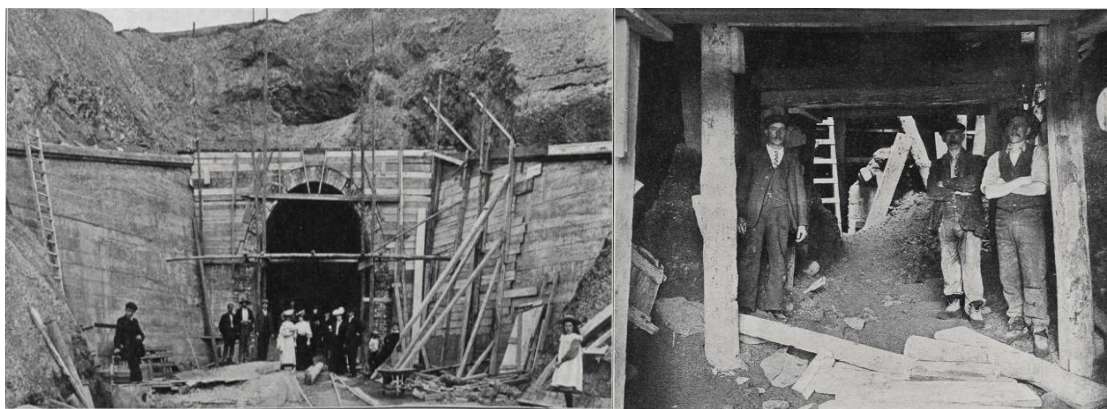
Desk study was an initial and very important part of the assessment. Desk studies included review of available information such as as-built drawings, construction stage photographs, relevant geological and geotechnical information and subsequent inspection and maintenance reports. The review of historical information in particular, including photographs and newspaper articles of the time, sourced from regional and national libraries, provided some useful insights about the construction methods, the quality of the rock mass, and in some cases the failures that occurred during construction. Some historical photographs from the construction of Seatoun tunnel portals are presented in Figure 3 and Hataitai Bus tunnel in Figure 4. The Hataitai photograph shows a tunnel collapse during construction, though its exact location is not known.

**Figure 4: Photographs of the construction of the portals (left) and tunnel section (right) of Hataitai tunnel taken in 1907. The photograph of the tunnel section is following a roof failure [10].**

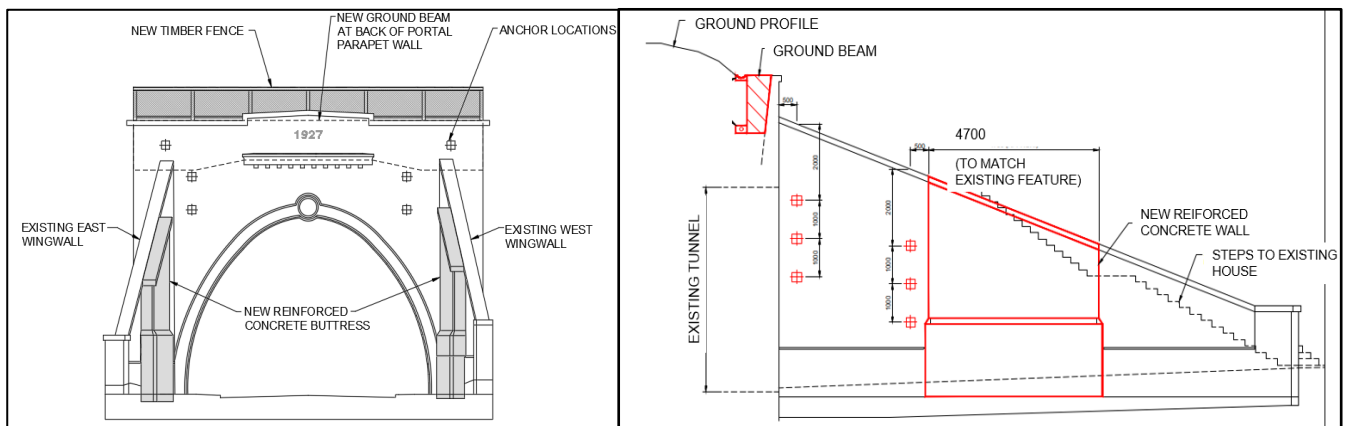
**Figure 18: General layout of strengthening measures of portal and wing walls at the north portal of the Northland tunnel.**

Photographs of the north portal after strengthening are given in Figure 17, and the strengthening works are illustrated in the diagrams of Figure 18.

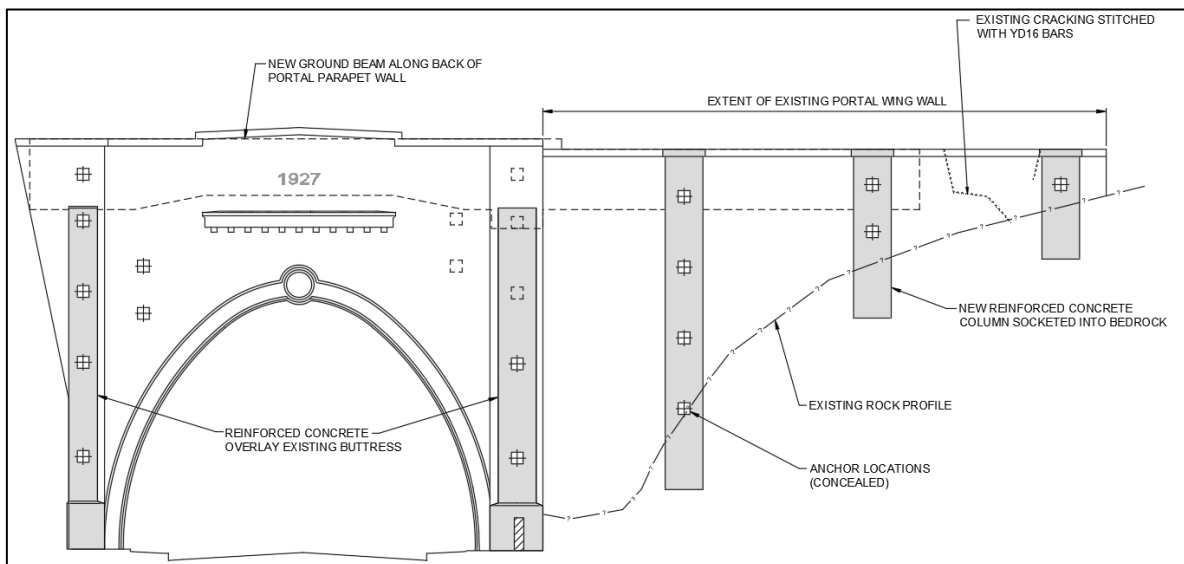
**Figure 19: General layout of strengthening measures of portal and wing walls at the south portal of Northland tunnel.**

The strengthening adopted for the south portal included (Figure 19):

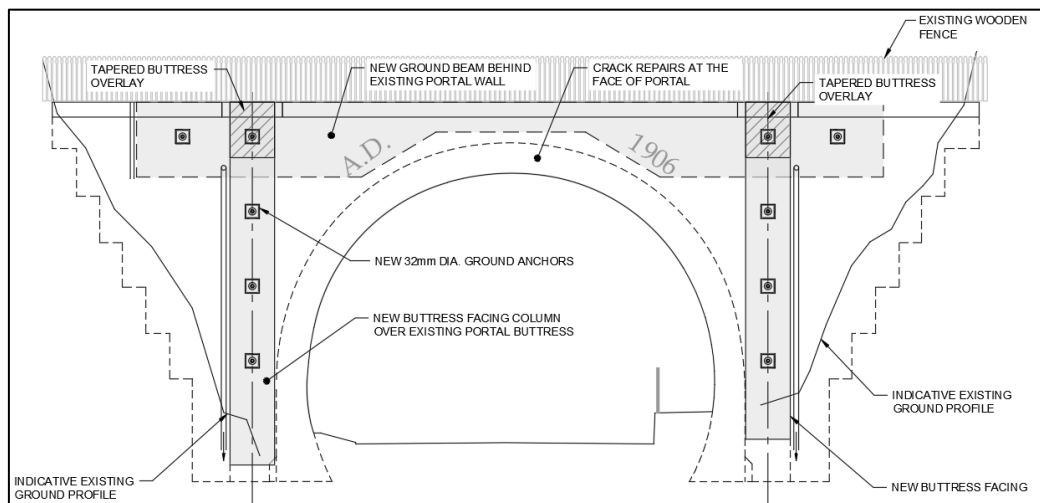
A previous assessment of the seismic behaviour of the Seatoun tunnel concluded that strengthening of the tunnel barrel was not necessary. The unreinforced concrete portal and wing walls at both portal ends and the retaining wall on the Strathmore end of the tunnel were found to be vulnerable to failure in moderate to large earthquake events, i.e., with recurrence periods larger than 100 years. Failure of these portal structures could lead to collapse of the tunnel barrel adjacent to the portals. This could cause access into Seatoun to be closed for several weeks or longer, as post-earthquake resources are likely to be focussed on the recovery of the city centre and regional access routes. Strengthening of the tunnel portals was recommended to enhance the resilience of this route.

*Figure 21: General layout of strengthening measures of Seatoun tunnel portals.*

The strengthening works comprised (see Figure 21):

The rock anchors were typically 8 m long, 32 mm dia. 1030 MPa, double corrosion protected bars grouted into rock. The anchors were post-grouted using a tube-a-manchette system to provide good capacity and minimise the need for pre-grouting and re-drilling in the variable rock conditions. General views of the Strathmore portal before and after strengthening are shown in Figure 22.

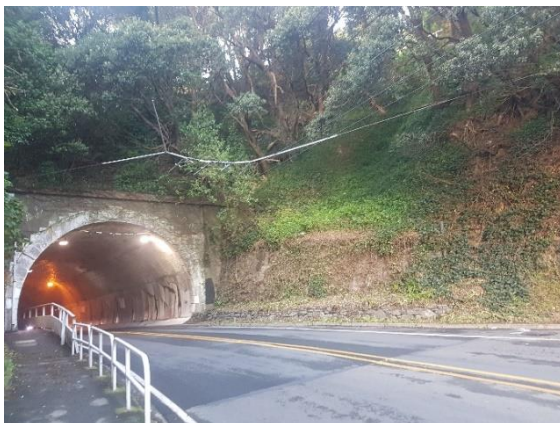
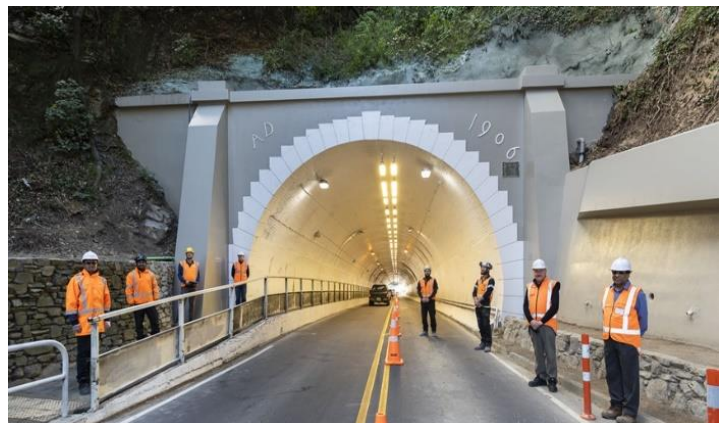
*Figure 22: Seatoun tunnel – view of the Strathmore portal, before and after the strengthening works.*

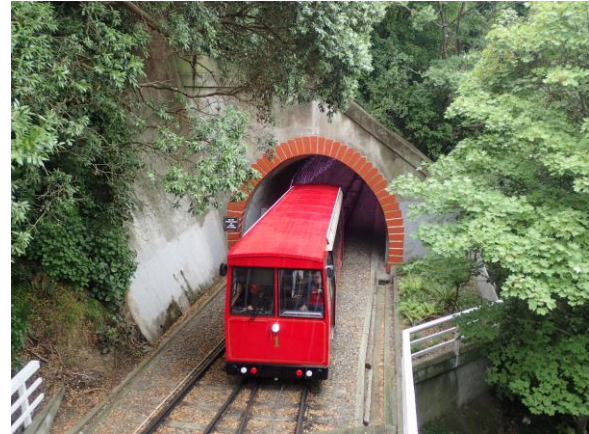
- The upper 40 m of the middle tunnel barrel (this is described in detail in the following sections).
- The upper portal of the Middle tunnel (MU), which has a height, up to 7 m (see Figure 26), including the north (left hand-) side wall, which is adjacent to Victoria University buildings uphill from the portal.

**Figure 26:** View of upper portal of middle tunnel built near a south dipping slope.

The upper 40 m length and the portal of the middle tunnel are in proximity to a steep slope (Figure 26). The tunnel barrel has low overburden, especially at the south side of the tunnel section, ranging from 2 m to 3 m near the portal and up to about 10 m along the 40 m section. A 15 m high, steep, concrete faced

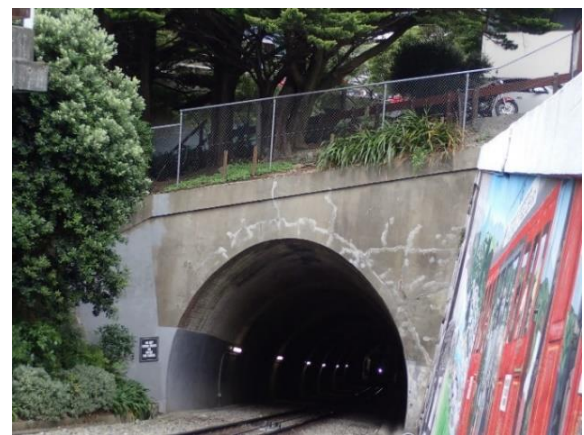
- The upper portal of the lower tunnel (LU) and south side wing walls (Figure 27, Figure 28), which are of considerable height (~6 m at the south side), have a shallow thickness of overburden and are adjacent to urban development. Cracking was observed on the portal and side walls.

**Figure 27:** Upper portal of the lower tunnel (LU).

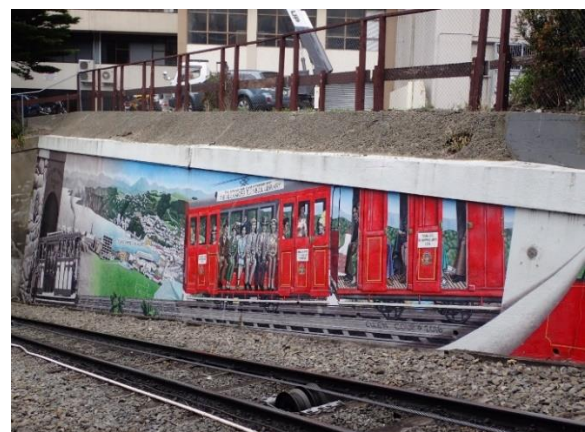
**Figure 28:** South side wall at the upper portal of the lower tunnel (LU).

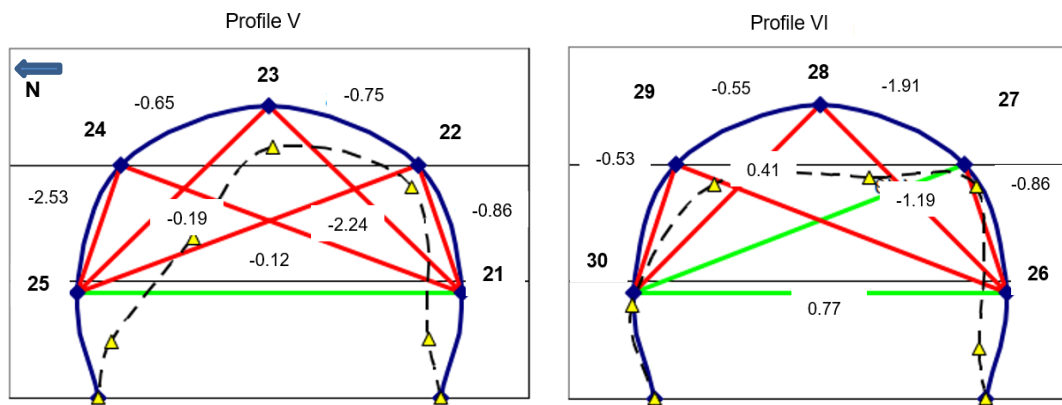
The monitoring results from the upper 40 m strengthened section of the middle tunnel indicated a slow rate movement of the crown towards the south, as shown in Figure 31 [35].

Figure 31: Convergence monitoring profiles V and VI, in the strengthened upper 40 m of the middle tunnel. Convergence (dashed line) compared to initial (blue line) with movement trend towards the south illustrated (not to scale) [35].
