SOIL LIQUEFACTION IN TOKYO BAY AREA DUE TO THE 2011 TOHOKU (JAPAN) EARTHQUAKE

Rolando Orense¹, Suguru Yamada² and Masahide Otsubo³

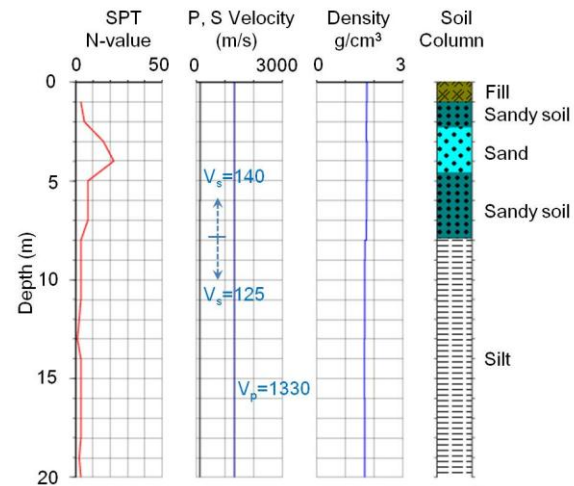
NIED, which maintains the K-Net stations, also has database of the soil conditions at the station locations. Figure 14 shows the soil profile at CHB008 station located adjacent to the City Hall in the old Urayasu area, near the boundary of the reclaimed site Shin-Urayasu (see Figure 3 for location). It can be observed that the sandy deposit is about 8 m thick with shear wave velocity of 140 m/s. Ground observations indicate that this area did not undergo liquefaction. Needless to say, no traces of liquefaction were observed in the natural sand formations in the old Urayasu, a stark contrast to the extensive liquefaction in the reclaimed area of Shin-Urayasu.

Figure 14: Boring log, P and S-wave velocity profiles and soil profile at CHB008 station (data from K-Net).
