# OBSERVATIONS OF THE PERFORMANCE OF EARTH BUILDINGS FOLLOWING THE FEBRUARY 2011 CHRISTCHURCH EARTHQUAKE

Hugh Morris<sup>1</sup> and Richard Walker<sup>2</sup>

## SUMMARY

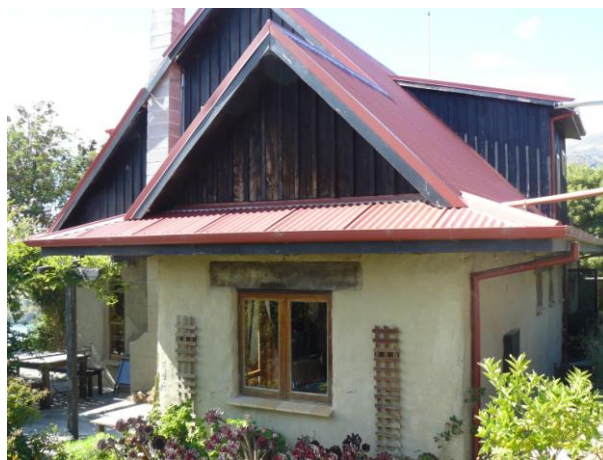
This reinforced adobe house used detailing and reinforcement that is similar to the New Zealand Standards ( see Figure 15).

**Figure 15:** Diamond Harbour reinforced adobe house overall view.

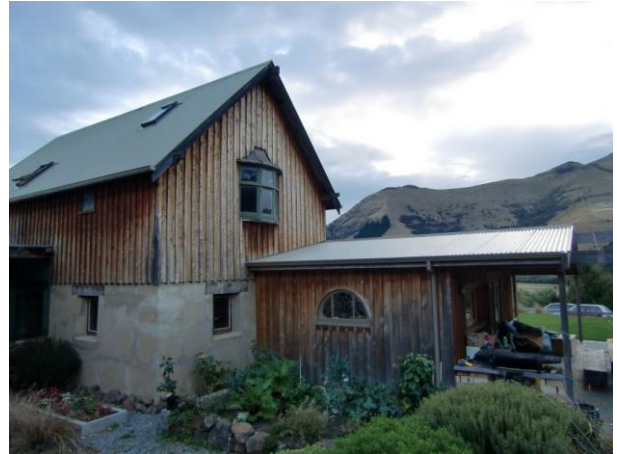
At Little River, House 19 had 2.4 m high and 400 mm thick rammed external earth walls and 300 mm internal walls (Figure 20) that formed part of the lower storey. A 400 mm architectural feature wall stands alone as shown in figures 21 and 22. The walls had a strong timber well fastened bond beam. The house was greater than 22 km from the February epicentre with a reported intensity of MM V and although the walls supported a light timber frame upper level the only damage was hairline cracks that extended less than 500 mm.

**Figure 20:** *Little River rammed earth house 19 overview showing exterior rammed walls.*

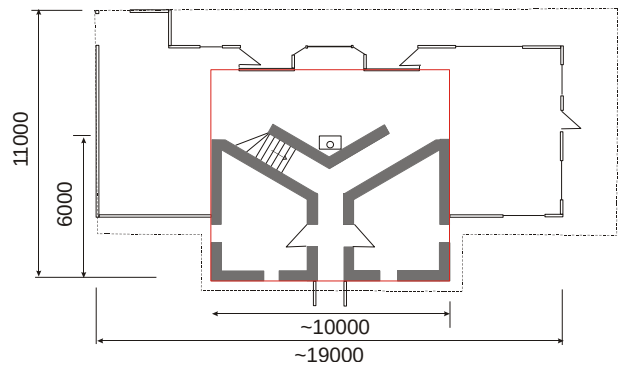
**Figure 21:** *Little River rammed earth House 19 ground floor plan showing rammed walls and outline of upper storey.*

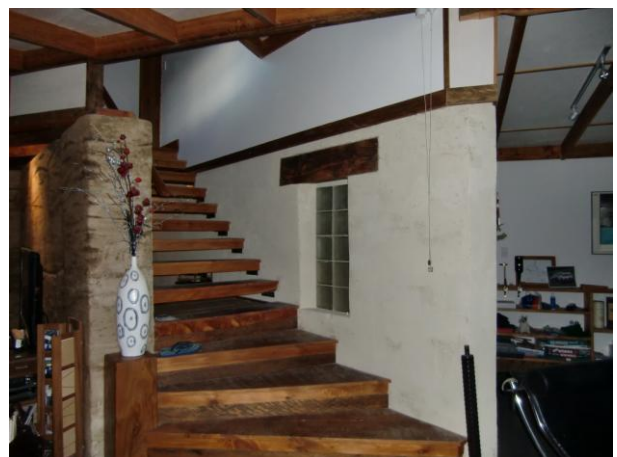
**Figure 22:** *Little River rammed earth House 19 internal feature wall and stairway. (Photo G North)*

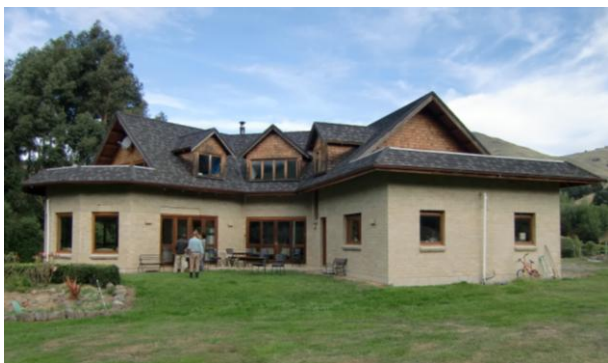
The Little River pressed earth brick house shown in Figures 23-25 had double skin reinforced pressed brick lower storey and performed well under the moderate shaking and significant lateral seismic loads generated by the large second floor and roof and large span beams, and was basically in good shape. Most cracking was reported to have been initiated in the September 2010 earthquake or earlier. No vertical control joints provided for the pressed brick walls, if these were provided there may have been less cracking.

There was no damage to the foundations or to the upper level, the west side of house had 100 by 40 mm studs at 400 mm c/s with 140 mm thick pressed brick veneer.

**Figure 24: Little River pressed earth house 18 overview of north facing walls.**
