# OBSERVATIONS OF THE PERFORMANCE OF EARTH BUILDINGS FOLLOWING THE SEPTEMBER 2010 DARFIELD EARTHQUAKE

**Hugh Morris<sup>1</sup>, Richard Walker<sup>2</sup> and Thijs Drupsteen<sup>3</sup>**

A reconnaissance survey of earth walled buildings in the Canterbury area was carried out in mid October 2010 following the Darfield Earthquake. Fifteen earth walled buildings were inspected during the survey including historic earthbuildings and recently constructed reinforced earthbuildings.

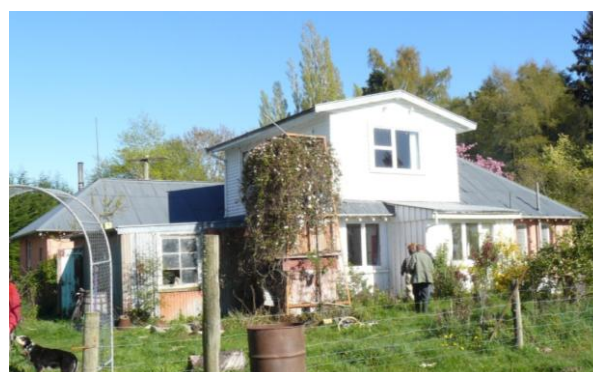
**Figure 5: Hororata Rammed Earth House , 1925, timber additions around 1960. (Building 1)**

The Hororata house shown in figure 5 has unreinforced rammed earth walls and was constructed in about 1925, also in the strong shaking region near Hororata. Two pre-existing

The house suffered moderate new cracking, and the bond beam, which stayed intact, moved horizontally along the walls by approximately 6mm. Movement of the bond beam relative to the wall caused diagonal cracking in the rammed earth wall adjacent to a window.

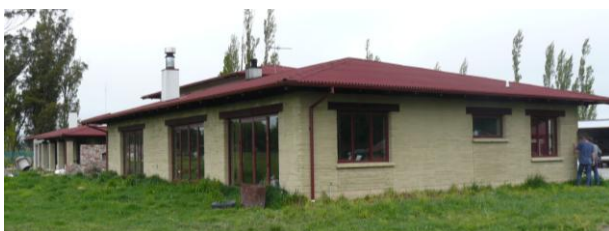
**Figure 8: Sefton Rammed Earth House (Building 10) 1995.**

**a) 500 m<sup>2</sup> rammed earth house with second level over garage**

The Sefton house has single storey rammed earth walls with vertical steel reinforcing. The vertical reinforcing was located at each end of the rammed earth wall panels similar to the details for partially reinforced earth walls in NZS 4299[9]. There was some slight cracking adjacent to some openings. One short internal wall had some minor horizontal cracking which the owner advised occurred during construction.

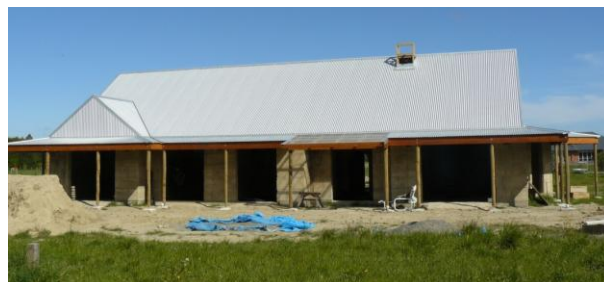
**Figure 13: Sandy Knolls Poured Earth House (Building 5).**  
*2010 Vertically reinforced only but no damage evident.*

A house under construction (Figure 13) near Sandy Knolls experienced very strong shaking with ground accelerations of approximately 0.8 g and estimated MMI of VIII. This house with cement stabilised poured earth walls and steel vertical reinforcing and reinforced concrete foundations and bond beams was under construction at the time of the earthquake. All the earthwalls and roof framing were completed but the roofing was not on and the timber ceiling diaphragms were not yet installed. The building was designed by the owner in accordance with NZS 4299. The building performed well with no damage evident.
