# DAMAGE TO NON-STRUCTURAL COMPONENTS AND CONTENTS IN 2010 DARFIELD EARTHQUAKE

**Rajesh P. Dhakal<sup>1</sup>**

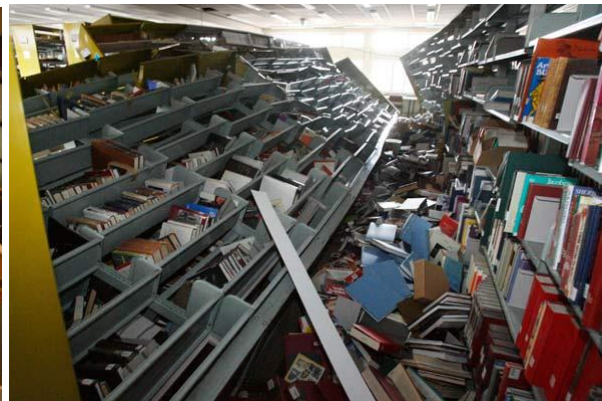
**Figure 7: Typical damage to racks and shelves.**

non-structural elements and suffered no interruption to their business services. One notable exception was damage to storage rack systems and the subsequent loss of stock. The damage to the rack systems varied. Complete collapse occurred to heavily loaded, relatively light gauge racks. It was reported by storeowners that more things fell from racks that were secured to the floor but not to the walls than the racks that were not secured to the floor. This might have been due to lower forces in the unsecured racks as a result of rocking and sliding. In some cases, it has also been found that inadequate provision of bolts in one segment of racking system resulted in twisting of the whole rack (see Figure 7). In some cases, cracks were found in the infill wall panel where the racks were anchored (see Figure 7). A sampling of the observed racking damage is shown in Figure 7.

In offices, unsecured book shelves fell to the floor. In libraries, even the shelves that were tied together collapsed (see Figure 7). It was found that the ties in this case were not strong enough and failed to resist the tilting tendency of the shelves. Shelves tied to the wall and tied with each other using strong ties were intact.

Damage to book shelves in university library

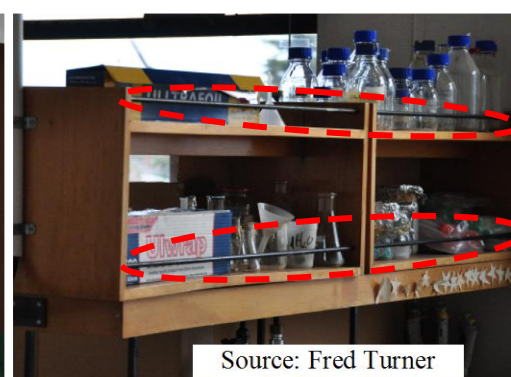
**Figure 9: Examples of good storage practice.**

Lips and bars at the edges of racks protecting the contents from falling down
