# GEOTECHNICAL ASPECTS OF THE 2007 NIIGATAKEN CHUETSU-OKI, JAPAN EARTHQUAKE

**Rolando P. Orense<sup>1</sup>, Masayuki Hyodo<sup>2</sup>, Hiroaki Kanda<sup>3</sup> and Junya Ohashi<sup>3</sup>**

## SUMMARY

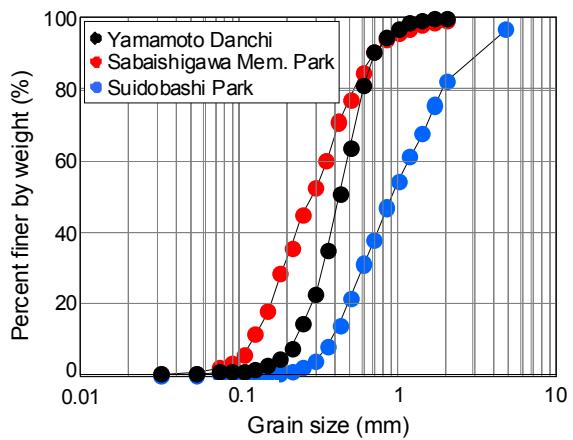
As mentioned earlier, sand boils were observed in various sites such as in riverbank deposits, beach deposits, dune sands and placed fills. Samples were obtained at three sites in Kashiwazaki City, namely in Yamamoto Danchi (Figure 7), Suidobashi Park (Figure 8) and Sabaishigawa Memorial Park (Figure 9) and the corresponding grain size distribution curves are shown in Figure 13. Although it can be observed that the sand boils in Suidobashi Park were much coarser than those in Sabaishigawa Memorial Park, all the grain sizes fit the range proposed by Tsuchida (1971) for materials with a high possibility of liquefaction.

**Figure 13: Grain size distribution curves of ejected sands**
