# RESTORATION OF ROAD AND RAIL TRANSPORTATION FOLLOWING THE GREAT HANSHIN EARTHQUAKE<sup>1</sup> OF 17 JANUARY 1995

I.J. Billings<sup>2</sup>

## ABSTRACT

This paper describes the restoration of the rail and road routes which were seriously damaged in the Great Hanshin Earthquake of 17 January 1995. It is based on observations and data provided during a visit to Kobe, Japan in July 1995, 6 months after the earthquake.

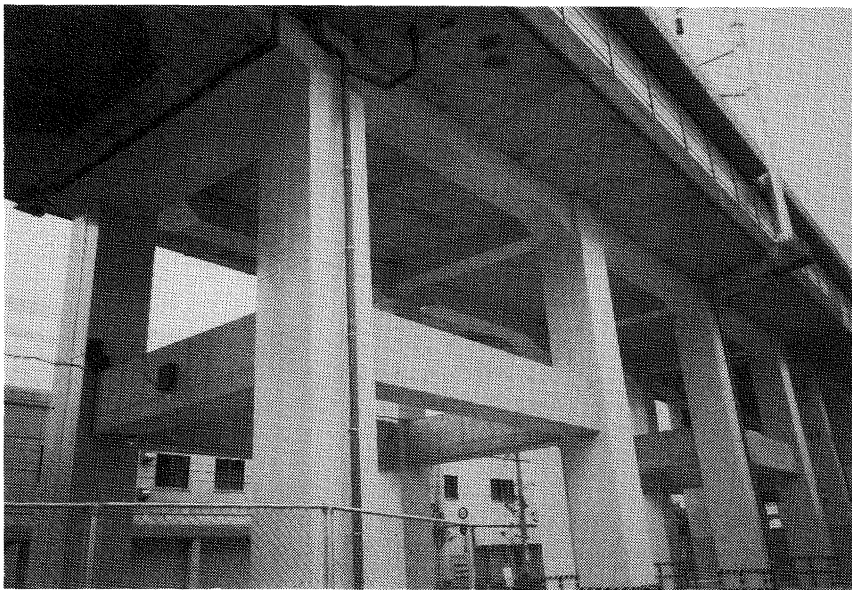
**FIGURE 6.7 Restored Shinkansen Viaduct**

The restored structure is shown in Figure 6.7. The columns are steel encased but the mid height beams are not.

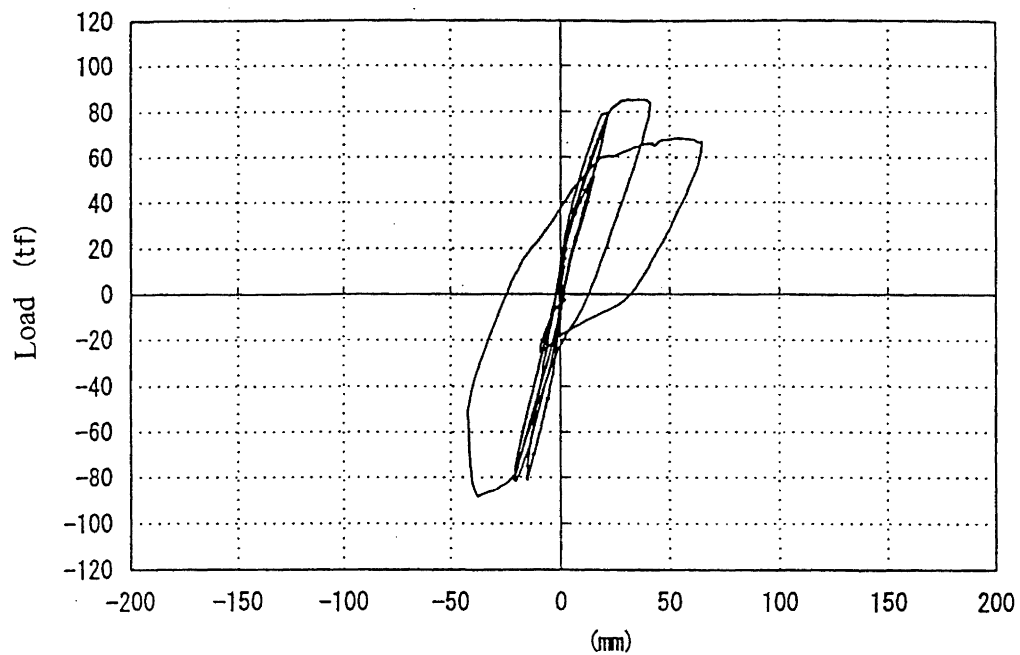
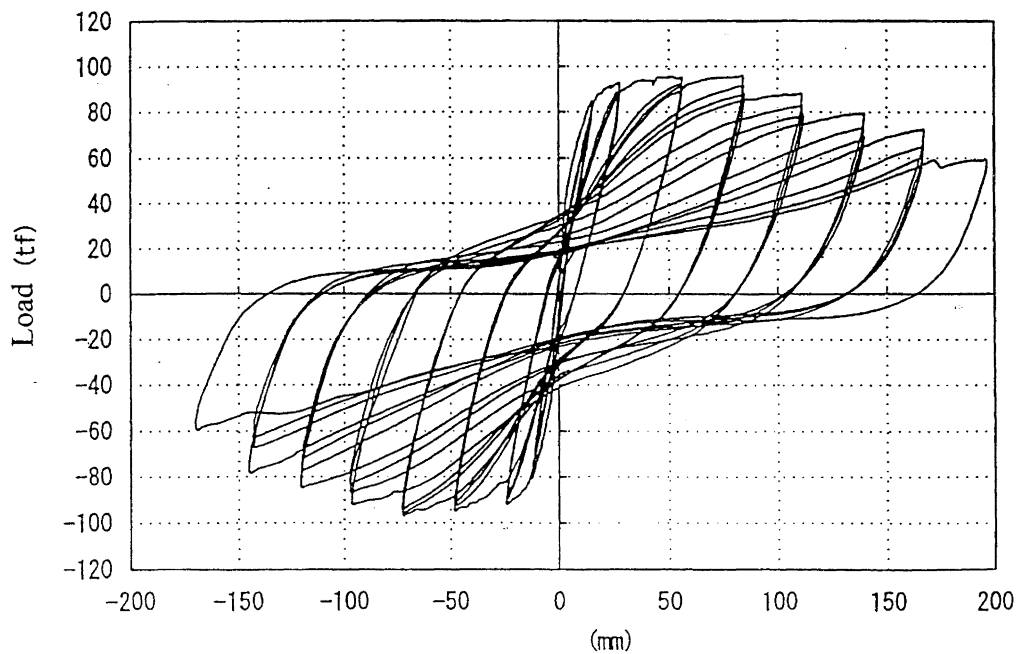
**FIGURE 6.11 Test Results Specimens 1 & 2**

Test results for specimens 1 and 2 are shown in Figure 6.11. As would be expected in the plastic hinge region at the base, the columns grew in dimension as the confining plates were loaded, specimen 2 reaching about 1000mm x 1000mm in size. The assessed ductility capability of the specimens is set out in Table 6.2 below.
