THE BEHAVIOUR, OVERVIEW OF DAMAGE AND RETROFIT OF STEEL BUILDINGS AFTER THE EARTHQUAKES OF SEPTEMBER 1985

Enrique Martinez-Romero⁽¹⁾

Presented at the Pacific Structural Steel Conference, Auckland, August 1986

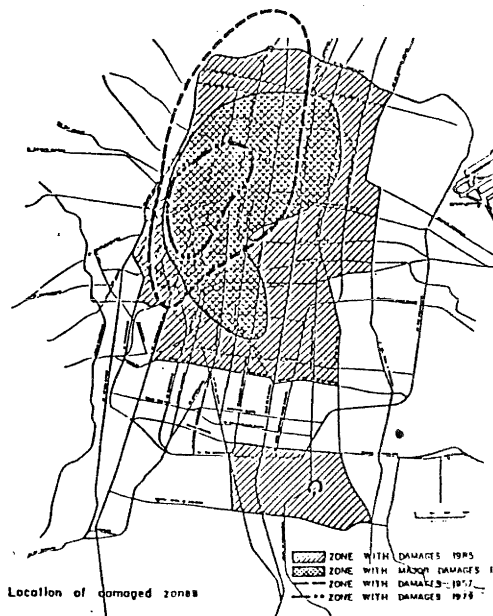
FIG. 3 - DAMAGED ZONE LOCATIONS

Damage from the 1985 earthquake was concentrated in the lake bed zone as shown in Figure 3. Areas of damage from the 1957 and 1978 earthquakes are also shown. In each of these previous earthquakes many buildings in the downtown area of the city were damaged or destroyed. Several of these previously damaged buildings which were not strengthened either adequately or sufficiently, did not survive the most recent earthquake.
