DAMAGE RATIOS FOR DOMESTIC PROPERTY IN THE MAGNITUDE 7.2 1968 INANGAHUA, NEW ZEALAND, EARTHQUAKE

D.J. Dowrick^{1,2}, D.A. Rhoades^{1,3} and P.N. Davenport^{1,3}

SUMMARY

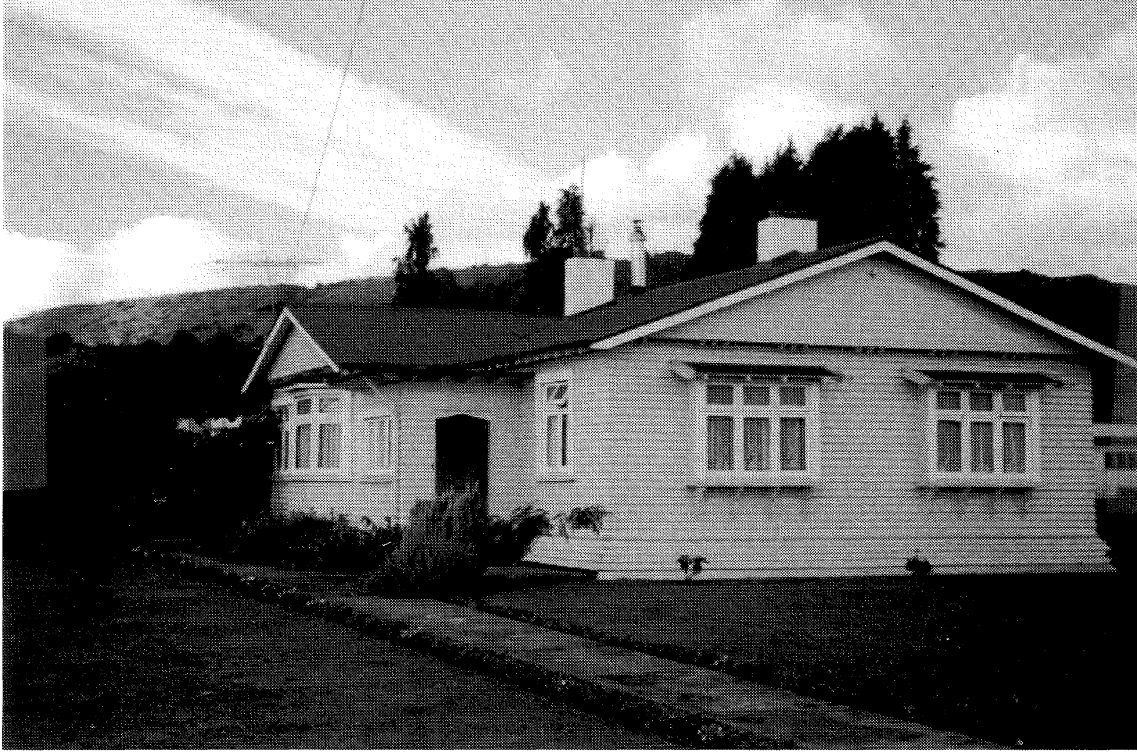
Figure 3(a): The most common type of pre-1968 West Coast house, one storey with a corrugated iron roof weatherboard wall cladding and piled foundations.

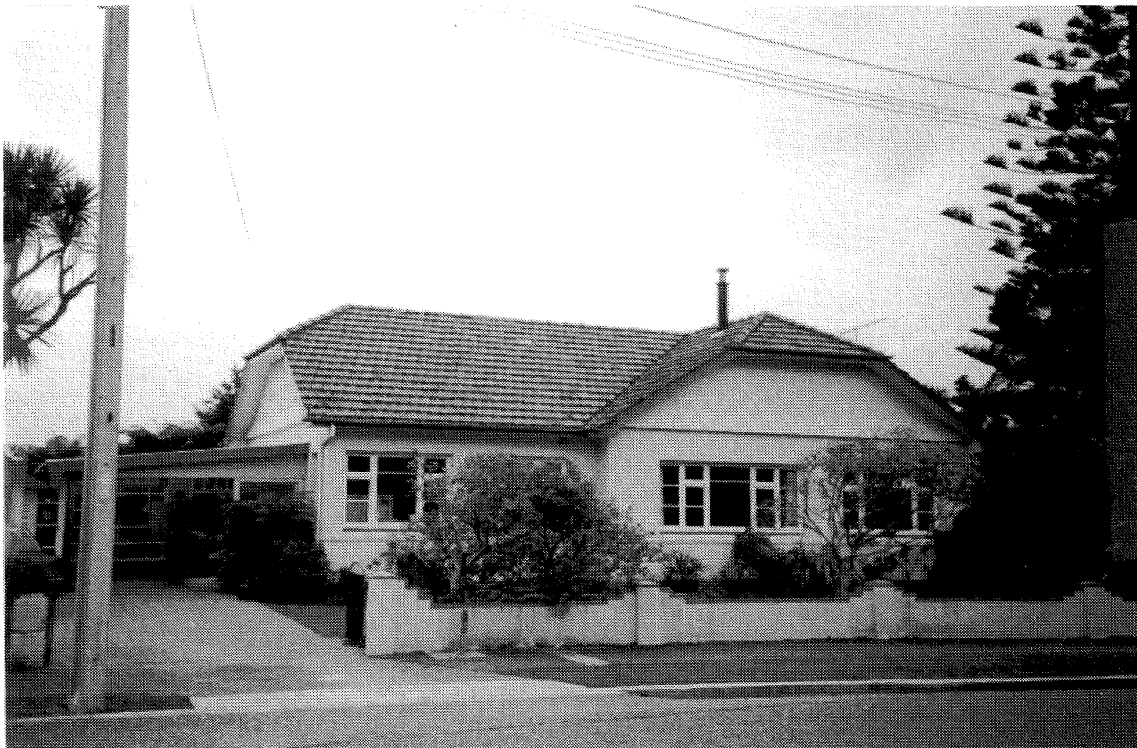
Figure 3(b): A pre-1968 one storey West Coast house with tiled roof, stucco veneer walls and concrete strip foundations.

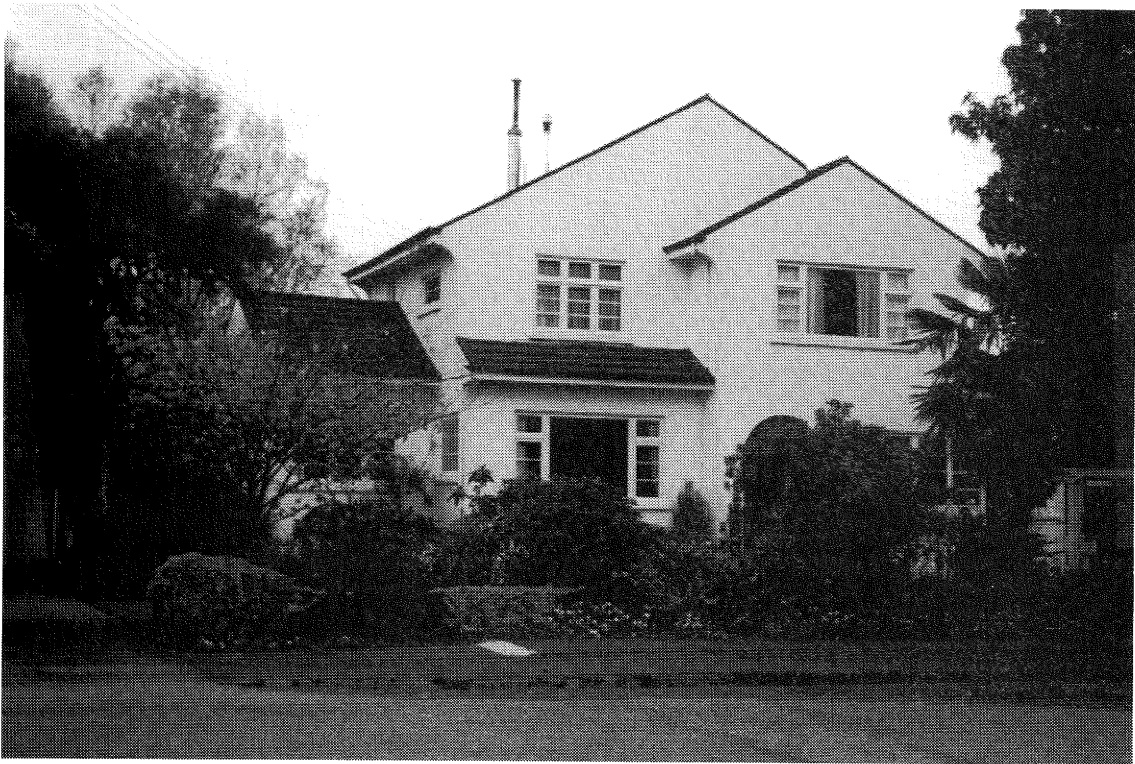
Figure 4(a): A pre-1968 two storey West Coast house with a tiled roof, stucco veneer walls and concrete strip foundation.

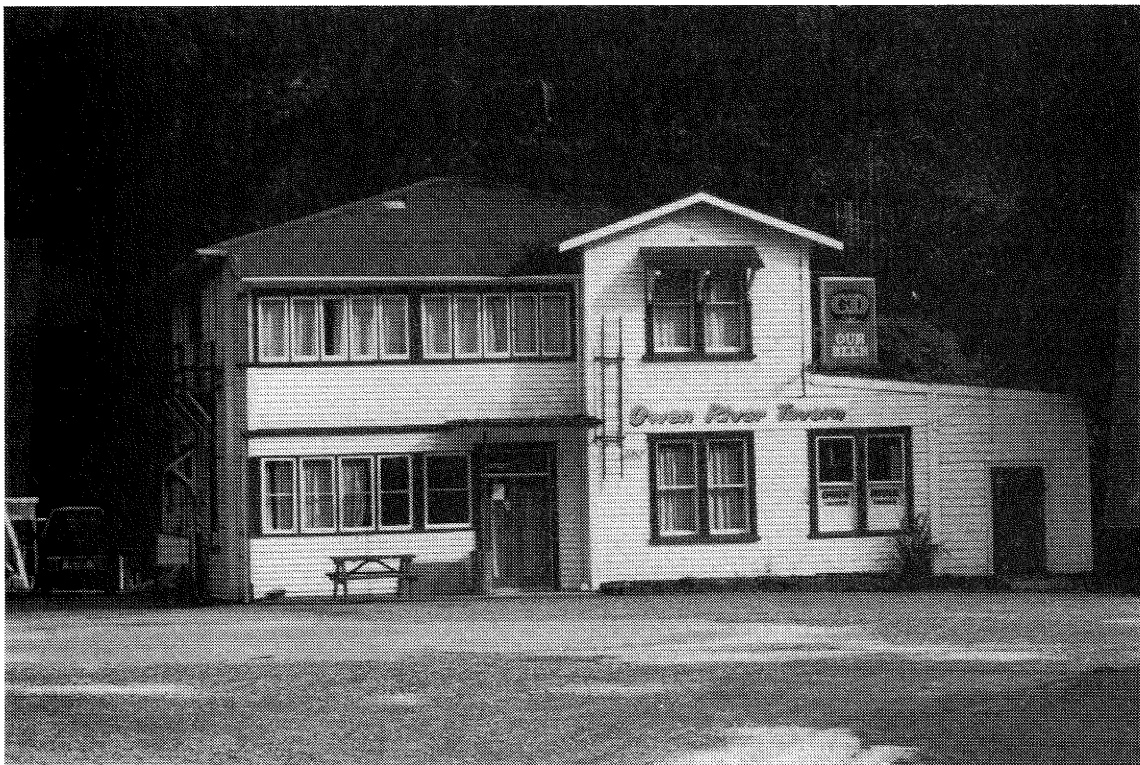
Figure 4(b): A typical pre-1968 two storey hotel of house style construction, with a corrugated iron roof, weatherboard wall cladding and piled foundation.

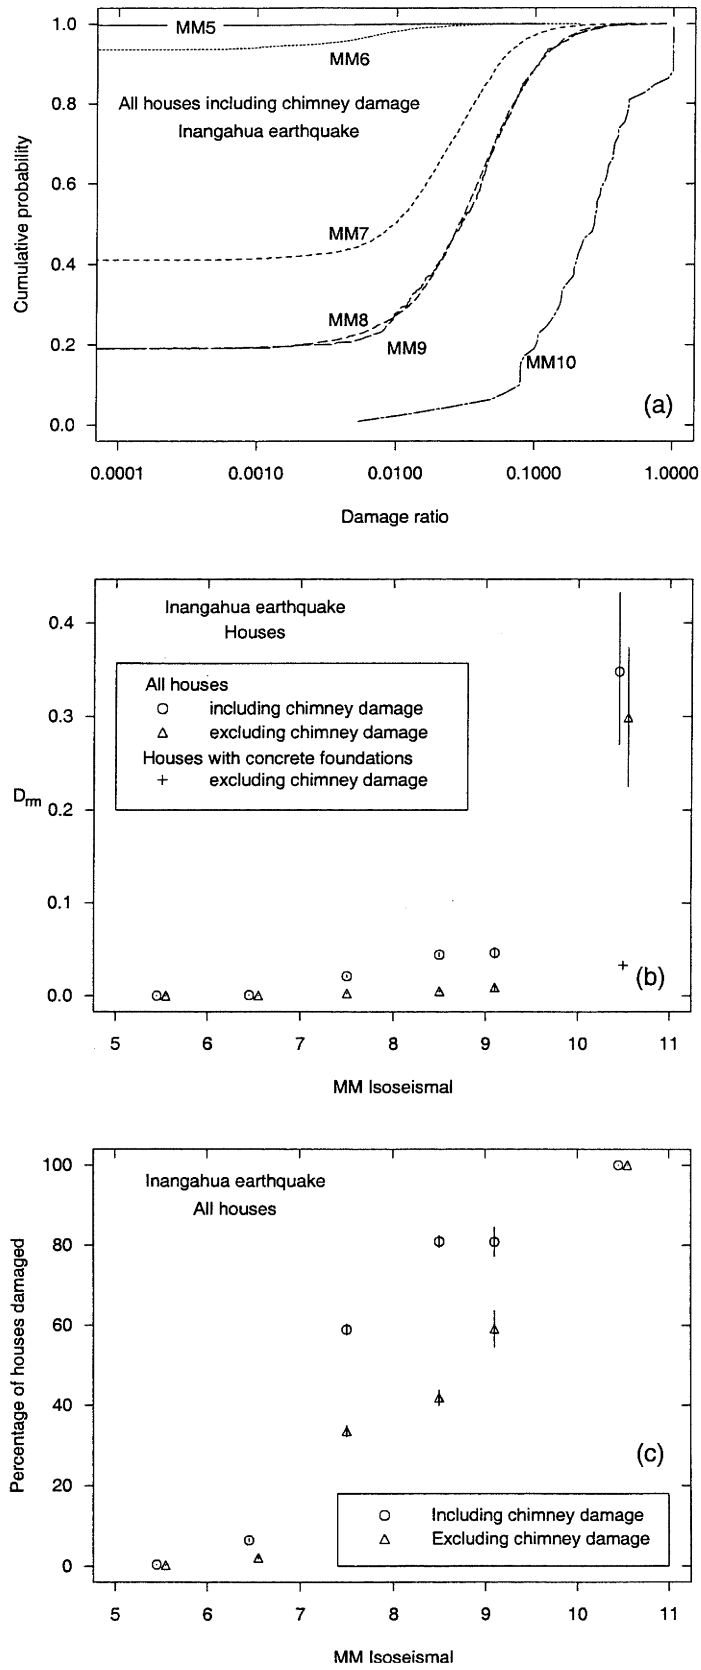
Figure 5: Three measures of vulnerability plotted as functions of MM intensity for all houses in the Inangahua earthquake: (a) Cumulative probability distributions of damage ratio, (b) D_{rm} and its 95% confidence limits, and (c) Percentage of houses damaged with its 95% confidence limits.

Plots of cumulative probability of damage ratios in the Inangahua earthquake are shown for all houses by MM intensity in Figure 5(a). There are six intensity zones, MM5-MM10, i.e. three more than were possible in our richest previous data set [6, 7]. The shapes of the distributions have

the now familiar lognormal form. While very small amounts of damage occur at MM5, Figure 5 shows that the amount of damage is very small and the practical threshold of damage is at MM6 for houses, especially those with brittle chimneys. This is consistent with the definitions of the MM intensity scale [22] (see Appendix 1), and confirms that the outer isoseismals (Figure 1) have been appropriately located.

When considering mean damage ratios, parallel effects are observed to those discussed above in terms of damage ratio distributions. Figure 5(b) shows plots of D_{rm} for six intensity zones. The values of D_{rm} (including all damage) for the Inangahua earthquake range up to 0.35 at MM10.

The remaining key parameter in evaluating damage levels is the percentage of houses damaged, which is plotted against intensity in Figure 5(c) with values ranging up to 100% at MM10. When chimney damage is included, there is a plateau of 81% between MM8 and MM9. These percentages are calculated as n/N from Tables 8, where n is the number of damaged houses including all claims with non-zero costs, where $n = 617, 832, 2961, 2146, 372$ and 55 for MM5-MM10 respectively. When claims below the insurance deductible are excluded the counts of n become $575, 707, 2930, 2133, 371$ and 55 .

definition of the MM intensity scale which states that at MM8 most unreinforced chimneys are damaged and many are brought down (See Appendix 1). This explains the surprising result shown in Figure 5(a), where it is seen that the damage ratio distributions for MM8 and MM9 are virtually identical when all damage is considered. Conversely the expected difference between MM8 and MM9 is seen when the dominating chimney damage is excluded (Figure 6(b)). Figure 6(c) further emphasises the enormous impact of brittle chimneys on the incidence and level of damage, through wide separation of the mean distributions and their 95% confidence limits at intensity MM8 for the cases including and excluding chimney damage.

Next consider mean damage ratio as affected by brittle chimney damage. The influence of chimneys on D_{rm} is very apparent in Figure 5(b) where D_{rm} is seen to range from 2.0×10^{-5} (excluding chimneys) at MM5 to 0.044 (including chimneys) at MM8 and then flattening off to rise only slightly to 0.046 at MM9. This plateau was explained above as a result of chimney damage reaching a near maximum at MM8. The dominance of brittle chimneys as an indicator of vulnerability is also illustrated by the ratio of D_{rm} including chimneys with that excluding chimneys, which in round figures is 1.8, 6, 9, 9, 5 and 1.2 for MM5 to MM10 respectively (Figure 7). The figure of 1.2 for the MM10 zone is close to that of 1.3 obtained for the MM10 zone in Napier in 1931 [8] where all houses also had brittle chimneys, and were of similar construction (weatherboarded and piled) to those of the Inangahua area.

Finally, consider the effects of chimney damage on the percentage of houses damaged, as depicted in Figure 5(c). The ratio of the percentage damaged including chimney damage with that excluding chimney damage is 1.5, 3.2, 1.8, 1.9, 1.4 and 1.0 for MM5 to MM10 respectively (Figure 7). For Napier (MM10 in 1931) [8], as in the Inangahua village area in 1968, nearly all houses had damage other than that caused by chimneys, the above ratio being 1.01. Considering the whole of the affected area (MM5 - MM10), the number of houses damaged would have been reduced by about 45% if no brittle chimneys had existed.

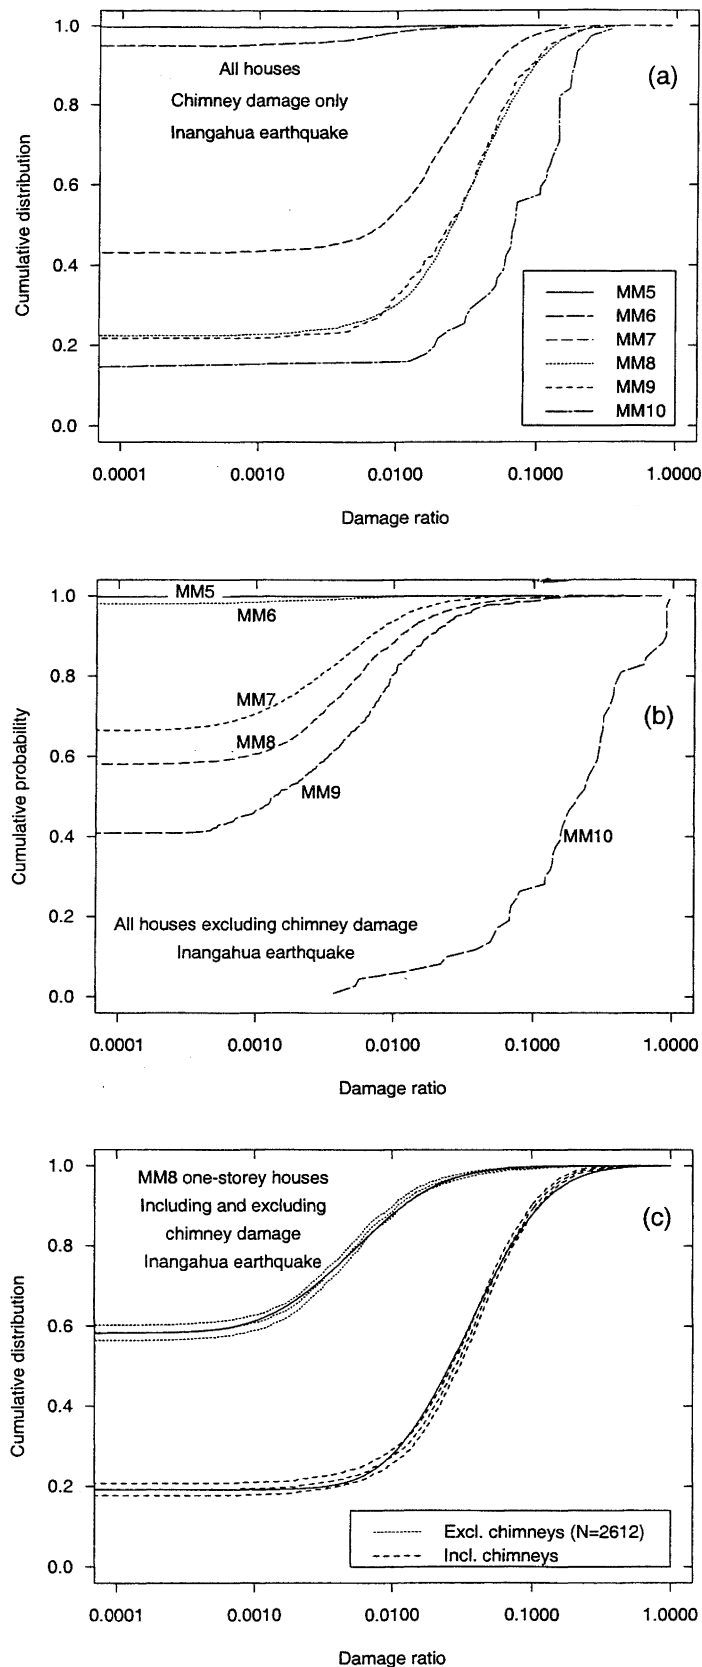
Figure 6: Three plots of cumulative probability distributions of damage ratio as a function of MM intensity for houses in the Inangahua earthquake: (a) One storey houses considering chimney related damage only, (b) All houses excluding chimney damage, and (c) One storey houses in the MM8 zone comparing cases including and excluding chimney damage. In (c), 95% confidence limits for the empirical distribution and the fitted lognormal curves for one storey houses in the MM8 zone with and without chimney damage.

First consider the distributions of damage ratios plotted in Figure 6(a) where the damage costs are restricted to those related to chimneys for intensities MM6 – MM10. The plots show emphatically how chimney damage saturates at MM8, with the curves for MM8 and MM9 being almost indistinguishable. This is what should be expected from the

In Figures 6(c) the fitted lognormal curves as expressed by μ and σ in Tables 7 and 8 lie close to the empirical cumulative probability curves, though the fit is not quite as close as in previous studies [6-10]. It is noticeable that the fit at MM8 is better for the case where chimney damage is excluded than when it is included, and this was the case for the other intensity zones also. This is understandable, because chimney damage not only contributed a high proportion of the total, but was also less variable than the damage due to other causes. This means that the distribution of damage ratios including chimney damage is effectively a mixture of two distributions with different variances, which cannot be represented completely by the single variance parameter σ of the lognormal model.

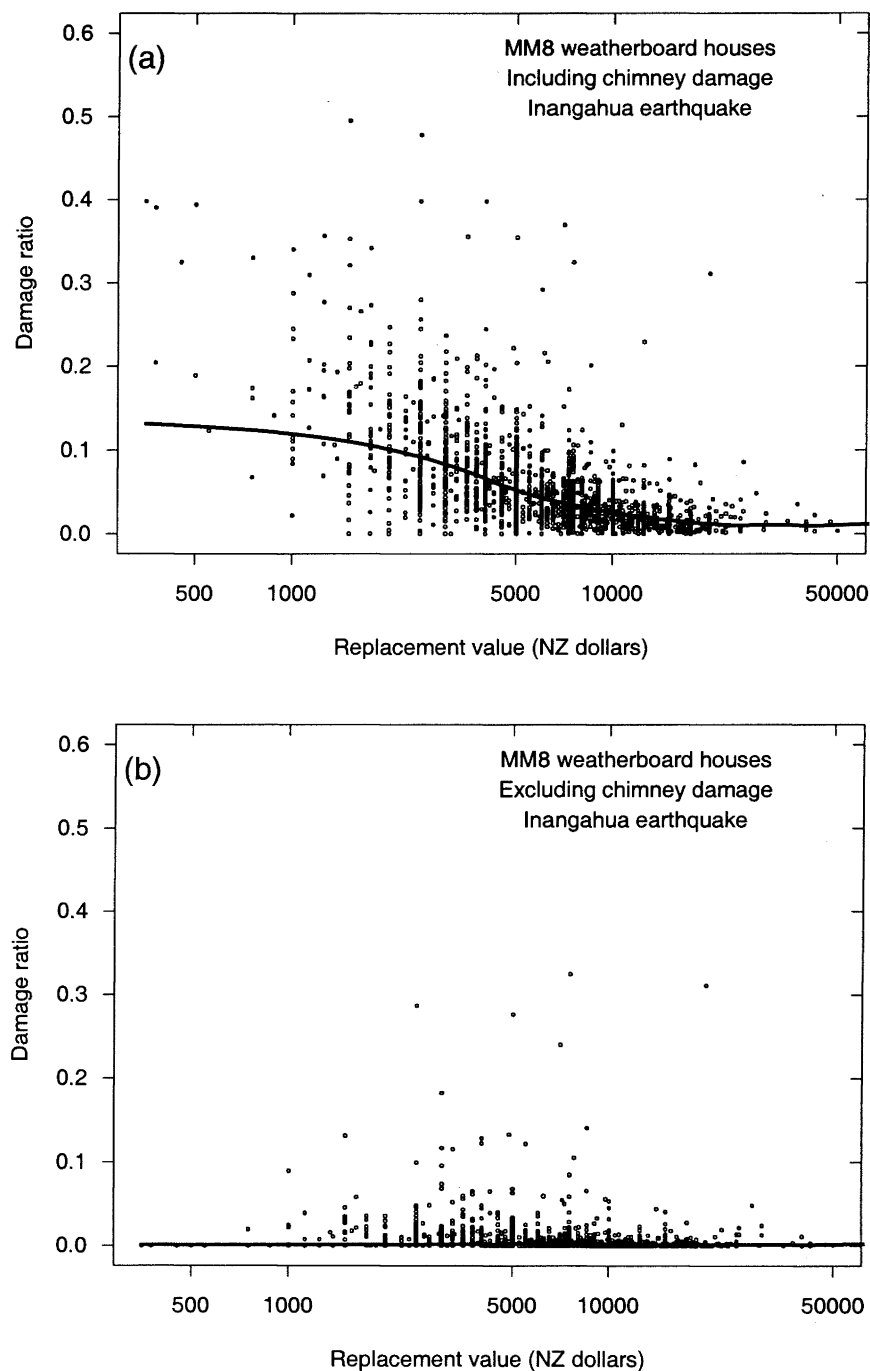
Figure 9: Plots of damage ratio versus insured value for one storey weatherboard houses in the MM8 intensity zone of the Inangahua earthquake, including a robust smooth trend line: (a) Including chimney damage, and (b) excluding chimney damage.
