BEHAVIOUR OF A PRESTRESSED CONCRETE INTERIOR BEAM-COLUMN ASSEMBLY UNDER CYCLIC LOADING: UNIT 1 TEST RESULTS

R. Park* and K. J. Thompson+

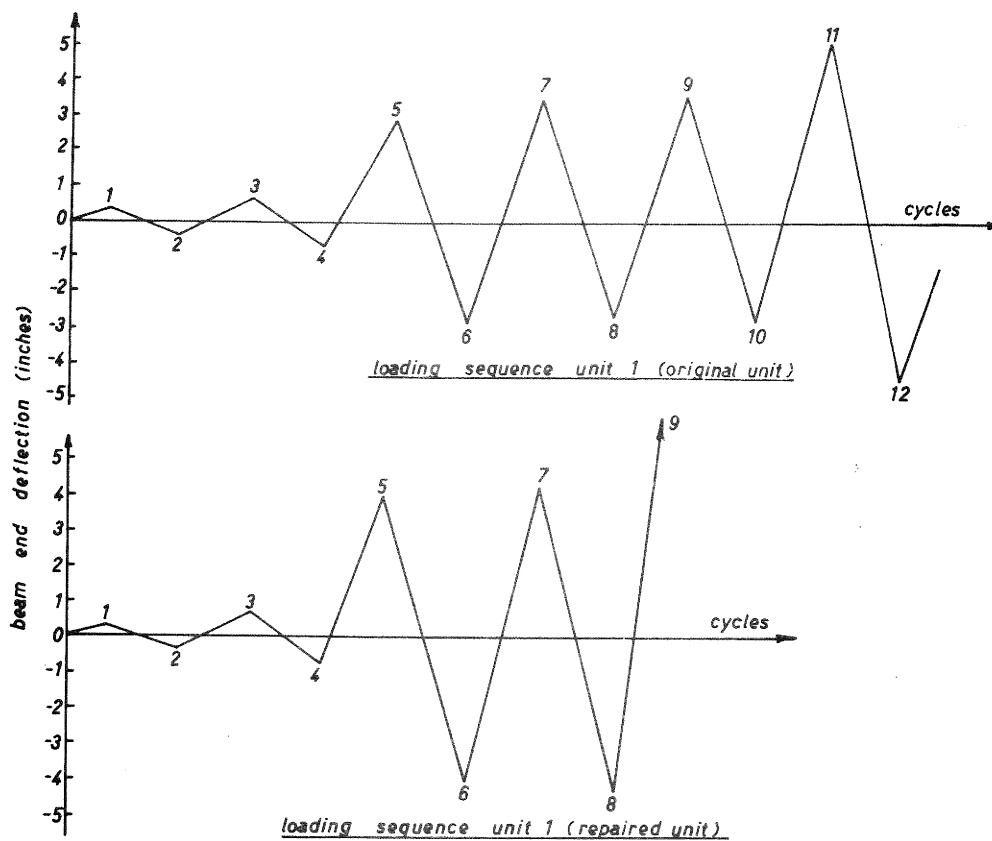
Fig. 6 Deflections of Beam Ends During Loading Cycles.

Fig. 8 shows the vertical displacement at the end of the left beam plotted against the beam moment at the column face. The numbers on the curves correspond to the peak of the loading cycles illustrated in Fig. 6. In loading cycles 1 to 4 the deformations were within the elastic or cracked elastic range of the beams. In these cycles the area within the load-deflection loops in Fig. 8 was small, indicating little energy dissipation during these initial cycles, and the recovery of deflection on releasing the load was almost complete. In load cycle 5 the beam reached its maximum moment capacity and crushing of compressed concrete commenced at the critical beam sections. On unloading some residual

After the testing of Unit 1 it was decided to repair the damaged concrete and to retest the unit to see if satisfactory structural behaviour could be achieved. The damaged beams were first jacked back to the horizontal position. (in practice this "straightening" of the structure may be the most difficult part of the repair operation). The damaged concrete in the plastic hinge regions was then chipped away (see Fig. 12) and two $\frac{1}{2}$ in dia. stirrups were placed around the remaining core of the beams in each damaged region. A mould was placed around the beam and new concrete was cast to give the original cross-sectional dimensions. After a time interval for curing and gaining strength the repaired test unit was loaded through the sequence shown in Fig. 6.
