SEISMIC EFFECTS OF BRACING IRREGULARITY OF LIGHT TIMBER-FRAMED BUILDINGS

Angela Liu¹ and Minghao Li²

(Submitted February 2022; Reviewed April 2022; Accepted July 2022)

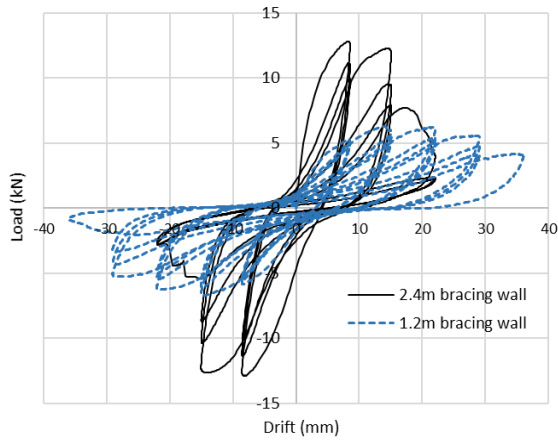
Figure 4: Load-drift hysteresis of 1.2m and 2.4m bracing walls without hold-downs.

Studies of P21 tests at BRANZ [18] show that an LTF plasterboard wall of reasonable length is expected to experience significant strength degradation and softening when the wall drift exceeds 22 mm over a 2.4 m storey height, i.e. approximately a drift ratio of 1%. Thus the drift ratio of 1% is established as the damage control criterion in evaluating the seismic performance of our case study buildings in an ULS earthquake event.

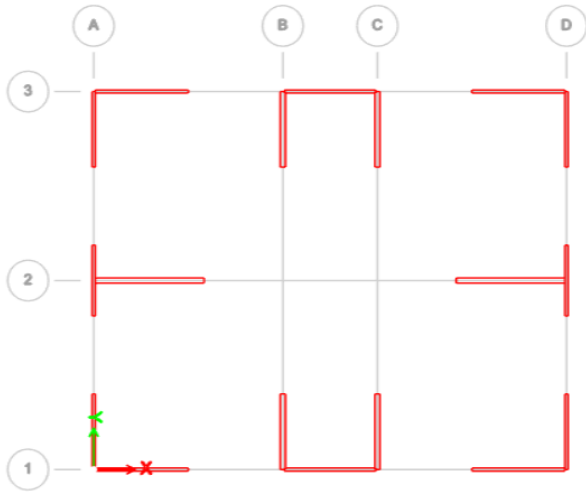
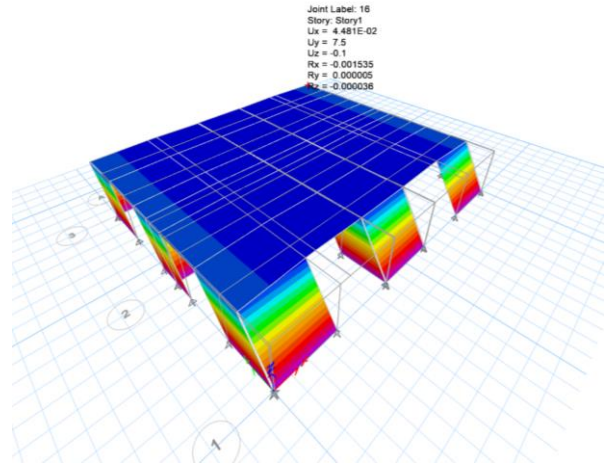
(i) Undeformed plan view

(ii) 3D deformed view

Figure 6: Deflections obtained for case study building RR.

Figures 6 to 8 graphically show the obtained lateral deflections at the roof eave level for three case study buildings when subjected to y directional seismic actions derived from NZS 3604:2011. Table 6 details the obtained Y directional deflection results of the case study buildings at the roof level.

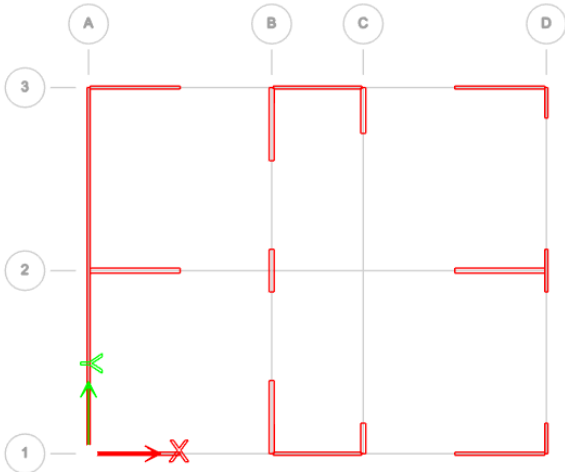
(i) Undeformed plan view

(ii) 3D deformed view

Figure 7: Deflections obtained for case study building IR1.

As described previously, the three case study buildings have varying degrees of plan irregularities, which are permissible by NZS3604:2011. Comparison of the induced lateral deflections of building RR with building IR1, as the values in table 6, shows that extreme irregular bracing arrangements as allowed by NZS 3604:2011 could result in significant amplification of lateral deflections, resulting in significant earthquake damage to the buildings in design earthquake events. In detail, the largest induced lateral deflection under an ULS seismic action as specified by NZS 3604:2011 was respectively 7.5 mm for the perfectly regular building RR and 37.8 mm for the extremely irregular LTF building IR1. A lateral deflection of 7.5 mm over a storey height of 2.4 mm of an LTF building is well within the established damage control limit, 1% drift ratio. In contrast, a lateral deflection of 37.8 mm over a storey height of 2.4 m of an LTF building (about 1.6% drift ratio for the case study building IR1) means that the building will experience significant damage and might end up with demolition due to high repair cost. The analysis indicates that the current irregularity limits in NZS 3604:2011 are not robust enough to avoid excessive damage and achieve reasonably consistent seismic performance of LTF buildings.

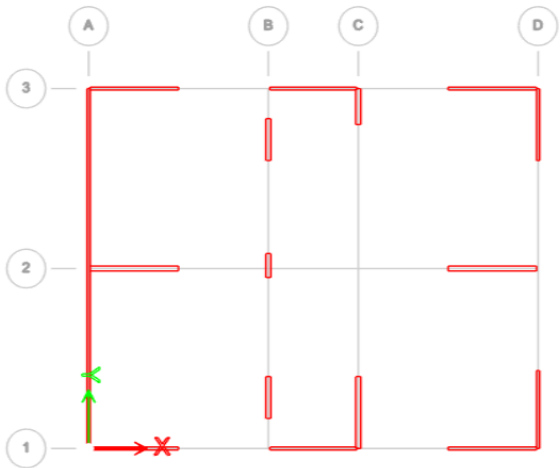
(i) Undeformed plan view

(ii) 3D deformed view

Figure 8: Deflections obtained for case study building IR2.

As shown in Table 6, this adjustment resulted in a significantly reduced lateral deflection, and the maximum lateral deflection for building IR2 was smaller than 22 mm, which is the established damage control limit 1% drift ratio. This implies that the current irregularity limits in NZS 3604:2011 should be tightened and the minimum bracing provisions along the bracing lines, especially the perimeter lines, should be revised in order to reduce the building torsional effect and enhance the seismic resilience of the LTF houses.
