DAMAGE STATES AND CYCLIC BEHAVIOUR OF DRYWALLS INFILLED WITHIN RC FRAMES

A.S. Tasligedik¹, S. Pampanin¹ and A. Palermo¹

SUMMARY

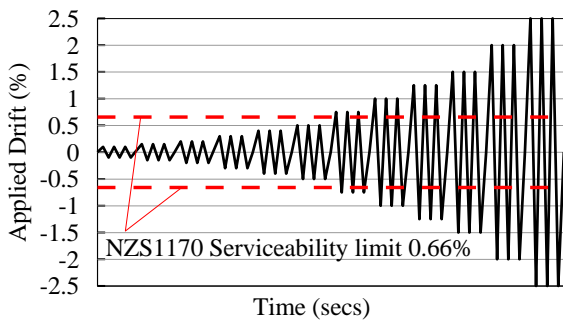
Figure 4: The applied drift history for quasi-static reverse cyclic testing.

Following the above criterion, the drift history shown in Figure 4 was prepared and used in the tests

The steel framed drywall was subjected to the given displacement history in Figure 4. At the initial cycle of 0.1% drift, there was no apparent damage to the drywall. At 0.15% drift, hairline cracking at the lining and the RC frame interface was observed for the first time. At 0.2% drift, the first cracking between the lining interfaces was observed. The observed damage up to this point was within serviceable levels. However, at 0.3% drift, the cracked lining interfaces deformed more and started to push against each other resulting in bowing at the interface. At 0.3%, also initiation of damage to the fasteners was recorded. Moreover, 0.3% corresponded to a slight strength drop followed by the ductile post-yield behaviour caused by the loss of the strut action given by the lining. At 0.4% drift, the bowing damage at the interfaces progressed further and lining A (refer to Figure 11 for the naming of the linings) started to rock on the lower beam causing some toe crushing at the bottom right corner of lining A. Further damage concentrated mainly around lining A and lining B. The force-displacement curve and the recorded measurements are shown in column B in Figure 10. The damage mechanism and damage summary of the test is shown in Figure 11.

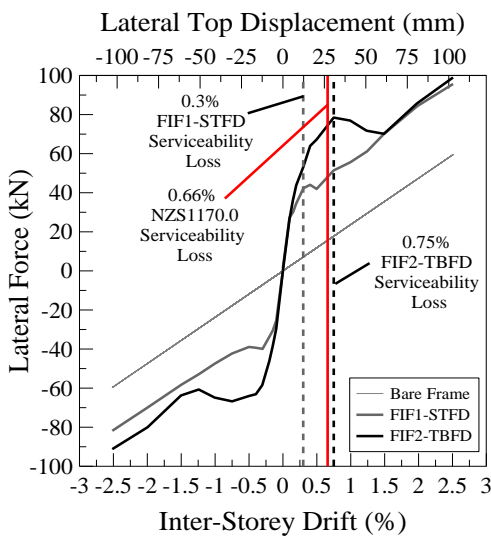
Figure 13: The envelope curves of BF, FIF1-STFD and FIF2-TBFD.

These values are summarized in the corresponding total force envelope curves in Figure 13. From these, it can be stated that the limit given by the equation (2) does not provide a reliable result for the steel framed specimen, FIF1-STFD. For the

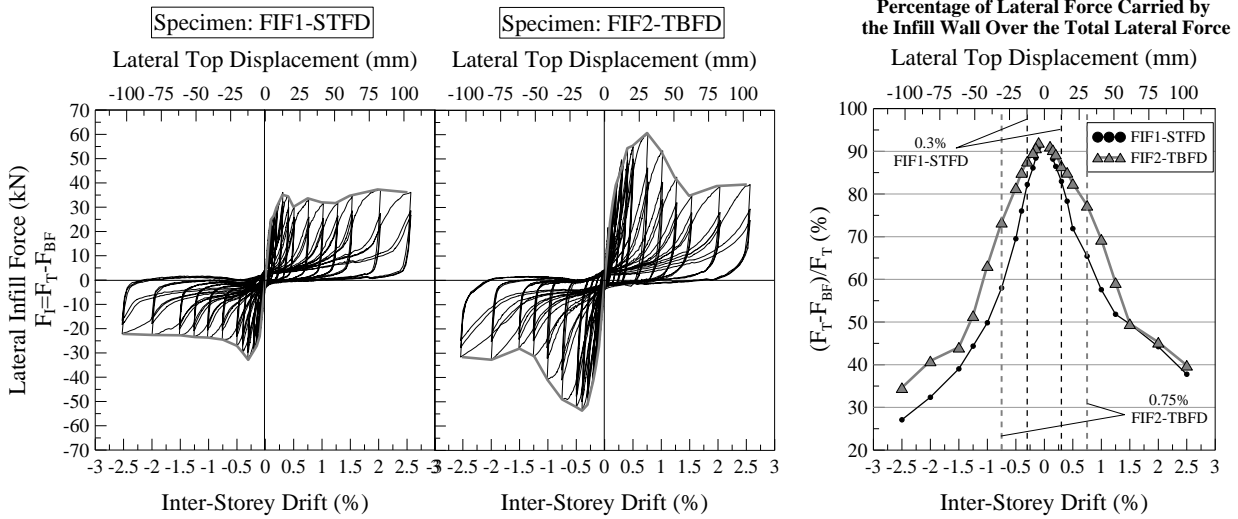
Figure 14: The curves for the lateral force carried by the infill walls ($F_I = F_T - F_{BF}$) vs. the inter-storey drift and its percentage over the total lateral force.

These numbers are consistent with the measured force-deflection curve for the timber framed specimen, FIF2-TBFD, in Figure 14. In this figure, the highest force carried by the infill wall approximately corresponds to 60 kN. Therefore, it can be deduced that at 0.75% drift, the boundary anchors between the timber and lower beam progressively started to rupture under shear, which in turn caused a brittle behaviour on the global response and increased deformation demand between the wall and the lower beam. This demand resulted in the crushing of the corner of the linings in the next cycles.

Another important observation can be made when the percentage of the total lateral force carried by the infill wall is plotted versus the imposed drift levels (Figure 14). Although both specimens lost their serviceability at different drift levels, the percentage of the total lateral load resisted by the infill walls are approximately 80% at these drift levels (82% for FIF1-STFD, 77% for FIF2-TBFD). As can be seen in that figure, as higher drifts are applied, this percentage decreases geometrically while following similar curves. However, it should be noted that these values are strongly related to the stiffness and strength of the surrounding frame. Given the characteristics of the testing apparatus, e.g. hinged shim at the first level beam and low level of initial post tensioning, the lateral load capacity of the frame is increasing as the drift increases. In a more standard situation, the “yielding” or nominal lateral load capacity of the bare frame will be achieved more rapidly (e.g. 0.6-1% drift) and have a less remarked hardening with increased drift level.

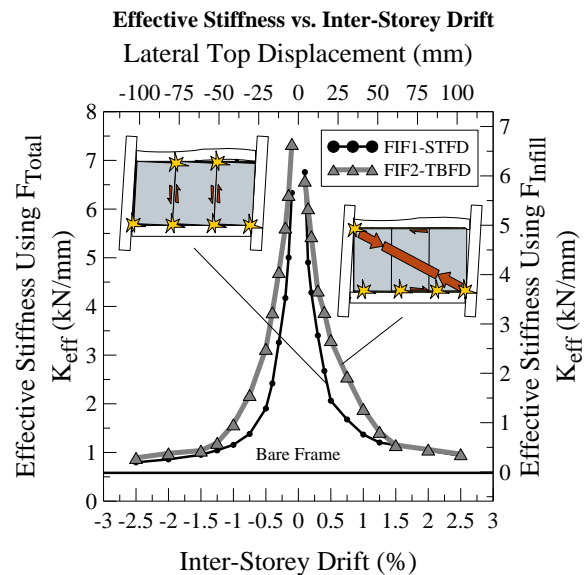
Figure 15: Stiffness degradation with respect to the inter-storey drift, plotted using total lateral force (left axis) and using the lateral force exerted by the infill wall (right axis).

dissipation properties with the major difference being at the initial stages until the 1.5% drift level where the connections of the timber framed specimen contributed the most to the difference. However, these values are very minor and negligible in structures. Moreover, the effective stiffness values were calculated using the points on the total force (F_T) and infill force (F_I) envelope curves of each specimen (Figure 15). Note that a conventional bare frame effective stiffness is usually about 0.3-1 kN/mm at ultimate. In the reported work, the effective stiffness of the bare frame is 0.55 kN/mm and thanks to the elastic behaviour of the setup, it remains constant at each displacement stage. Depending on the bare frames of different stiffness, these curves may shift. In the reported study, the bare frame is a very flexible bare frame which is used to observe the wall behaviour and its interaction.

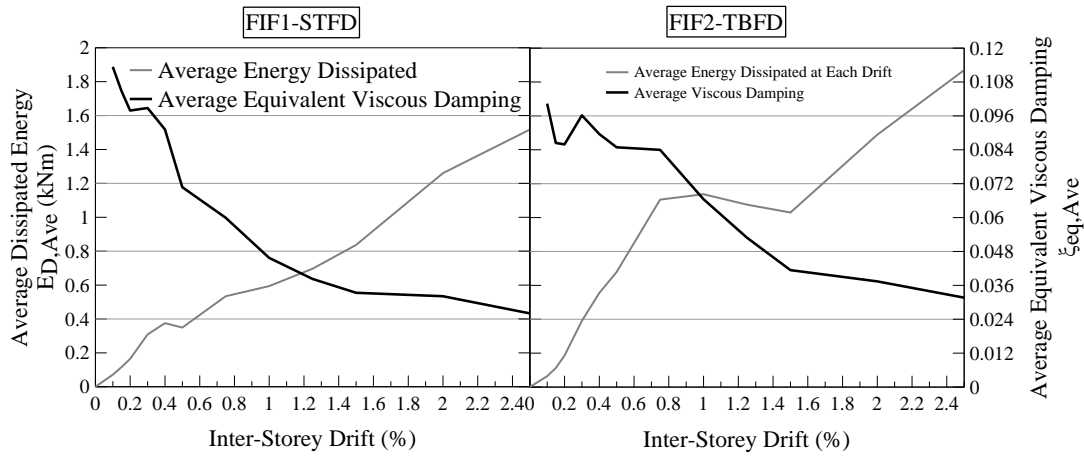
Figure 16: Average viscous damping/ dissipated energy with respect to inter-storey drift.

The calculated values for ζ_{eq} and E_D are averaged at the applied drift amplitudes and plotted in Figure 16. As can be seen, both specimens have comparable damping and energy
