PREVALENCE OF NEW ZEALAND'S UNREINFORCED MASONRY BUILDINGS

Alistair P. Russell¹ and Jason M. Ingham²

SUMMARY

Unreinforced masonry (URM) buildings remain New Zealand's most earthquake prone class of building. New Zealand URM buildings are classified into typologies, based on their general structural configuration. Seven typologies are presented, and their relative prevalence, age and locations are identified.

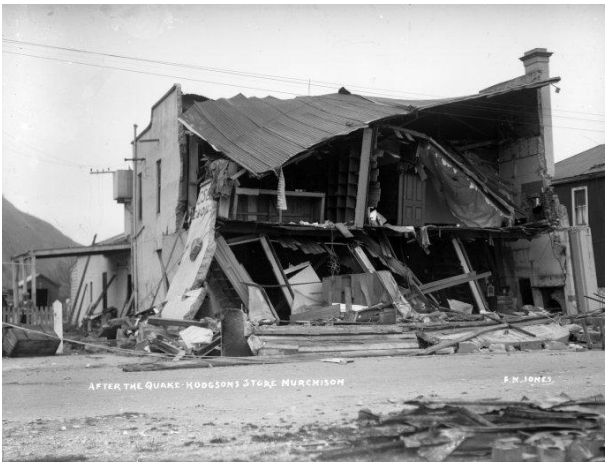
Figure 15: *General store damaged by the 1929 Murchison earthquake [Alexander Turnbull Library].*

The M7.8 earthquake that struck Murchison on the 17th of June 1929 was felt throughout New Zealand [15]. Fortunately, the most intense shaking occurred in a mountainous and densely wooded area that was sparsely populated. Casualties were therefore comparatively light and the damage was mostly confined to the surrounding landscape, where the shaking triggered extensive landslides over thousands of square kilometres. Nonetheless, the shock impacted with damaging intensities as far away as Greymouth, Cape Farewell and Nelson (see Figure 15 and Figure 16). Fifteen people were killed in the Murchison Earthquake.

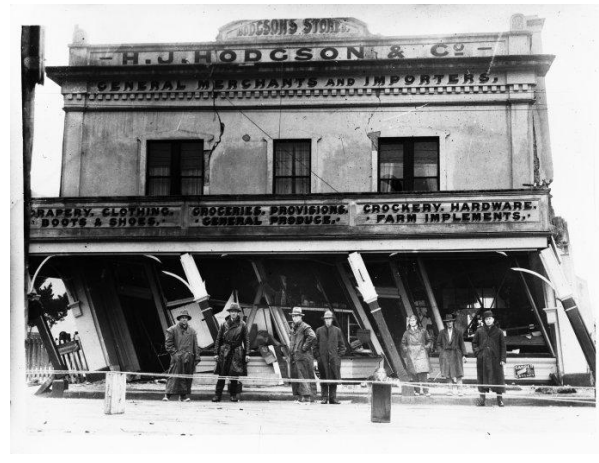
Figure 16: *Damaged business premises after the earthquake of 17 June 1929 [Alexander Turnbull Library].*

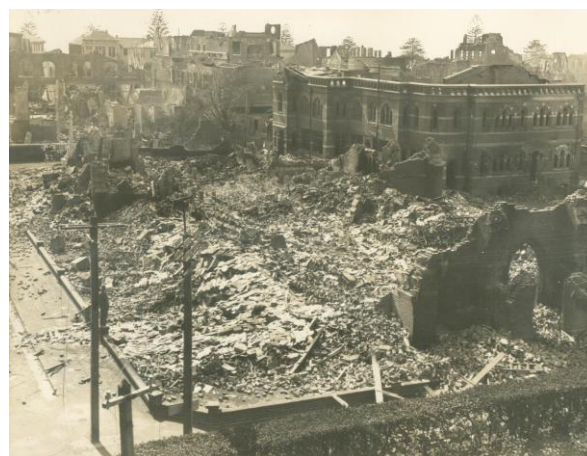
Figure 22: *Ruins of the Napier Anglican Cathedral after the 1931 Napier Earthquake [Alexander Turnbull Library].*

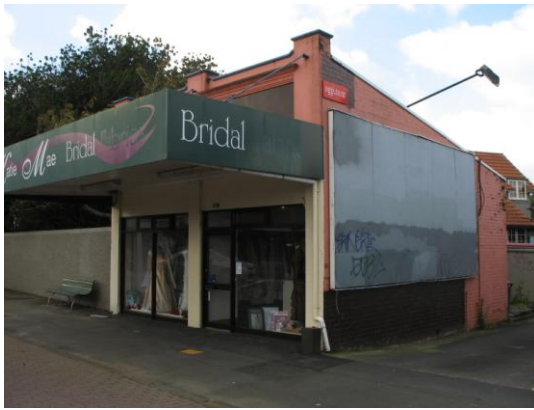
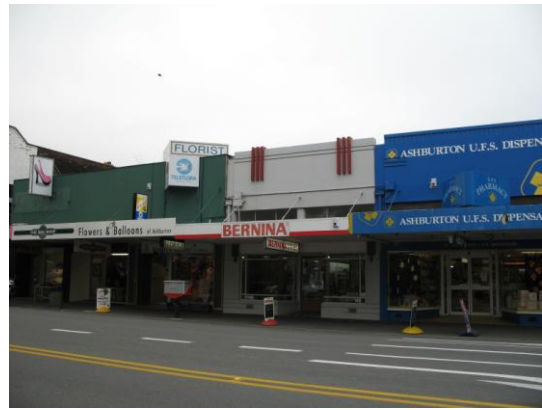
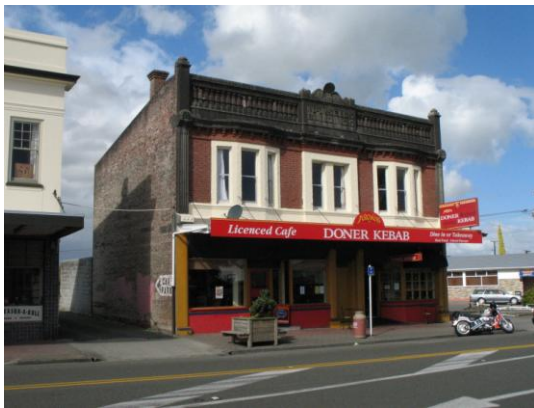
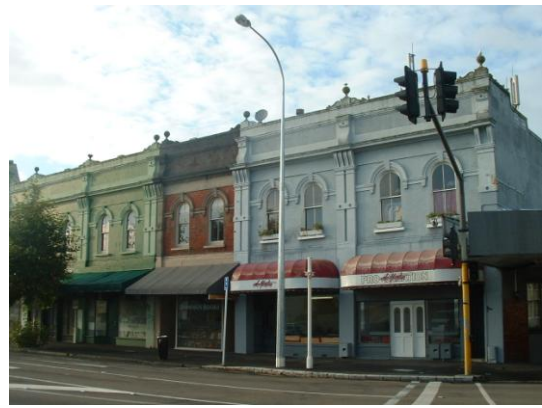
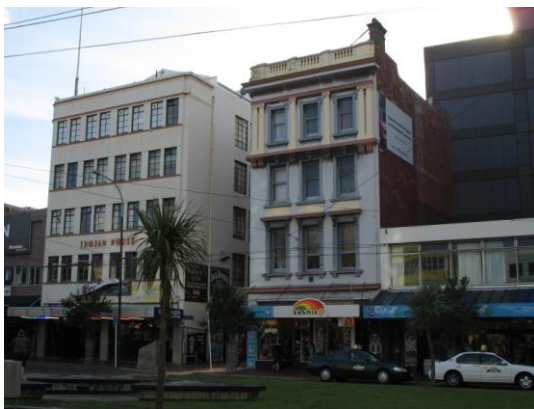
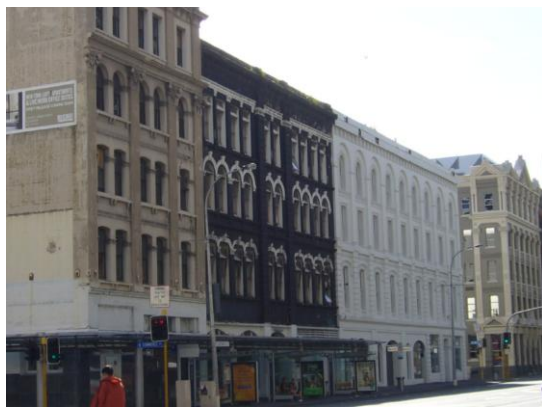
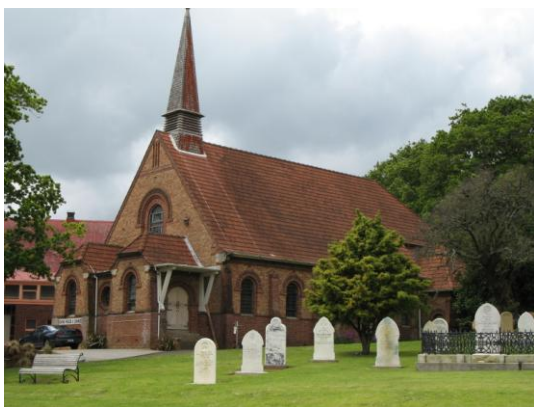
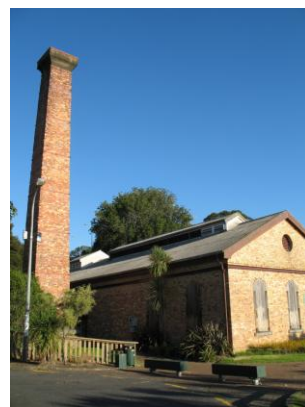
Figure 25: Photographic examples of New Zealand URM typologies.

Typology A building – one storey isolated.

Typology B building – one storey row.

Typology C building – two storey isolated.

Typology D building – two storey row.

Typology E building – three+ storey isolated.

Typology F building – three+ storey row.

Typology G building – religious.

Typology G building – institutional.

It has since been identified that the New Zealand building stock warrants seven typologies, which are outlined in Table 1, and photographic examples are given in Figure 25. Buildings are separated according to storey height, and whether they are isolated, stand-alone buildings or a row building made up of multiple residences joined together in the same overall structure. A suggestion for the expected importance level of the structure is also given, according to AS/NZS 1170.0:2002 [22]. All identified URM buildings fall into importance level 2 or higher, with medium to high consequences for loss of human life. Within the identified typologies, further distinctions can be made. For example, Type A buildings can be divided into those which have a dividing wall down the centre (Type A1), and those which do not (Type A2). Type G buildings are generally monumental structures and those which do not fit easily into the other categories. Usually for such structures unique detailing is encountered, and unique analyses are necessary. Nevertheless there are useful sub-classifications which can also be made within this grouping.

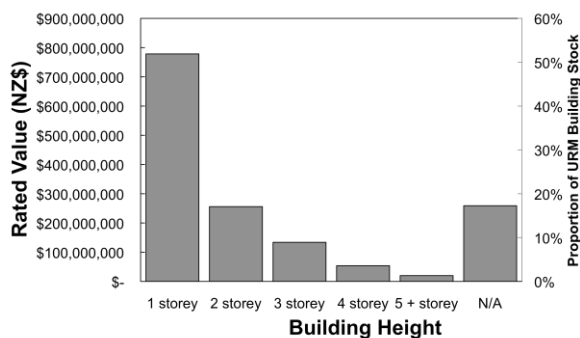
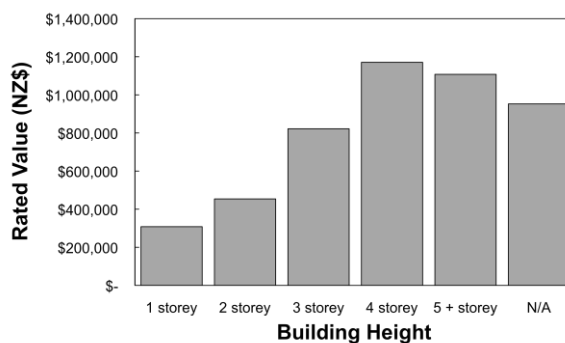
Figure 30: Valuation of URM building stock according to height.

(a) Total value

(b) Average value

The aggregate of the financial value and the average value of each building height are shown in Figure 30, and Figure 31 shows the number of URM buildings according to storey height. There was a small number of buildings where the number of storeys was estimated as 5 or 6, and these were grouped as 5+ storeys.

As shown in Table 6, New Zealand has in existence nearly 3,600 URM buildings, with a collective financial value (in 2009) of approximately NZ\$1.5 billion. The majority of the URM building stock consists of one-storey buildings, with the caveat on how this was determined noted above. It is clear from Figure 30 that as the building height increases, the average value of the building also increases. Because the number of one-storey buildings is by far the greatest, the aggregate value of that building height is also the greatest, despite the comparatively low average value of each building. Thus it appears that the New Zealand URM building stock is largely made up of smaller, lower value buildings, and that in particular, the combination of one- and two-storey URM buildings constitutes 86% of the entire New Zealand URM building stock (see Figure 32). One-storey buildings make up 70% of all buildings, but only 51% of the total value of all URM buildings, and conversely buildings taller than one-storey make up only 30% of the number of buildings, but 49% of the value. The average value of the building should determine the investment associated with seismic assessment and retrofit, and thus it may be concluded that while there are comparatively fewer larger buildings, the investment associated with their seismic assessment and retrofit can be justifiably higher. Similarly, low-rise buildings may require simplified and repeatable assessment methods and retrofit interventions.

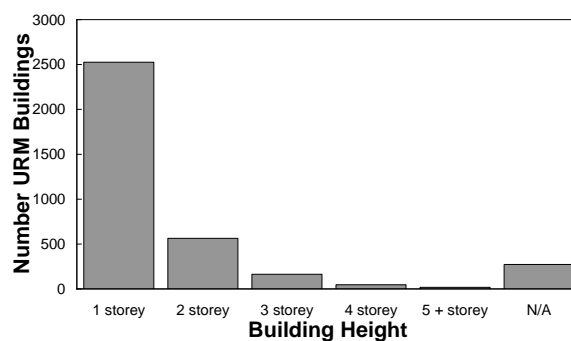
Figure 31: Number of URM buildings according to storey height.

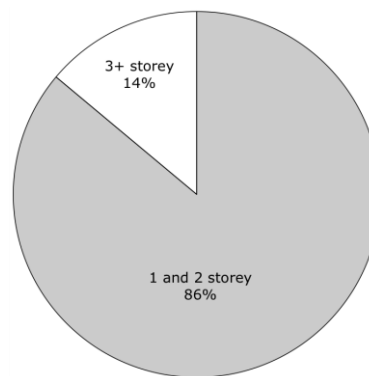
Figure 32: Number of “low rise” (1 and 2 storey) buildings as a proportion of all New Zealand URM buildings.

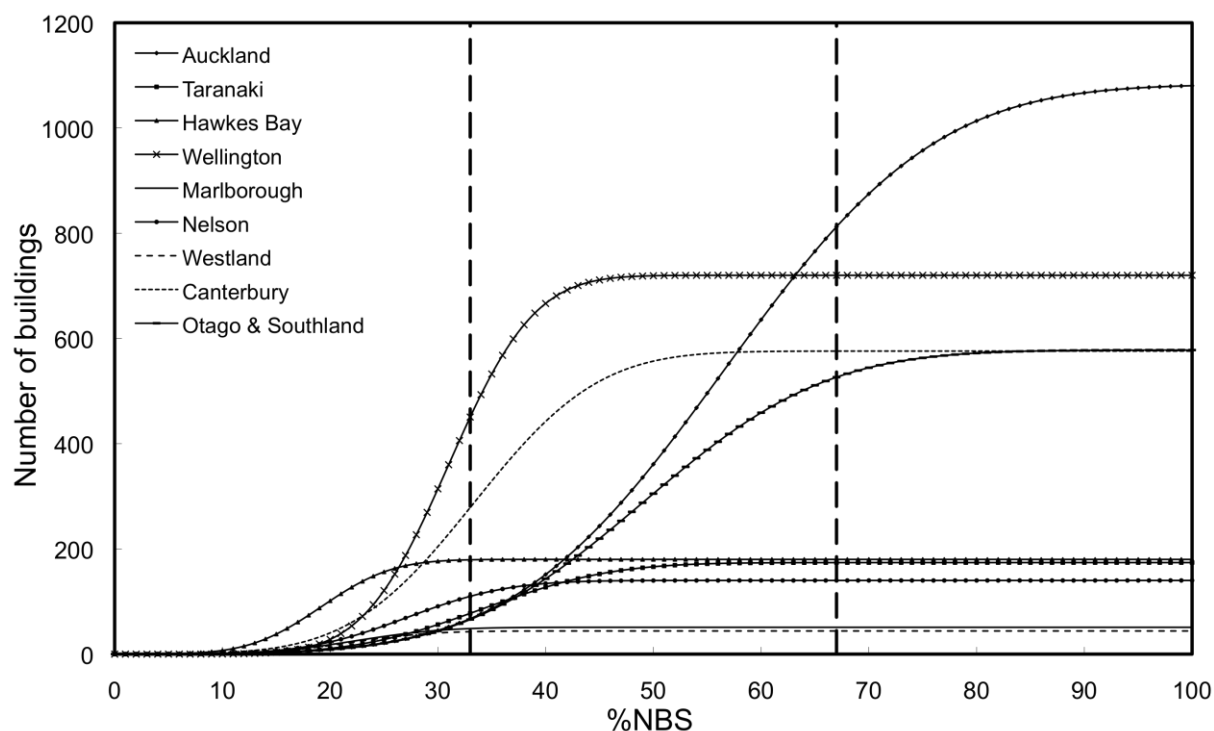
Figure 33: Estimated %NBS of URM buildings in Provinces throughout New Zealand.

Applying the mean number of URM buildings estimated from both methods above (3,750 URM buildings in total) to the normal distribution of %NBS scores, an estimate of all the %NBS scores for each of the provinces can be evaluated, as shown in Figure 33. From Figure 33 the number of URM buildings in each province with an estimated %NBS below 33, between 33 and 67, and above 67 can be evaluated. Thus the number of URM buildings in each province which are

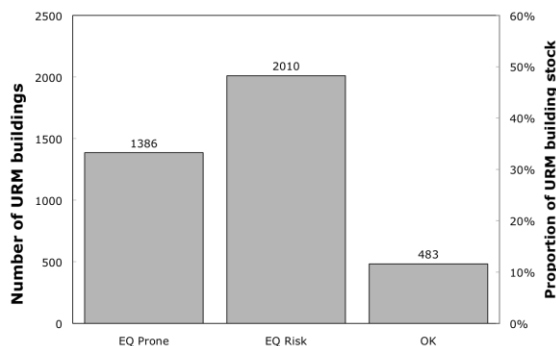
**Figure 35: National estimate of potentially earthquake prone and earthquake risk URM buildings.**

potentially earthquake prone, potentially earthquake risk and unlikely to be significant, respectively, can be estimated. This is shown in Table 8 and aggregated to determine the estimated overall number of URM buildings in these categories throughout all New Zealand, as shown in Figure 34 and Figure 35. From these results (Figure 33 – Figure 35 and Table 8), it can be seen that up to 35% of URM buildings currently existing in New Zealand could be potentially earthquake prone, and additionally up to 52% could be potentially earthquake risk, such that approximately only 13% of existing URM buildings can be expected to not be a significant earthquake risk. Most of these buildings are in regions of higher seismicity, which is the most critical factor in the vulnerability of URM buildings. Bothara *et al.* [37] noted from assessments conducted in Wellington, that “most unreinforced masonry buildings have been confirmed as potentially earthquake prone.” This statement is in agreement with the results presented here, in which 92% of URM buildings
