EARTHQUAKE STRENGTHENING OF OLD MASONRY WITH REFERENCE TO THE AUCKLAND FERRY BUILDING

C R Gurley* and J S F Nicholls*

Auckland Branch of the
INSTITUTION OF PROFESSIONAL ENGINEERS (NEW ZEALAND) ON
WEDNESDAY 18 AUGUST 1982

ABSTRACT:

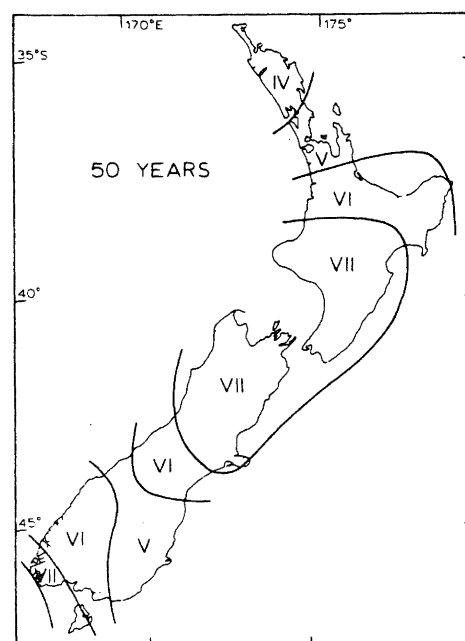
Figure 1

Figure 1. Shows the expected Mercalli intensities with a mean return period of 50 years.

THIS RETURN PERIOD FOR A NORMAL BUILDING IS TAKEN ON 50 YEARS BEING A GENERAL BUILDING LIFE. THIS CURRENTLY IS TOO SHORT!

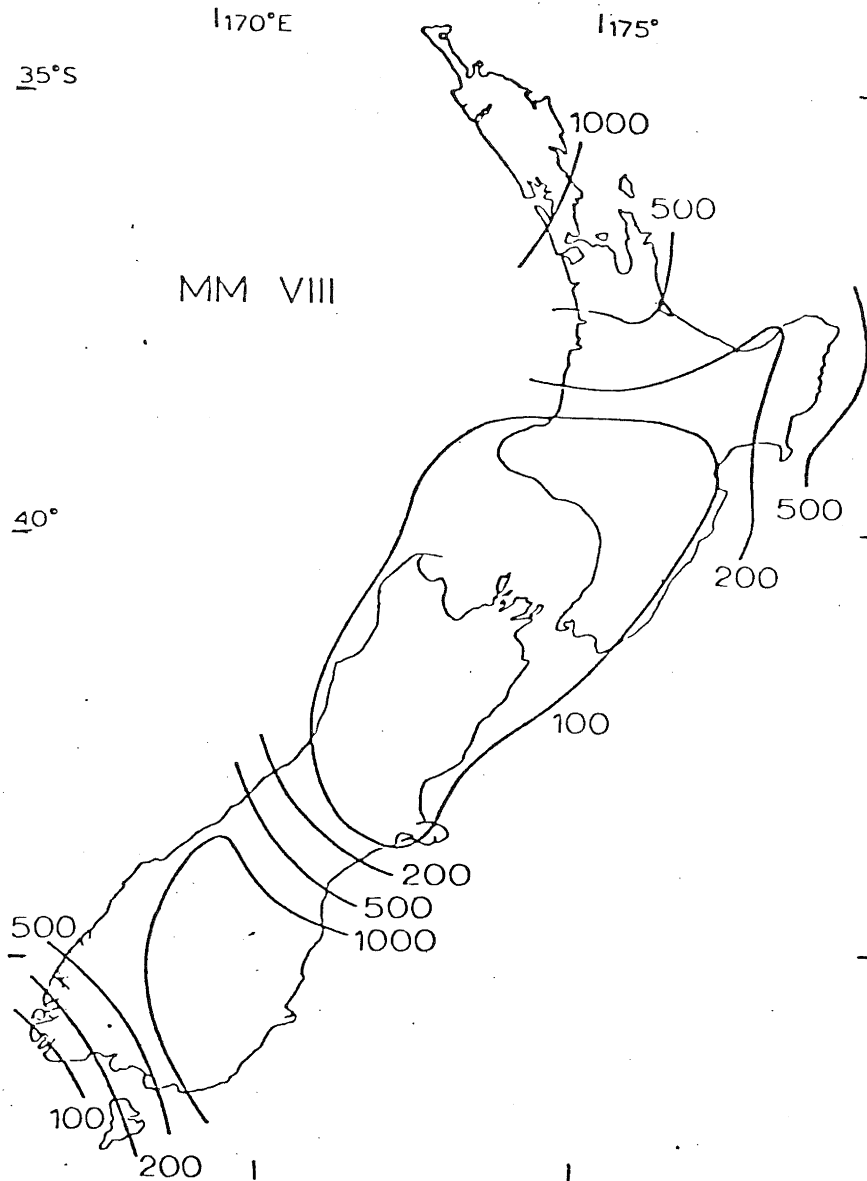
Figure 2

Figure 2. Shows the mean return period (years) for Mercalli intensities VIII and greater.

With respect to restoration and conservation of buildings, earthquakes with intensity of MM7 or greater are of interest. We note that the predicted mean for Wellington is 20 years but the last MMVII has been in 1942 - 37 years ago. Before that there was one in 1914 - 28 years previously and then in 1904 - 10 years before. Another earthquake 9 years earlier almost reached MMVII.

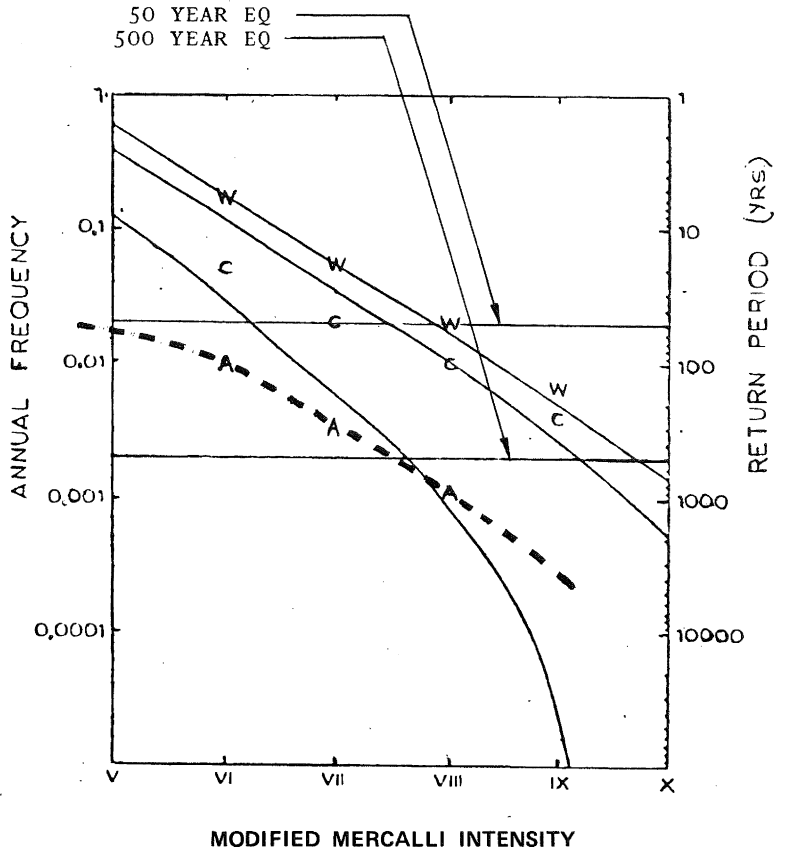
Figure 3

Figure 3. Shows return periods or frequencies against Mercalli intensities.

The solid lines show the 1981 tentative new results.

W = Wellington
C = Christchurch
A = Auckland - - -

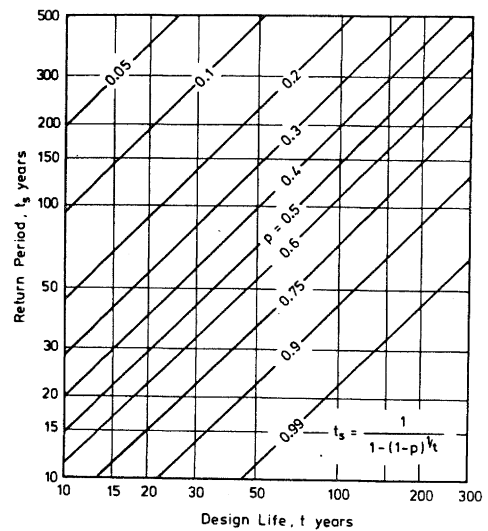
We can assess for an extended design life the return period of the earthquake to be considered. For a new building this implies consideration of a 500 year Earthquake hence for an extended design life the return period could be construed as even longer.

FIG. 4 : RELATION BETWEEN RETURNED PERIOD t_s , DESIGN LIFE t , AND PROBABILITY OF EXCEEDENCE P .

Figures 4 and 5 are based on work by the Group on Seismic Design of Bridges of the N.Z. National Society for Earthquake Engineering. (NZNSE Bulletin September 1980).

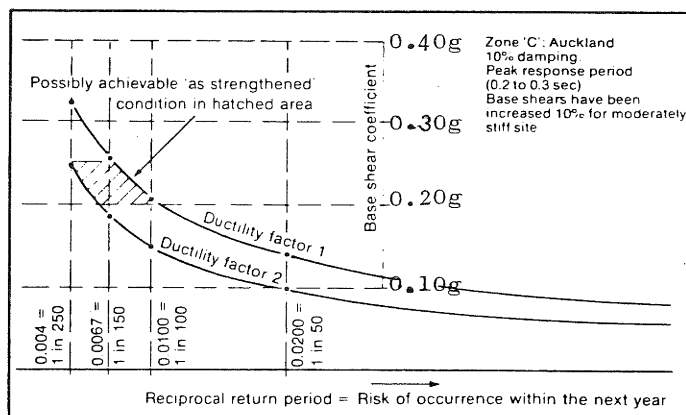
Figure 5

W.D. Smith's work produces estimates of risk related to Mercalli Intensity and these, in turn, can be related (not at all precisely) to ground acceleration.

In later sections of this paper, we discuss the order of strength which seems achievable by inserting new reinforcing steel into the fabric of the Ferry Building. It does seem to be possible to strengthen the building so as to bring it within the hatched area of Figure 5.

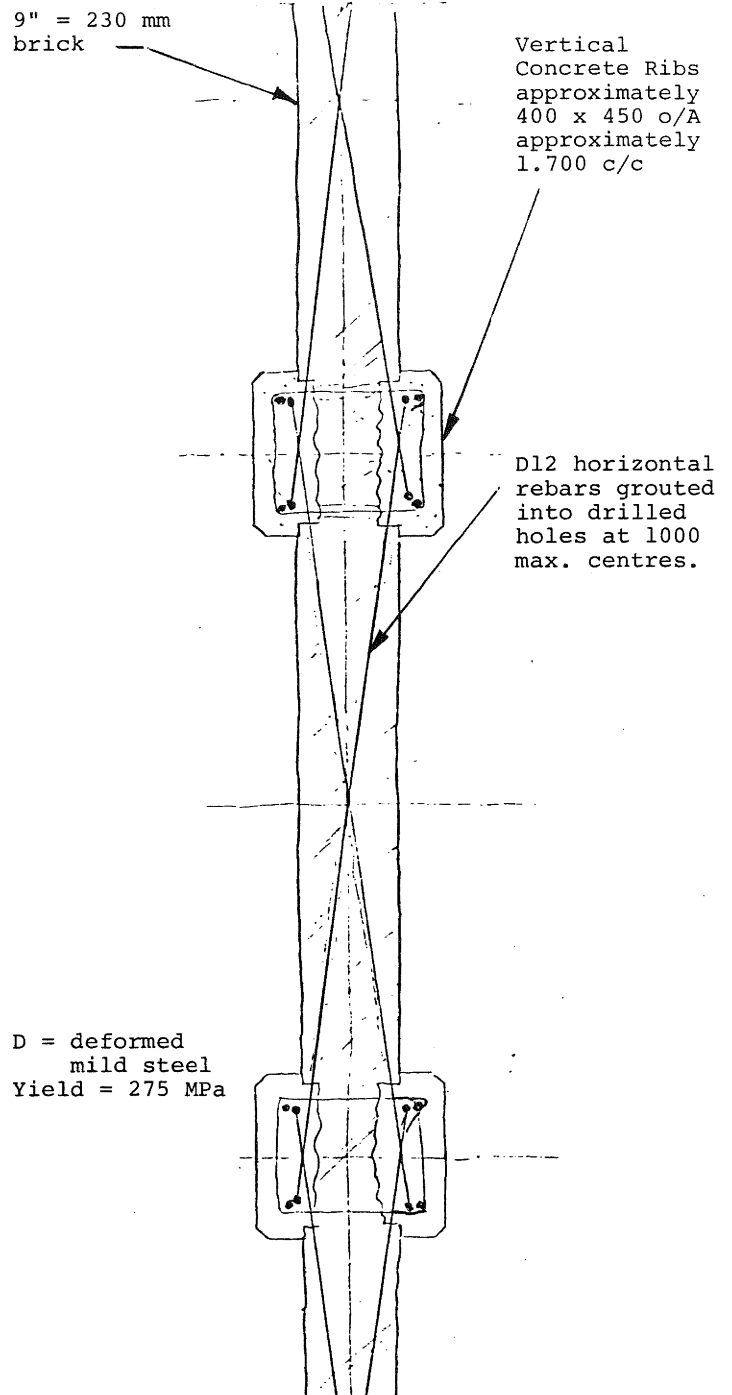
Figure 6

FERRY BUILDING PLAN

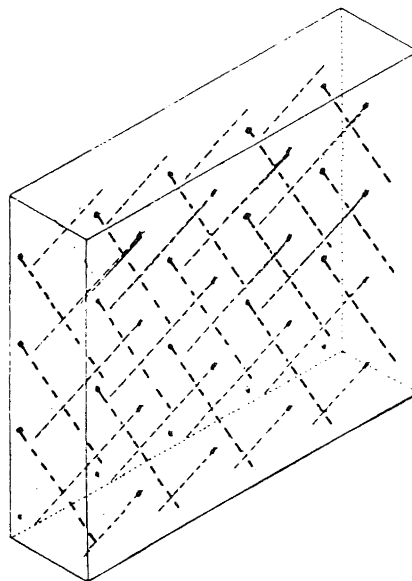
Figure 7

Figures 6 and 7 show typical reinforcement grouted into drilled holes at an angle to the vertical. The bars are not envisaged as having any particular positive anchorage. This curtain provides several effective reinforcing bars at each point over the height of the walls with bars lapped in staggered pairs. The bars can combine with a 'lazy tongs' effect and these curtains of steel can be selectively positioned in the facade and will be effective:

TYPICAL FONDEDILE 'CURTAIN'
