## NAILED MOMENT JOINTS IN TIMBER STRUCTURES

The development, design and testing of a nailed steel side-plate joint for the transfer of bending moments in timber structures is described.

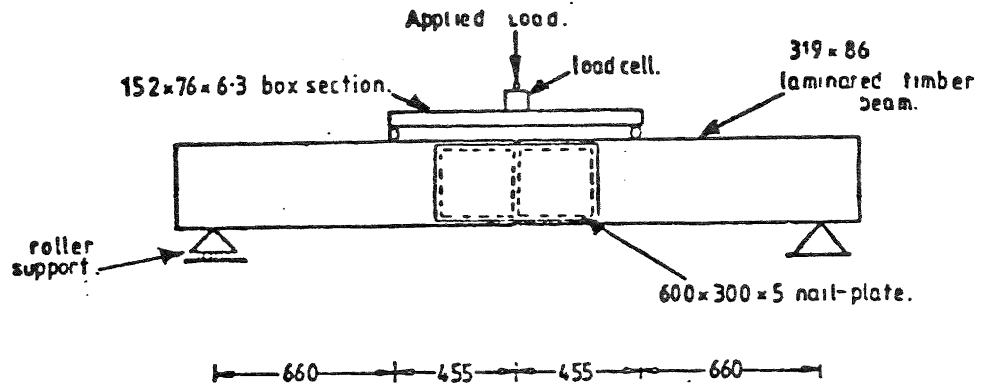
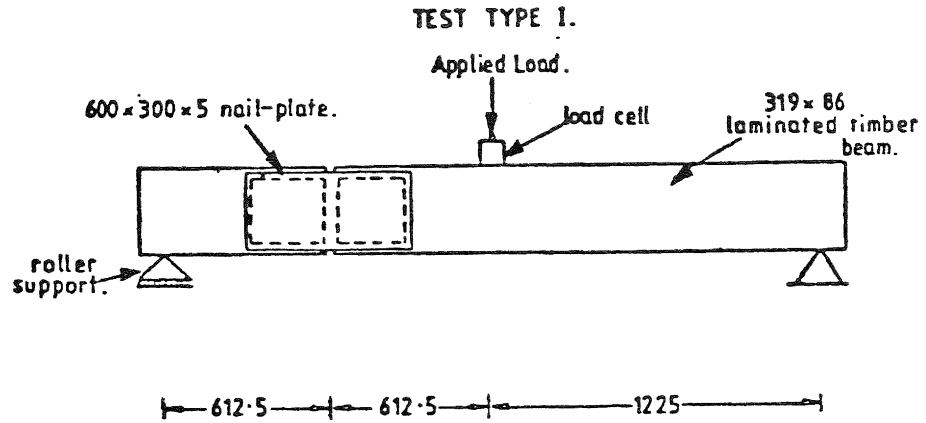
FIG. 6 GENERAL TEST ARRANGEMENT (FROM REF. 3)

TEST TYPE II

As the research for an M.E. thesis, (3), a number of nail plate moment resisting joints were tested. Four different patterns of 30mm by 3.55mm diameter galvanised bracket nails were used and the number of nails was kept low so that the joints would fail by nail slippage with no fracture of the timber members. Fig. 6 shows the general test arrangements and a typical moment versus joint behaviour curve is shown in Fig. 7.

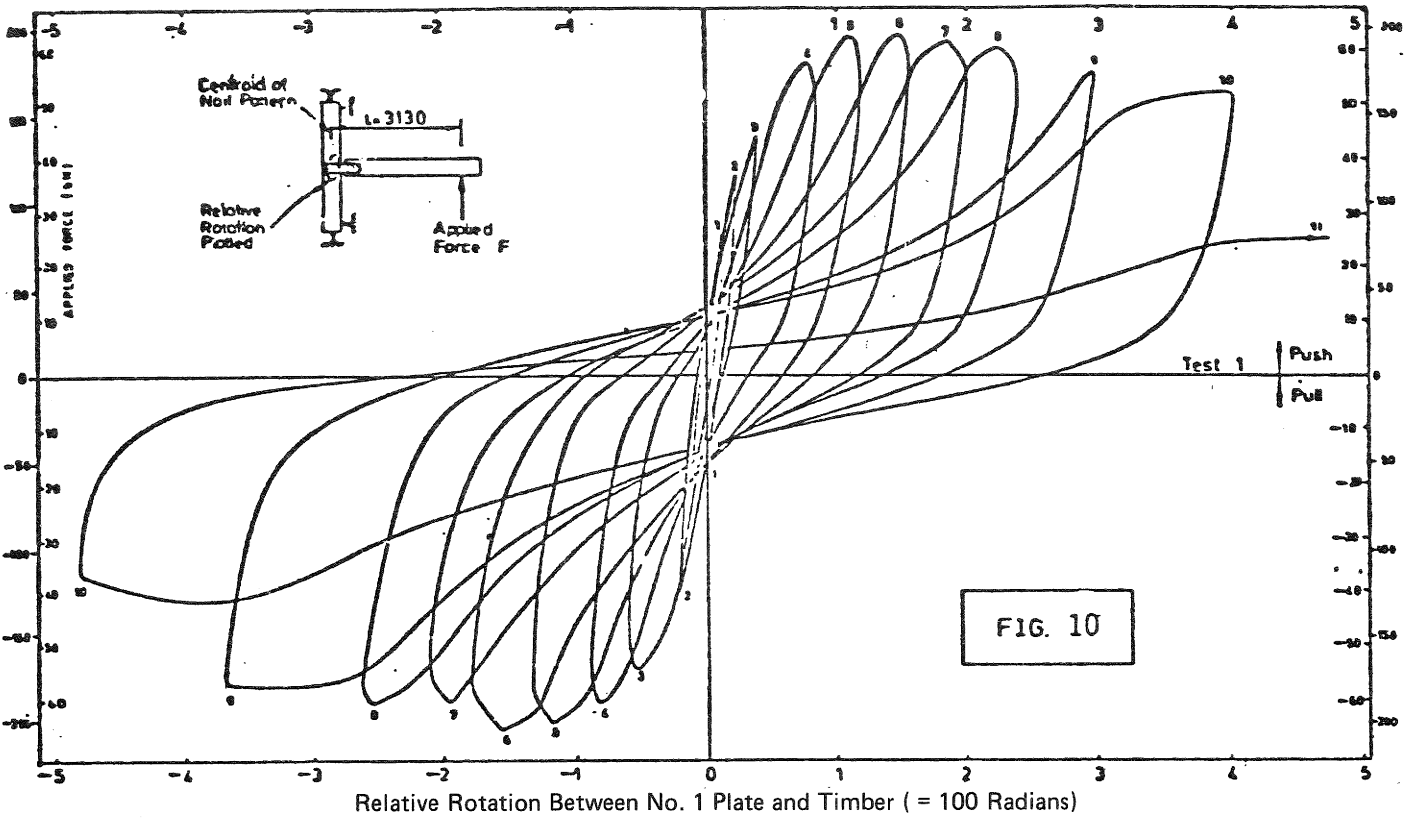
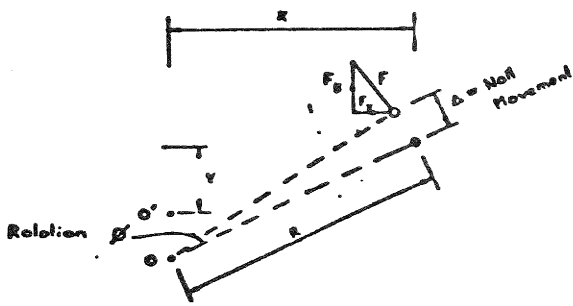
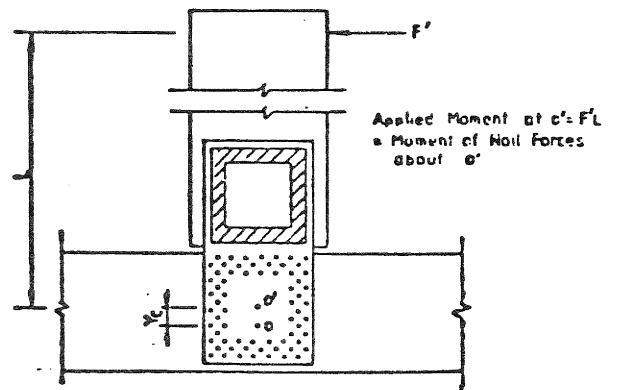
FIG. 11 ANALYSIS OF BASIC NAILPLATE

$$\Delta = R\phi$$

$$F = 1.266\Delta^{0.25} - 1.006\Delta^{0.5} + 4.204 \frac{\Delta}{1+\Delta}$$

$$M = \sum F_y x + \sum F_x y$$

$$F^1 = M/L \quad \text{Adjust position O until } \sum F_x = F^1$$

is shown in Fig. 9. The relative rotation and translation between the timber and nail plate was measured at A and B, and a typical plot for the rotation at A is presented in Fig. 10. The hysteresis loops look similar to those obtained from small sample testing, and a theoretical curve linking peak points can be developed from the regression curves as illustrated in Fig. 11. Assuming rigid body movement of the nailplate, the assumed centre of rotation point O is adjusted until equilibrium is achieved at each rotation considered. The torsional resistance of the nail group about O provides the moment M.

A comparison of the theoretical and experimental rotation at point A adjusted for moisture content and grain orientation shows good agreement. A good approximation of the theoretical curve is obtained by assuming the centre of rotation O is at the centroid of the nailgroup O' thus simplifying the calculations.
