## SERVICEABILITY FRAGILITY FUNCTIONS FOR NEW ZEALAND RESIDENTIAL WINDOWS

### ABSTRACT

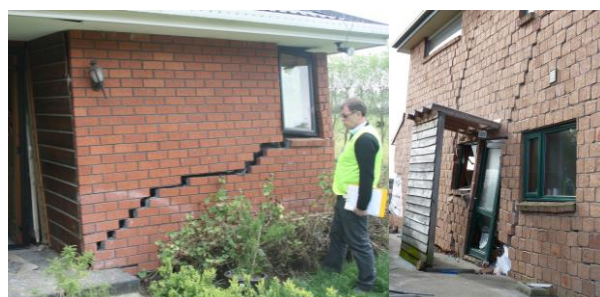
*Figure 1: Damage to windows following Canterbury earthquakes.*

Residential window systems have also at times shown significant resilience with damaged buildings having windows surviving quite well following earthquakes even though the surrounding building was heavily damaged as seen in Figure 1. Full-scale testing on educational light timber frame buildings has shown that windows can provide significant lateral load resistance and can resist damage to the glass at significant drift levels [7].

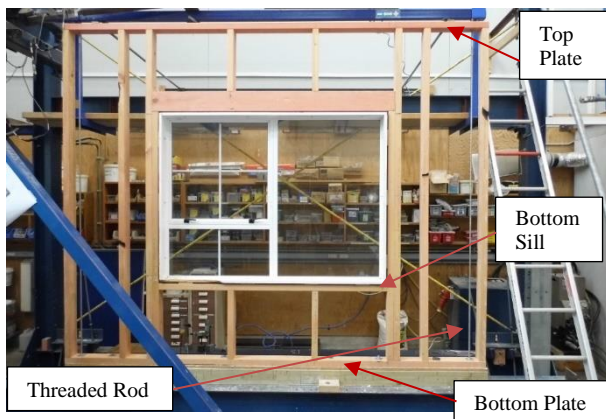
**Figure 2: Typical timber frame with window installed prior to plasterboard installation.**

For each test the timber frame was installed in a rigid steel loading frame typically used for P21 bracing testing [10] as seen in Figure 2 and shown schematically in Figure 5. The bottom plates of the timber frames were secured to the test frame using 12 mm diameter threaded rods which were placed 100 mm in from each wall end such that the rods would line up with holes in the top plate. The threaded rods were installed through holes drilled through the bottom plates and secured with two nuts in order to represent a coach screw connection to a timber floor or an anchor bolt connection to a concrete floor. The rods then extended up through the top plate to serve as an uplift restraint in an effort to provide a more realistic overburden scenario. The bottom plates were also held down securely through a 20 mm layer of particleboard into a 120 mm x 120 mm timber beam using 12 mm x 120 mm coach screws. These coach screws were installed next to each stud in order to securely hold down the bottom plate and avoid lifting or sliding of the plates during testing.

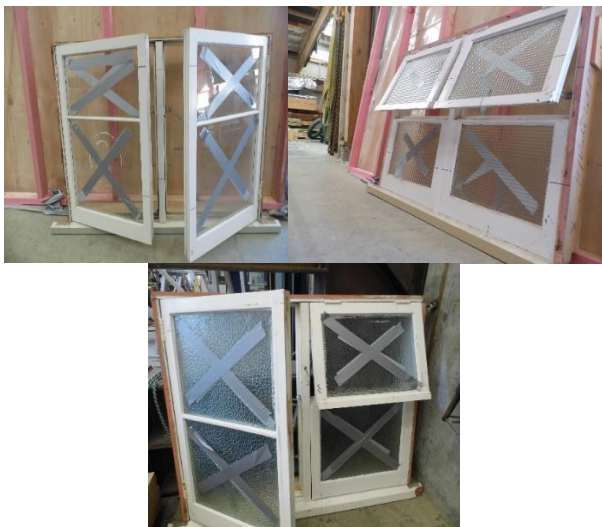
**Figure 3: Wooden windows for residential fragility testing (Window 1 (Top Left): 1,290 mm wide x 1,030 mm high; Window 2 (Top Right): 1,320 mm wide x 990 mm high; Window 3 (Bottom): 1,325 mm wide x 1,050 mm high).**

Six different windows were selected for the test, three wooden (Figure 3) and three aluminium (Figure 4). The window manufacturers were not known as the windows were sourced from building recyclers in the Wellington region. Wooden window frames and sashes were made from unidentified timber but were very typical of commonly used New Zealand residential windows. All windows opened outwards. All aluminium windows had single pane glass with double and single openings.

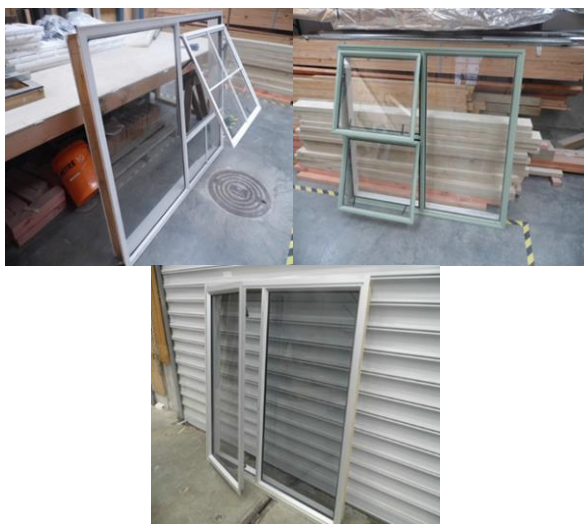
**Figure 4: Aluminium windows for residential fragility testing (Window 1 (Top Left): 1,600 mm wide x 1,200 mm high; Window 2 (Top Right): 1,202 mm wide x 1,160 mm high; Window 3 (Bottom): 1,500 mm wide x 1,250 mm high).**

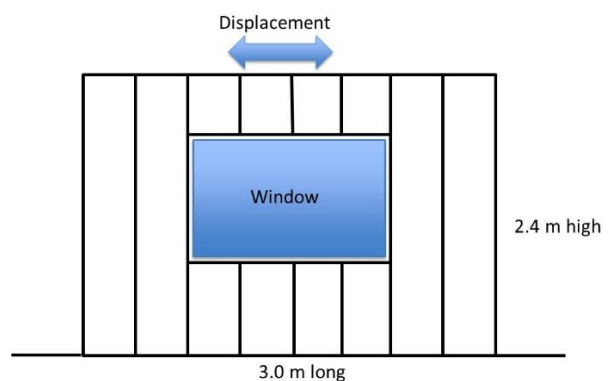
**Figure 5: Schematic diaphragm of window testing within timber frame.**

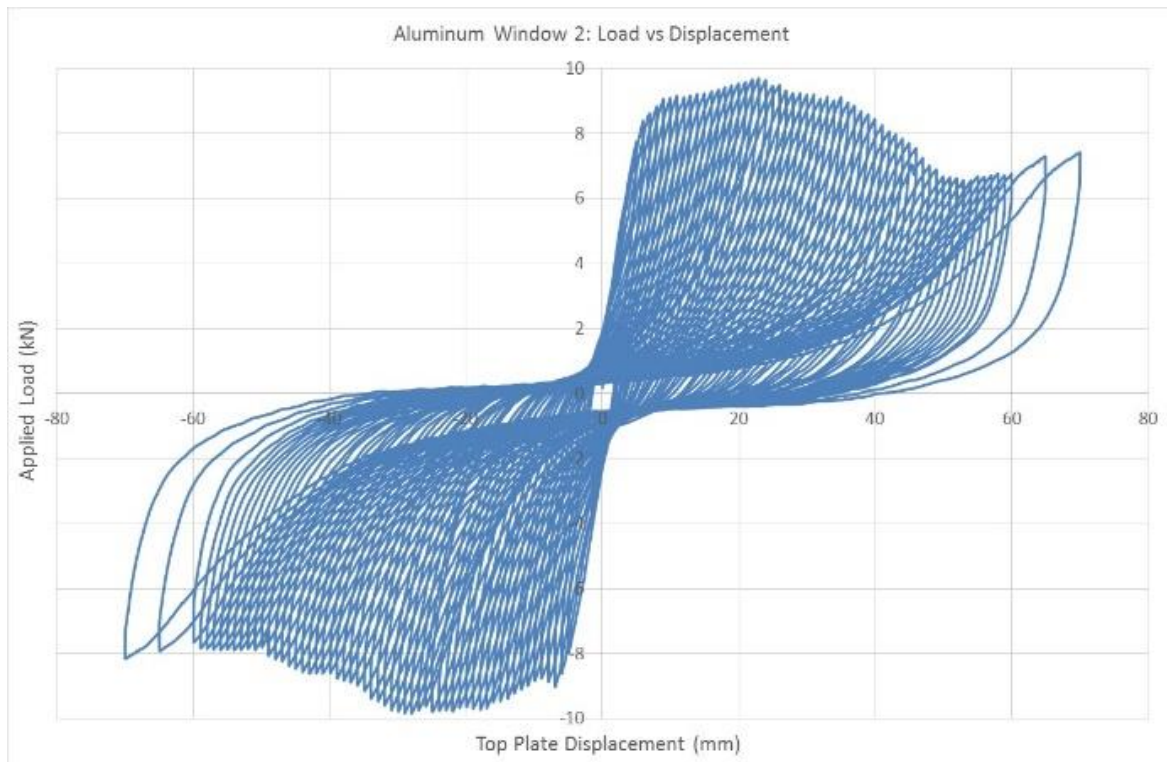
Figure 6: Typical hysteresis plot for aluminium window specimens.

Load and displacement data recorded during testing allowed development of hysteresis plots for all specimens. Examples are provided for aluminium and timber windows in Figure 6 and Figure 7, respectively.

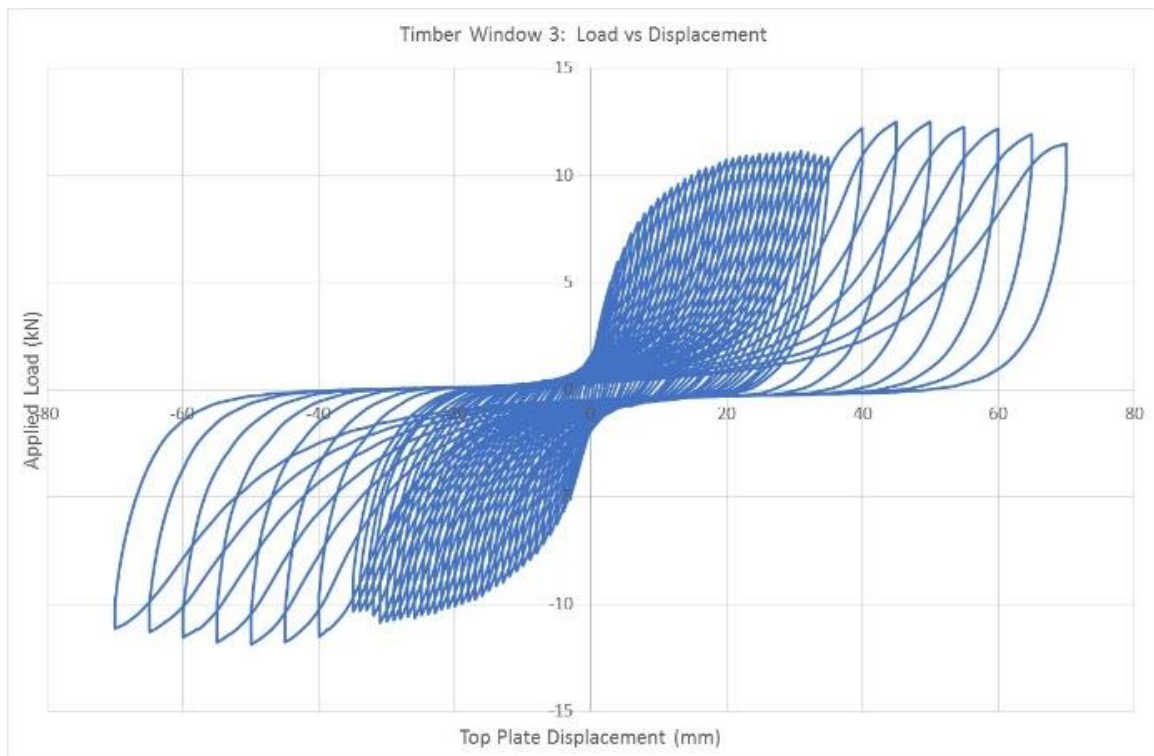
**Figure 7: Typical hysteresis plot for timber window specimens.**

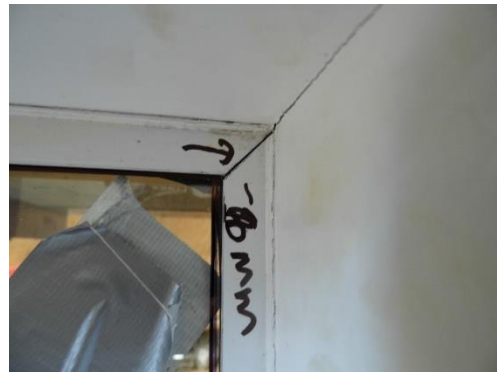
**Figure 8: Example of Criteria 1 damage.**

1. Observance of gaps in window frames that would potentially affect building weather tightness
2. Jamming or inability to open window panes that would require some repairs
3. Rotation of window frames within wall panel requiring more significant repairs.

Examples of Criteria 1 and Criteria 3 damage are shown in Figure 8 and Figure 9, respectively. Criteria 2 evaluations were conducted by attempting to open windows at the various displacement levels. For each test specimen the criteria were

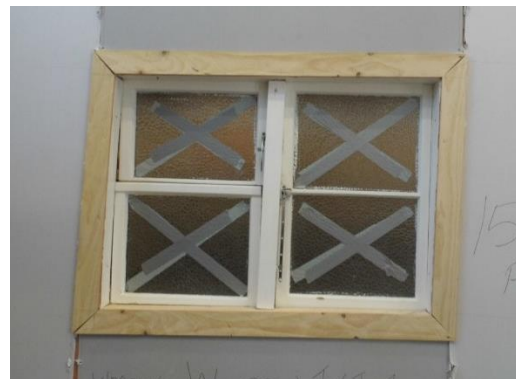
**Figure 9: Example of Criteria 3 damage.**

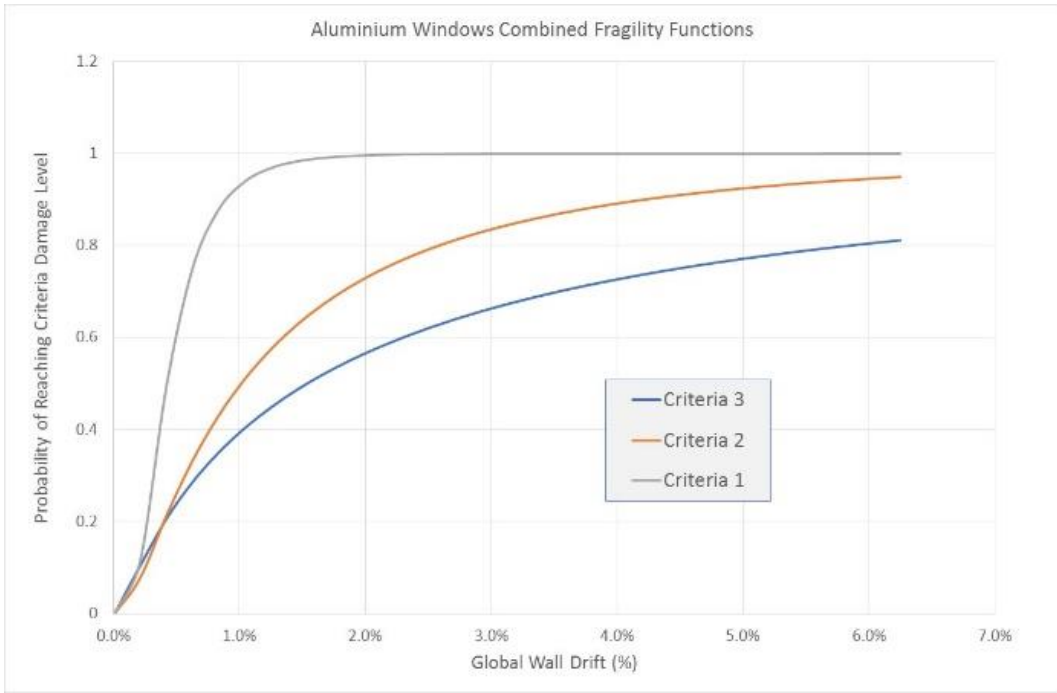
Figure 10: Fragility functions for aluminium residential windows.

determined and correlated with resulting drift levels so that fragility functions could be derived using Method A [11] and are shown in Figure 10 for aluminium windows and Figure 11 for wooden windows. Table 1 provides data gathered and used for fragility curve development.

Fragility functions for the two window types indicate that wooden framed windows are more likely to be damaged at lower drift levels than aluminium framed windows in residential walls. For both types of windows there is a high probability of gaps occurring in the frames at low drift levels, even in the realm of serviceability limit states, and this can potentially allow water ingress and affect the durability of timber structural systems. Because light timber framing is an inherently flexible structural system, it is feasible that by increasing the stiffness of the walls it would be possible to decrease window damage and reduce potential weather-tightness issues after an earthquake. Stiffening the walls would likely be outside the scope of NZS 3604 and would therefore require some specific engineering design solutions to be investigated.

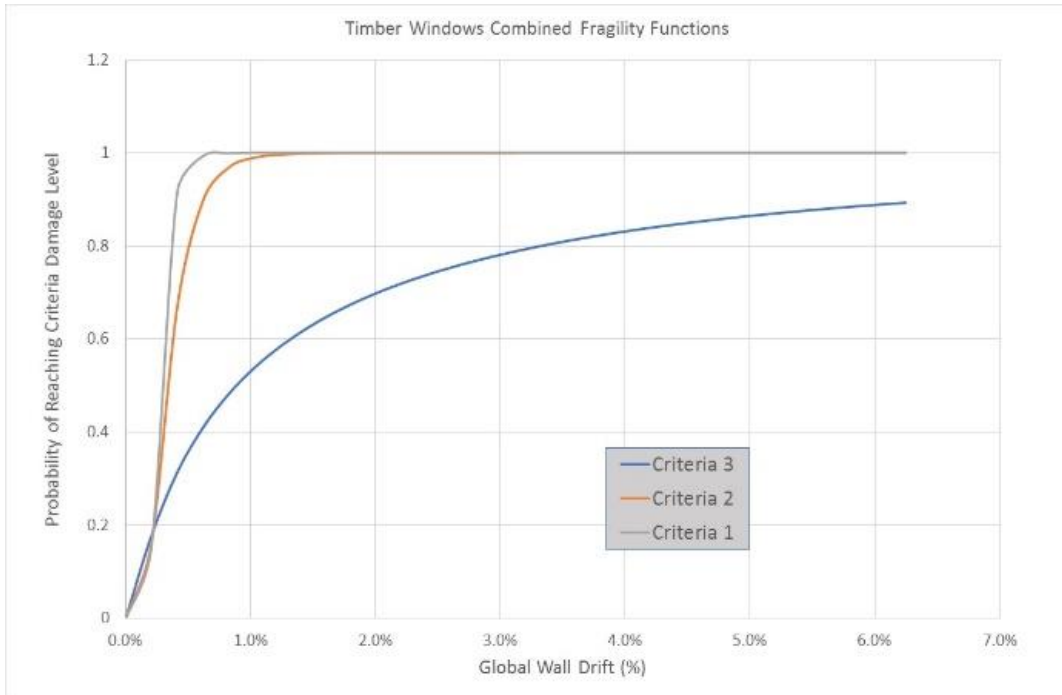
Figure 11: Fragility functions for wooden residential windows.
