POST-EARTHQUAKE REPAIR AND STRENGTHENING OF REINFORCED CONCRETE BEAM-COLUMN CONNECTIONS (THEORETICAL & EXPERIMENTAL INVESTIGATION)

Alexander G. Tsonos¹ and Konstantinos V. Papanikolaou¹

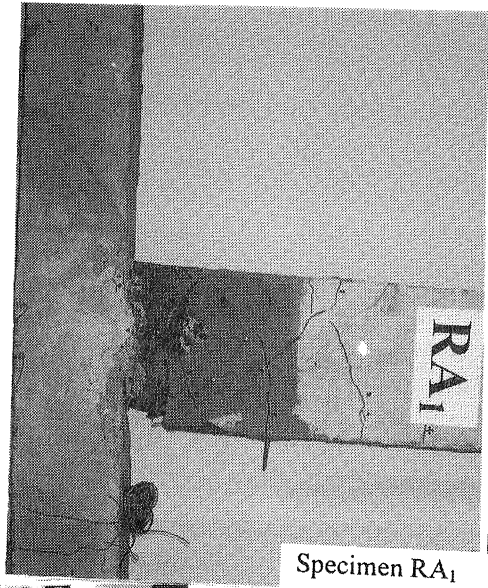
Figure 6. Views of the failed subassemblages RA₁, RE₁, RF₁, RF₂, RL₁ and RL₂.

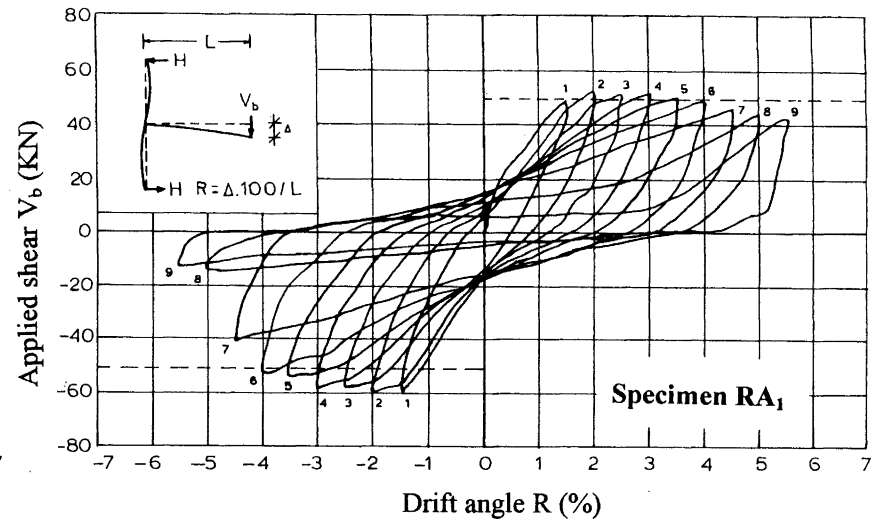
Figure 8(a). Hysteresis loops of specimens A_1 , RA_1 , E_1 and RE_1 .

From these diagrams the effectiveness of the examined epoxy resin repair technique in restoring satisfactorily the strength, stiffness and energy dissipation capacity of the repaired specimen RA₁ is shown. Thus, the repaired subassemblage achieved almost the same strength, stiffness and energy dissipation capacity as compared with those of the original subassemblage A₁ (see Figures 9(a), 9(b) and 9(c)).
