THE STRENGTHENING OF AUCKLANDTOWN HALL

T W Robertson¹

SUMMARY

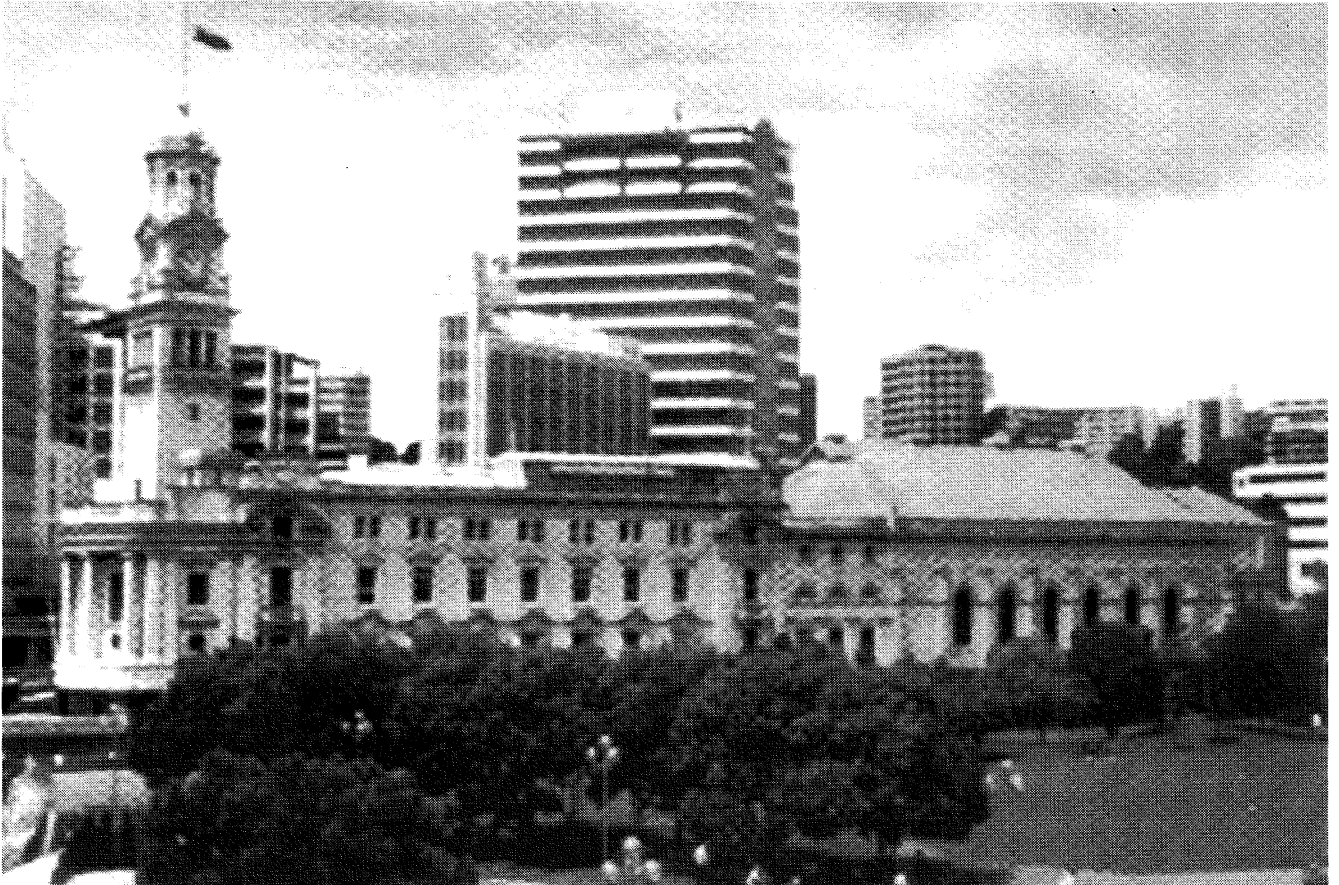
FIGURE 1 View of the Town Hall from the West

The West Elevation of the building is shown in Figure 1. The general form can be ascertained from Figure 2 which shows the floor plan at the Queen Street level. The building is wedge shaped in plan and divided into four main zones. These are identified as: the Great Hall, the Concert Chamber, the Apex (which houses the office area and Council Chamber) and the Prow which includes and supports the clock tower at the north end of the building.

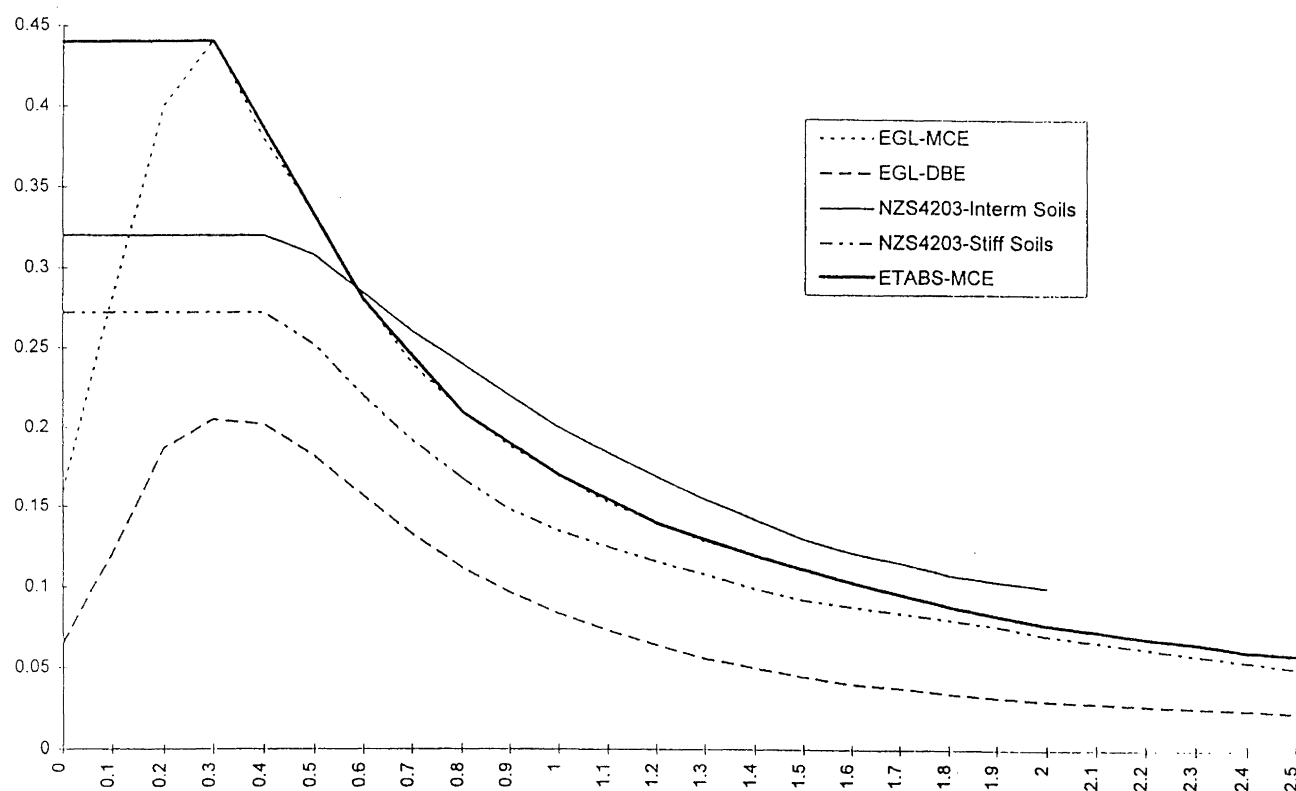
FIGURE 4 Response Spectra

In 1993 a separate consultant was engaged to assess and report on the site seismicity[2]. This study provided site specific spectra for a Design Basis Earthquake (DBE) and MCE. These events were respectively lesser and greater than the spectrum determined from NZS 4203[3]. These spectra are shown in Figure 4.
