EXPERIMENTAL INVESTIGATION INTO THE SEISMIC FRAGILITY OF A COMMERCIAL GLAZING SYSTEM

Fransiscus A. Arifin¹, Timothy J. Sullivan² and Rajesh P. Dhakal³

Keywords: Glazing, Fragility, Seismic Performance, Experimental

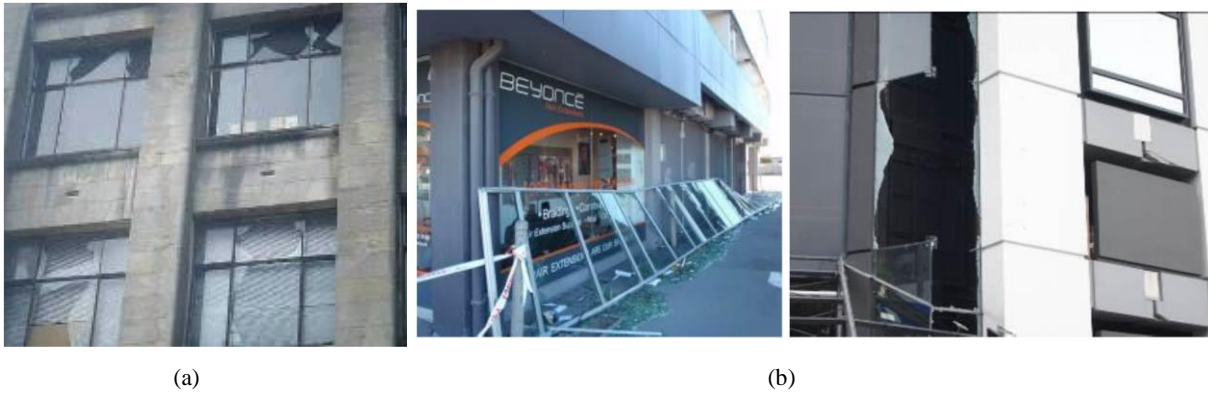
Figure 1: Examples of glazing damage that occurred in (a) the September 4th 2010 Darfield earthquake [1] and (b) the February 22nd 2011 Christchurch earthquake [2].

Recent events, such as the 2016 Kaikōura earthquake and the 2010-2011 Canterbury earthquakes, have highlighted the damage earthquakes cause to glazing systems [1, 2]. Figure 1 illustrates damage to glazing observed from the Canterbury earthquakes. Photos in the printed media [3] of shattered glass on footpaths and reports that areas may be cordoned off because of the risk posed by falling glass remind us that the performance of glass windows/glazing in earthquakes can be a life-safety matter. There were many reports of injuries due to broken glass lying in egress routes following the Canterbury earthquakes. In addition, the repair of glass facades can be costly and time-consuming and accessibility to damaged parts can pose a significant challenge in many cases. Following the Kaikōura earthquake, it was claimed that glazing repairs in downtown Wellington cost as much as \$50,000 per pane [4].

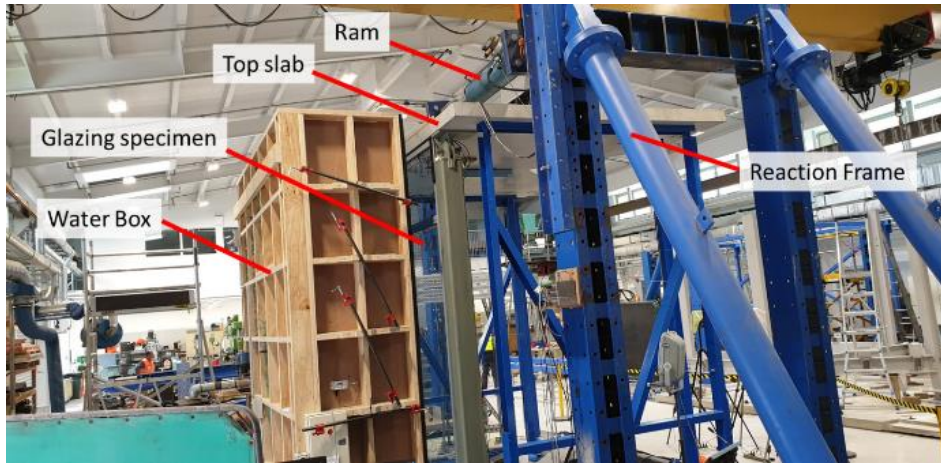
Figure 3: Photo of overall experimental set-up realised in the laboratory.

Figures 2 to 4 illustrate the experimental set-up adopted for the testing. The glazing was erected between two concrete slabs, representing two different floors of a building with a storey height of 3.6m. The weight of the slabs was carried by steel frames at either end, designed to permit translation of the top slab in the longitudinal direction and prevent translation in the orthogonal direction. A hydraulic actuator capable of imposing 800kN force was fixed between the top slab and a steel reaction frame (see Figures 2 and 3). Steel posts were flanked either side of the glazing specimen; thereby fitting full scale one-storey glazing specimens 2.976m long by 3.385m high (when the glazing was built up to underside of the concrete slab). A timber water-box was designed and erected to support four spray nozzles, spaced 1800mm apart as seen in Figure 4 and approximately 900mm away from the glass specimen (in line with the recommendations in NZS4211: Specification for performance of windows (2008) [14]). Figure 4 also shows a water tank from which water was pumped at a controlled flowrate through piping to the four nozzles inside the water-box. The system was designed such that the water applied to the specimen would drain to a sump and be pumped back to the water tank for recirculation as part of the test.

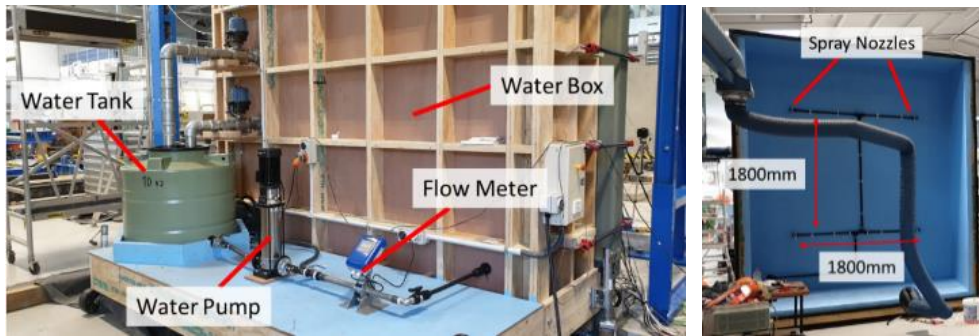
Figure 4: Equipment required for water-tightness test. View from rear (left) and view of spray nozzle locations inside box (right).

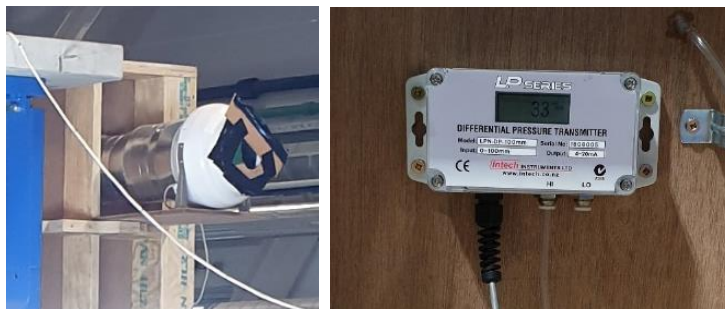
Figure 5: Air pressure control unit. Air blower (left) and differential pressure sensor (right).

The system also included an air blower and air pressure transducers measuring interior and exterior air pressures to permit controlled air pressure to be applied during water testing, in line with NZS4284 recommendations, shown in Figure 5.

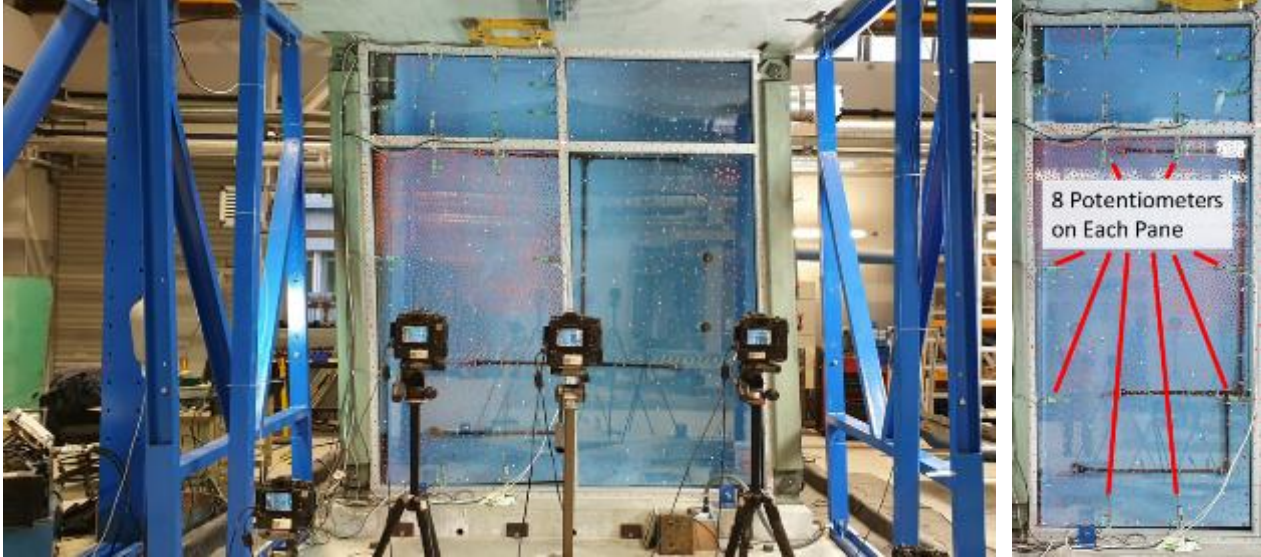
Figure 7: Photo showing glazing specimen and instrumentation used in the experimental testing, showing cameras and red dots used for particle-tracking (left) and potentiometers used to monitor displacements of panes relative to framing (right).

The curtain wall glazing specimens examined in this work are a standard type of commercial glazing unit commonly found in New Zealand. The glazing, shown in Figure 7, included two tall glass panes 1.426m wide by 2.56m tall over the lower part of

the façade and two smaller glass panes 1.426m wide by 0.662m tall in the top part. The aluminium framing included a 16mm clearance between the glass edges and the framing, with low-rise PVC wedges (gaskets) rolled into position to provide a water seal. The outer edges of the framing were screwed into the steel posts either side of the glazing, the concrete slab at the top and a concrete upstand at the bottom.

The instrumentation used in the testing included a load cell in the actuator measuring the applied force, as well as displacement transducers measuring the in-plane and out-of-plane displacements of the top slab. Furthermore, as shown in Figure 7, particle tracking was used to monitor the in-plane movements of the framing and glass, with a number of potentiometers also used to measure the displacements of the glass panes relative to the framing.

A summary of the results obtained in the three experimental tests is reported in Table 1. In addition to these global results, it was observed that damage was initially seen in the larger panes (refer Figure 7). The panes were observed to slide and rotate prior to locking up within the framing and hence the total drift capacity for DS3 was very large, at around 5%. On the contrary, loss of water-tightness occurred at drifts as low as 0.15%, with the median drift capacity being 0.35%.

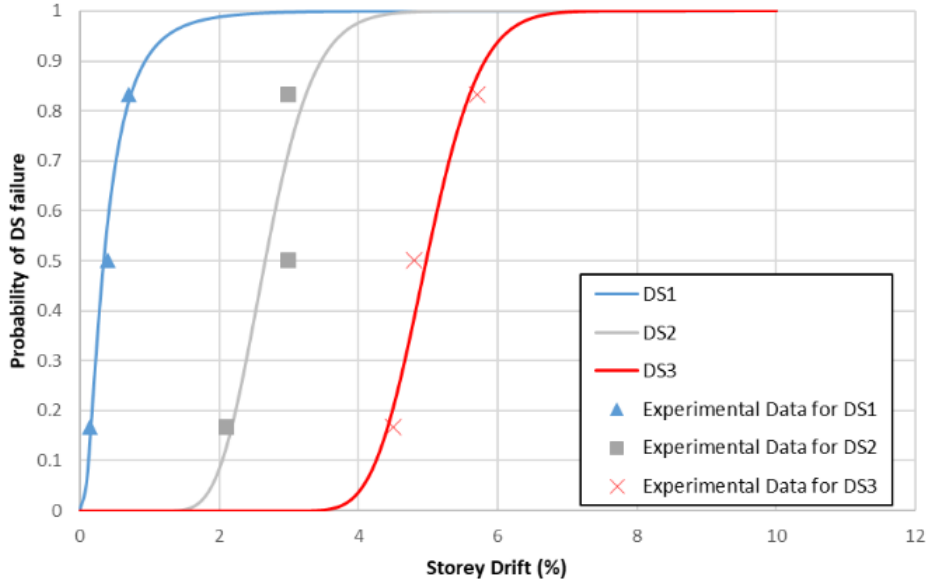
Figure 8: Fragility functions for commercial glazing, obtained from experimental tests results.

To establish fragility curves, a log-normal distribution was assumed and regression analyses were conducted to identify the median and dispersion for each damage state in line with recommendations of Porter et al. [16]. The resulting fragility parameters, together with a description of the three damage states investigated, are presented in Table 2 and plotted in Figure 8. These results shown in Figure 8 define the fragility for different damage states via Equation 1.

where $P_i(D)$ indicates the conditional probability that the glazing system will experience damage corresponding to damage state “DS $_i$ ” or worse when the demand is D , Φ represents the standard normal cumulative distribution function, D is the variable demand parameter (e.g. drift), x_i is the median value of the test results, β_i is the dispersion (logarithmic standard deviation) of the test results, and subscript “ i ” represents the damage state of interest (e.g. $i=1$ signifies DS1).
