SEISMIC PERFORMANCE OF REPAIRED LIGHTLY-REINFORCED CONCRETE WALLS

ABSTRACT

As a result of the 2010-2011 Canterbury earthquakes, over 60% of the concrete buildings in the Christchurch Central Business District have been demolished. This experience has highlighted the need to provide guidance on the residual capacity and repairability of earthquake-damaged concrete buildings. As limited testing has been performed on repaired components, this study focuses on the performance of severely-damaged lightly-reinforced concrete walls repaired through replacement of reinforcement and concrete in the damaged region. The damage prior to repair included buckling and fracture of longitudinal reinforcement, crushing and spalling of concrete, and, for one of the two specimens, out-of-plane instability of the gross section. Prior to repairing the wall specimens, tensile testing of reinforcement with welded connections was conducted to verify acceptable performance of welds suitable for reinstating the damaged reinforcement. Repairs to the specimens consisted of removal of damaged concrete through either hydro-demolition or jack hammering, followed by cutting and removal of damaged reinforcement a

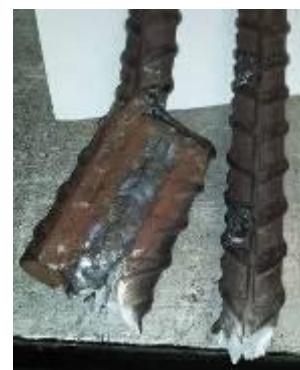
Figure 3: Fracture of double lap splice at weld.
