NON-DESTRUCTIVE METHOD TO INVESTIGATE THE HARDNESS-PLASTIC STRAIN RELATIONSHIP IN CYCLICALLY DEFORMED STRUCTURAL STEEL ELEMENTS

SUMMARY

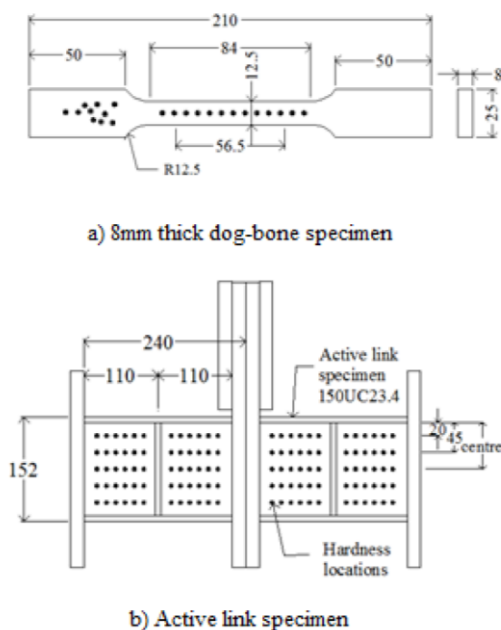
Note: Hardness from the dog-bones were measured at grip ends and along the length of reduce section

Figure 1: Hardness test specimens and locations.

specimen dimensions were determined from the tensile test requirements, given in Standards [10], [11] and [12]. The active link specimens were designed according to [11] Clause 12.11.1, HERA Report R4-76 [13] page 11.1-28 and literature by [14]. Limitations on cyclic loading capability and specimen size restricted the link section to a Grade 300 150UC23.4 section with the clear link length complying with the requirements of NZS 3404 Clause 12.11.1.2 to behave as a shear link. The specimen mass was well above the 5 kg minimum weight required by the portable Leeb hardness tester TH170. Hardness was measured at two different locations on the dog-bone specimens and at five locations on the web of the active links, as shown in the diagram (a) and (b) Figure 1.

A series of cyclic tests have been carried out to determine the link between hardness and cyclic plastic strain. An active shear link specimen as given in Figure 1 (b) was designed and fabricated according to the design guidelines discussed in hardness technique. Universal column section UC150UC23.4 was used instead of a universal beam section due to the lower shear capacity and greater flexural-torsional stability of the column sections resulting from their geometry compared with the beam sections. UC type sections are typically used in EBF systems in buildings for the same reasons, shows the active shear link setup for full scale cyclic testing.

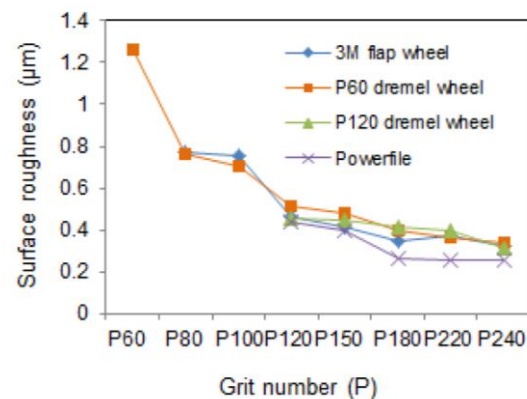
Figure 2: Comparison of surface roughness with different surface cleaning methods [9].

For accurate hardness test results, surface roughness has been identified as an important parameter during this study. Test specimens must meet specified criteria for surface roughness according to the American Society for Testing and Materials [6] for hardness determination of metallic materials by rebound based portable machines. Any paint, including undercoat and surface coat, pits and scale must be removed. The TH170 manual [7] states that the surface roughness (Ra) needs to be less than 1.6 micrometer (μm). A plot of surface roughness versus grit numbers is shown in Figure 2. This plot shows that grit numbers P60 to P240 are fine enough to achieve this result. The results of hardness versus surface roughness based on three preparation methods, previously presented in [9], show that a roughness below 0.6 microns is required for accurate results.

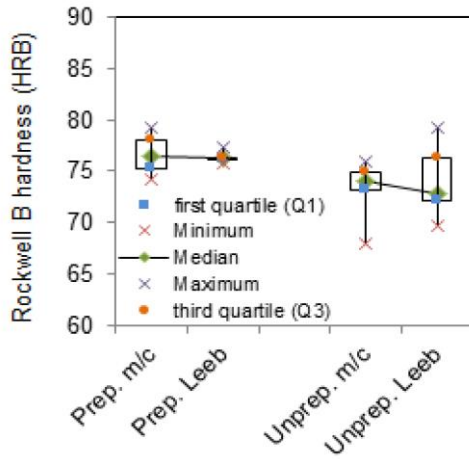
Figure 3 illustrates the difference in hardness readings between surfaces prepared to $R_a = 0.6$ microns and unprepared surfaces using the two different hardness methods. It was also found that the TH170 does not read when the tested surface is covered with paint or mill scale. Based on these test results, the Powerfile with P120 belts followed by P180 hand sanding was adopted throughout this investigation. Rockwell B hardness (HRB) and Leeb hardness for a prepared surface with grit numbers up to P240 and an unprepared surface of cleaned and mill scale removed is presented in Figure 3. There is significantly greater variation in the Rockwell and Leeb readings from the unprepared surface and a slight difference in the average value. This highlights the need for surface preparation to achieve a roughness of $R_a < 1.6$ microns.

Figure 3: Comparison of hardness between surfaces prepared to $R_a < 0.6$ microns and unprepared surfaces using a Rockwell B machine and Leeb TH170 hardness tester on a 25 mm thick specimen.

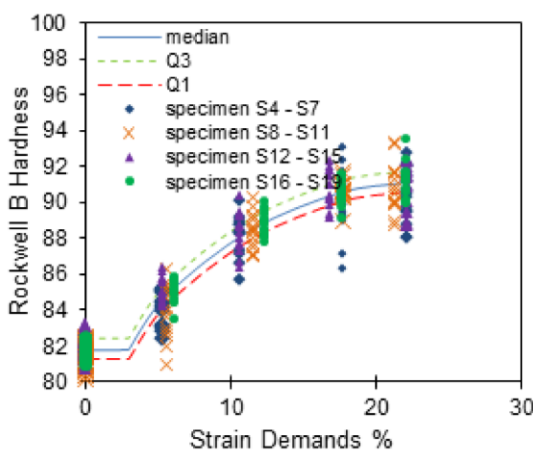
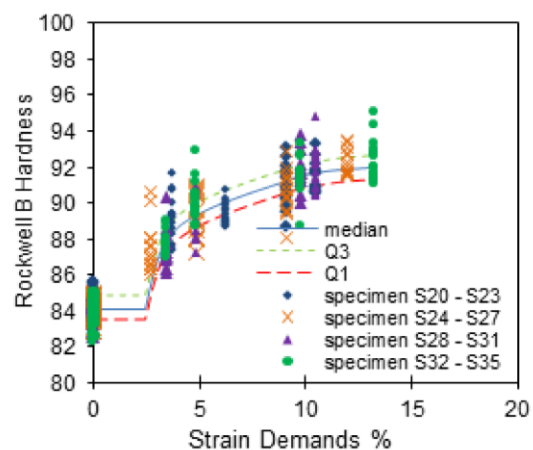
(a) Tensile-hardness relationship for 8mm thick specimens

(b) Tensile-hardness relationship for 12mm thick specimens

Figure 4: Hardness - tensile relationship for 8 and 12 mm dog-bone specimens at various strain demands.

Uniaxial tensile testing was carried out on 8 mm and 12 mm thick hot rolled steel plates, followed by Rockwell hardness testing using a bench top Rockwell machine. Targeted plastic strains for tensile loading were 5%, 10%, 15%, and 20% of the 8mm thick specimens and 2.5%, 5%, 10% and 15% of the 12 mm thick specimens. Bench top Rockwell hardness was measured at each strain level using the scale B, RB, with a 100 kgf and a 1.588 mm (1/16”) diameter ball indenter. Both surfaces of all the test specimens were prepared as explained in Section 3. Minimum edge distance was kept more than 2.5 times the indenter diameter and more than 3 times between two indentations according to [8]. Measured hardness against plastic strain is presented in Figure 4.

for up to four sets. Prior to tensile testing, zero strain, Rockwell hardness for 8mm thick specimens ranged from 80 to 83 and for 12 mm thick specimens from 82 to 86. The hardness from zero strain to the commencement of plastic strain (i.e. across the yield plateau) was considered to be constant when plotting the hardness versus strain results. The strain corresponding to the end of the yield plateau was determined from the force-displacement diagram. The rationale for this is due to the material strength, not increasing until the yield plateau region is exceeded, meaning that the hardness will not increase in that region either. For Grade 300 steel that extends out approximately 2.8% plastic strain. At each strain level, 15 hardness readings were taken and then average, minimum, maximum and median values determined. Hardness gradually increased with increasing plastic strain, in both cases, as shown in Figure 4.

Figure 4 shows the majority of hardness values fall between the first and third quartile (Q1 and Q3), indicating that this relationship is within the acceptable limits. Based on monotonically strained specimen test results, the relationship between monotonic plastic strain and hardness can be determined and use to calculate residual plastic strain demand from monotonic loading.

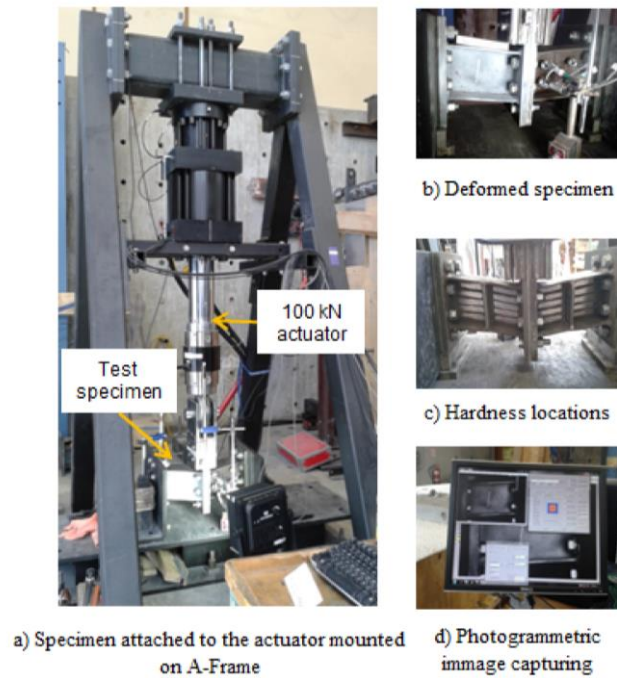
Figure 5: A full scale active link specimen under cyclic loading. Test Hall, University of Auckland.

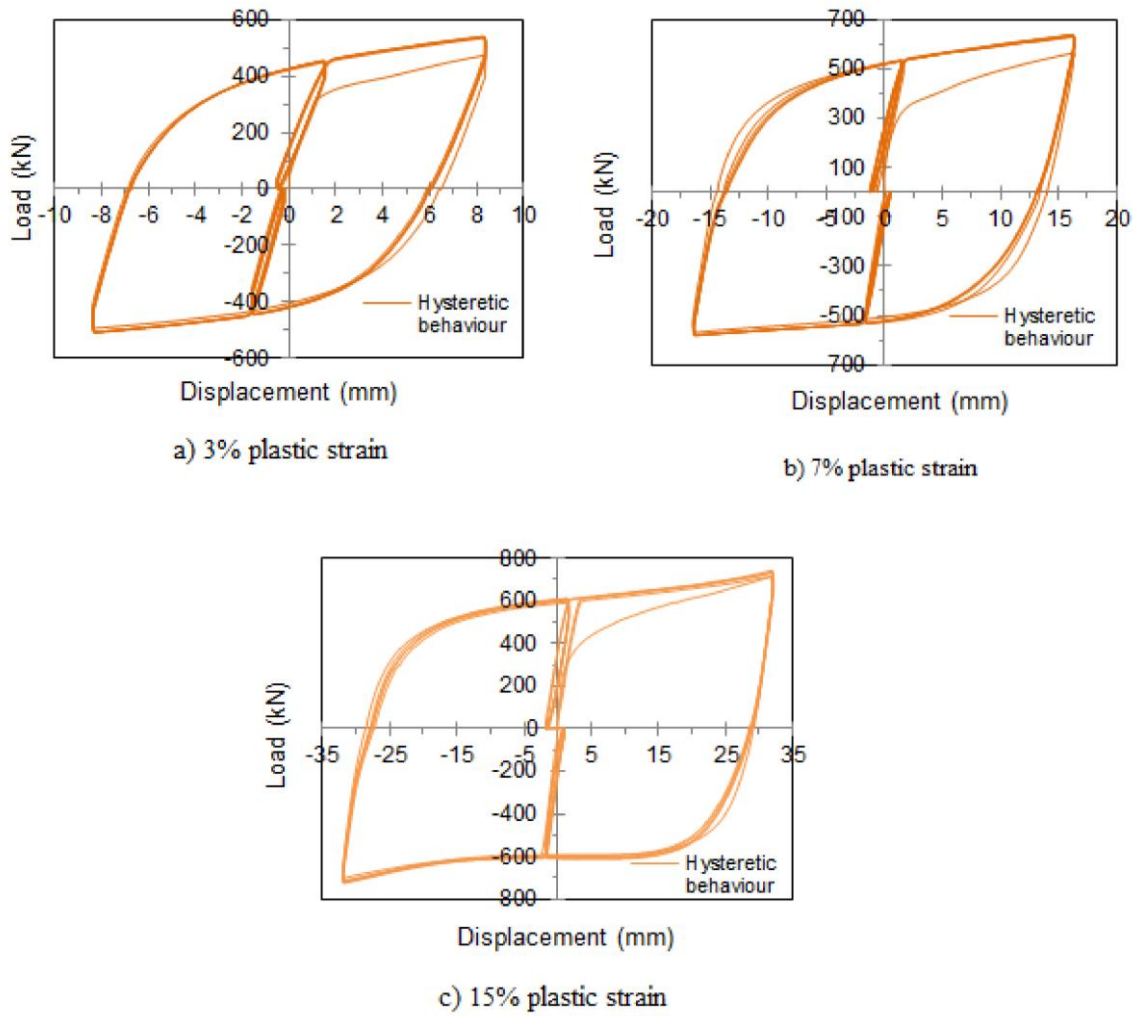
Figure 6: Cyclic load displacement behaviour.

Cyclic load versus plastic displacement for these tests is presented in Figure 6. Note that this is a plastic displacement of the active links; the ram displacement was greater due to elastic flexibility in the testing system which was accounted for. A baseline set of hardness readings was taken before the tests and then hardness was measured at maximum loads and when the loads were removed in each cycle, giving 4 sets of hardness tests per cycle. Active links were tested under a displacement controlled environment to maintain uniformly distributed strain across the webs. Figure 5 (a) and (b) shows the specimen at maximum deformation; hardness measurement locations are given in (c) and photogrammetric unit while capturing images is shown in (d).

Load displacement diagrams in Figure 6 show, the excellent ductility and efficient energy dissipation capacity of the designed active link beam. For the 3% plastic strain and its corresponding hardness, the specimen was pulled up to +8.3mm, then unloaded so that the specimen was plastically deformed but not loaded. Hardness was measured. Then the specimen was pushed down to -1.5 mm and unloaded to return to approximately the zero displacement position. Hardness was measured again. This was repeated for the reversed loading in -8.3 and +1.5 mm, giving 4 sets of hardness tests per cycle. Cyclic loading was repeated and hardness was measured for up to 5 cycles. For the 7% plastic strain, the specimen was pulled and pushed to ± 16.3 mm and ± 1.5 mm. For the 15% plastic strain, the deformations were ± 32.3 mm and ± 1.5 mm. While the cyclic testing and hardness measurements were being taken, photogrammetric images were being recorded simultaneously at the speed of 1 image per second with the pixel density of 3840 x 2764.

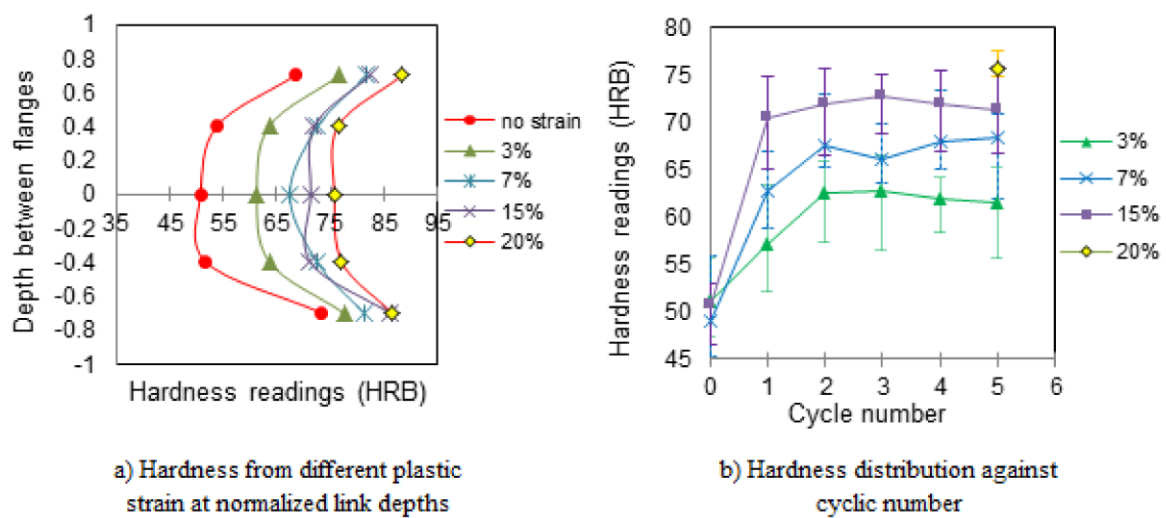
Figure 7: Comparison of average hardness from the five cycles of loading with different cyclic plastic strain levels using TH170 and hardness comparison at the centre of the link versus cyclic number for different strain levels.

Figure 7 (a) shows that the hardness increases with increasing

plastic strain demand and the hardness between three selected strain levels is noticeably different. Hardness measurements presented in Figure 7 are from the test locations give in (b). At the centre of the web, the average hardness measured by TH170, before the test was 50. Average hardness value for the 3% plastic strain specimen was 61 and for the 7% plastic strain specimen 67. Average hardness for 15% plastic strain was 71 and the 20% trial specimen (hardness measured at the end of 5th cycle) exhibited 75.8 average hardness.

Hardness at the centre of deformed links was plotted against the cycle number as shown in Figure 7 (b). Upper and lower boundaries of hardness in each cycle were similar between the hardness values. Average hardness, increased with increasing plastic strain demand, as observed from Figure 7 (a). At no strain (zero cycle number), hardness range is between 45 to 55. Hardness gradually increases up to the second cycle with no significant increase for subsequent cycles. However, the 15% specimen achieved very little incremental increase in hardness in the second cycle. Neither material softening nor hardening was evident in this study for up to five cycles. However, that is for cycles of constant plastic strain. In the future and final stage of this project, active link specimens will be tested under variable cyclic plastic loading to determine the effects of the loading regime on the measured hardness.

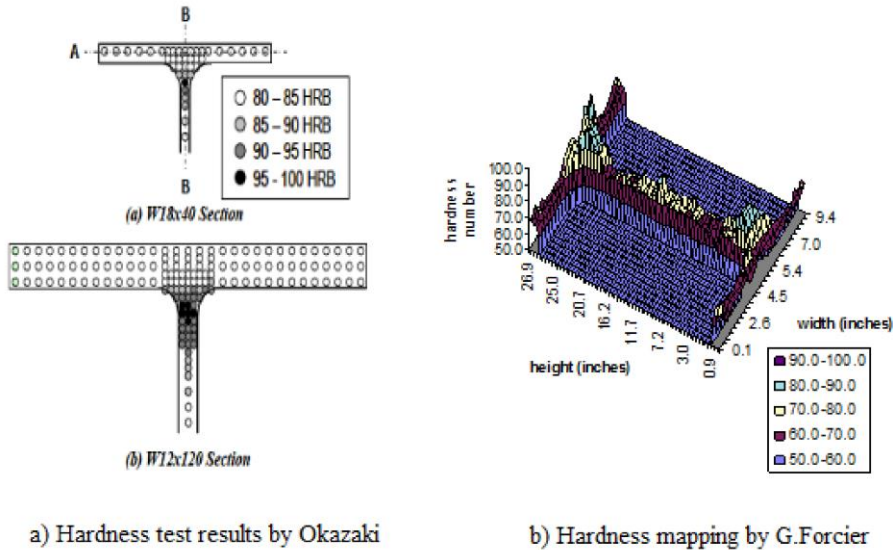
Figure 8: Hardness test results by Okazaki in 2004 [17] and G.Forcier [18, 19].

and Leon *et al.* [18,19]. Figure 8 illustrates hardness test results by Okazaki and G.Forcier.

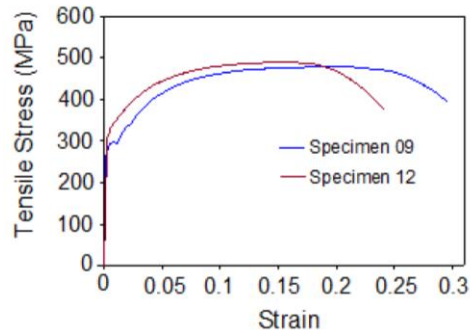
a) DIC test setup for monotonically loaded specimen

b) Overall DIC stress vs strain curves

Figure 9: Test setup for 6.1 mm thick dog-bone specimen and overall DIC stress strain curves.

inelastic surface strain development in metals. Hence, a trial test was carried out monotonically using two dog-bone specimens extracted from a section as the active links as shown in Figure 9 (a). The strain measured using DIC was compared with extensometer strain to identify the accuracy of the DIC method before using it in cyclically deformed active links. Trial test results from both the methods strongly agreed with each other. Hence the DIC technique was adopted to

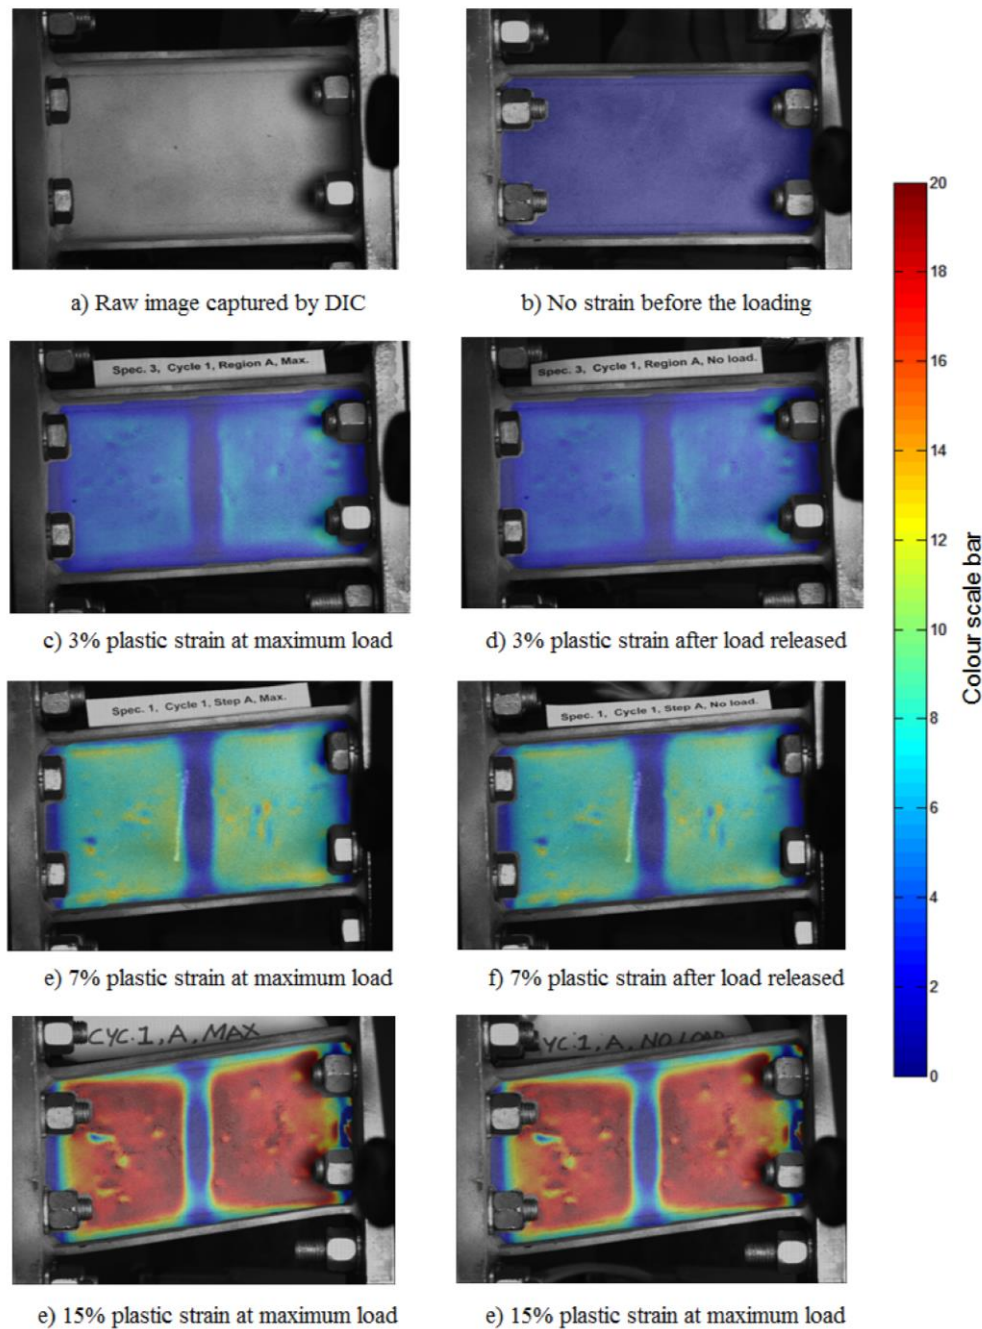
Figure 10: Strain contour plots across the web of the active link specimens using DIC by CACM at The University of Auckland.

Three sets of active links as shown in Figure 1 (b) sprayed surface pattern of two layers of spray paints. Black graphite spray on a silver background to ensure the paint uniformly covered the test surface with spaced black speckles. Figure 10 (a) shows a prepared specimen ready for a test and (b) shows strain contours of the non-deformed specimen.

Premature paint flecking as shown in Figure 10 occur throughout. As a result, the system records the baseline strain approximately 2% higher than the overall strain across the web; as recorded according to the colour scale bar. When the average strain across the web was checked by TRIDENT V3.0 the DIC strains match acceptably the level of plastic strain induced by the deformation controlled loading. Figure 10 (c)

represents contour plots where the specimen was fully loaded to 3% strain and (d) is the specimen when the load was

released. The influence of the stiffener on the opposite side of the web is clearly picked up by the contour plots. Slight differences in contour plots have been observed between (c) and (d), however strain demand was slightly higher close to the flanges and around the welds as seen from the hardness comparison for 3% plastic strain in Figure 7 (a). Figure 10 (e) and (f) show 7% strain contours when the specimen was loaded and released. Higher contour values are observed than (c) and (d) and their highest close to the flanges and around the welds. An increase in hardness close to the flanges for 7% plastic strain is also significant. In Figure 10 (g) are 15% plastic strain contours when the specimen was at maximum

load and (h) when the load was removed. Significant change in contour plots are observed and non-uniform contours due to flecking of paint is noticeable. Plastic strain close to the flanges and around the welds is noticeably increased, for the 15% plastic strain cycles, but at this level of deformation the active links are starting to come into inelastic axial tension as well as high shear strain. That is seen in the hysteresis curve, Figure 6 (c). High plastic strain near the flanges due to manufacturing induced plastic strain [9] was clearly picked up by both hardness technique and DIC system. However, interestingly the DIC system showed that the cyclic induced plastic strain develops near simultaneously over the full depth of the web, even though the top and bottom quadrants that have the pre-existing manufacturing induced plastic strain. This is as expected given that the test is displacement controlled.
