MODEL TESTS ON BEHAVIOUR OF GRAVITY-TYPE QUAY WALLS SUBJECTED TO STRONG SHAKING

**Ikuo Towhata¹, Md. Jahangir Alam², Tsuyoshi Honda³
and Satoshi Tamate⁴**

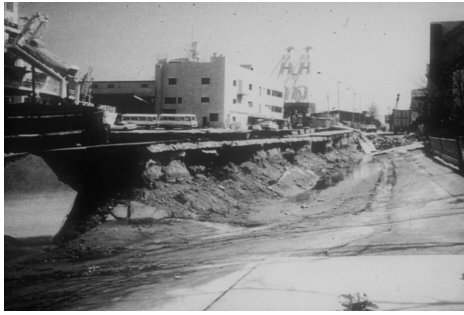
Figure 1: Significant distortion behind a gravity quay wall in Kobe Harbour.

Figure 1 illustrates the significant distortion of Kobe Harbour in the 1995 earthquake. This part of the harbour consisted of a gravity quay wall with loose backfill sand behind. Such a distortion stopped the function of the harbour and affected the local economy for a long time. Figure 2 indicates another effect of the distortion of quay walls; the backfill area was subjected to significant tensile deformation as evidenced by surface cracks. This kind of ground distortion would affect embedded structures and destroy them. In this context, seismic reinforcement of existing harbour quay walls is frequently discussed.

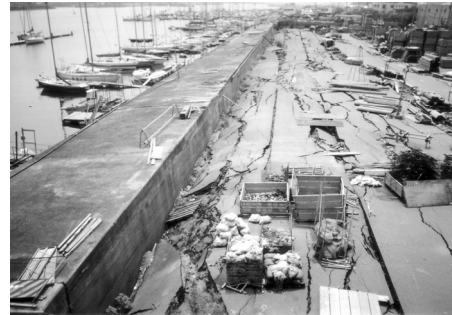
Figure 2: Failure of backfill ground behind gravity quay wall (Nishinomiya Harbour).

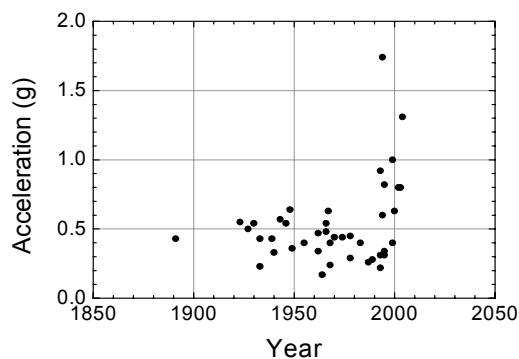
Figure 3: Increasing values of recorded maximum accelerations in recent decades.

One significant problem in the retrofitting of existing structures is the increasing magnitude of design earthquakes. This situation is partly due to the increase in the maximum accelerations which have been recorded during recent earthquakes (Table 1 and Figure 3). Another reason is certainly the awareness of the economic and social effects due to damage of important structures. It is noteworthy that the recent discussion on seismic design under very strong earthquake motion allows a certain extent of deformation, while total collapse has to be prevented. This idea appears to be valid for gravity quay walls as well. With these issues in mind, the present paper addresses model tests in both 1-g and centrifugal field that were conducted on mitigation of large deformation of gravity quay walls. The key issues therein were retrofitting of "existing structures" and "very strong earthquake shaking".

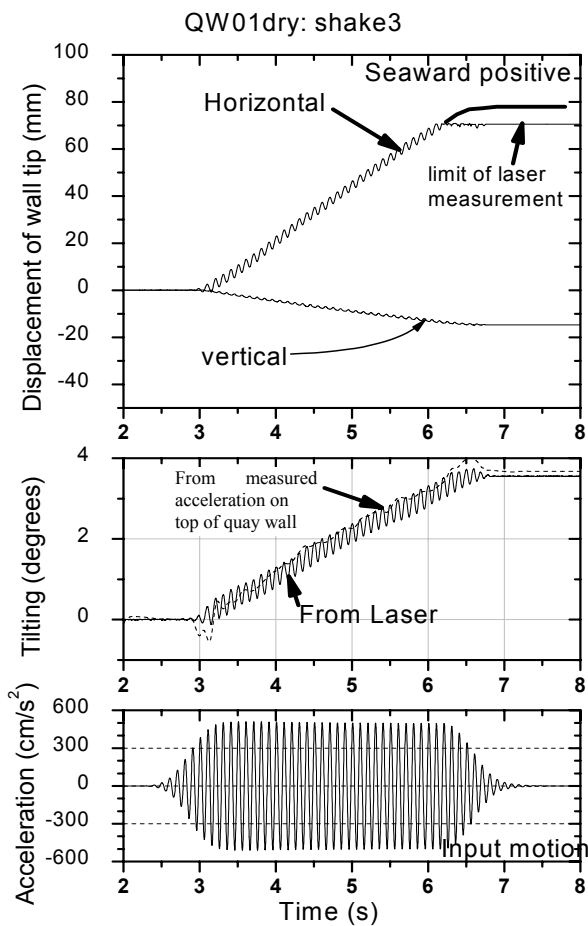
Figure 6: Wall displacement time histories and input motion of shake3 of test QW-01dry.

The base motion and quay wall displacements during shake3 are shown in Figure 6. When acceleration amplitude exceeded 0.4g, quay wall displacement and tilting started, which indicated that the designed caisson wall is stable against an acceleration level below 0.4g. Simple stability calculations against earthquake induced inertia force of quay walls was done on the basis of the force diagram in Figure 7. When the friction angle between the rubble mound (gravel) and caisson (wooden box) is assumed to be 35° [7], 0.40g acceleration induces a 500 N inertia force per meter width of the quay wall which can not mobilize the translation of quay wall when only static active earth pressure is mobilized upon small displacement of quay wall. Because frictional resistance under the quay wall was 660 N forces per meter width and active thrust of the backfill was 75 N forces per meter width. Therefore, it is reasonable to say that additional required force for mobilizing translation of quay wall came from the dynamic earth pressure of the rubble filter. The photograph shown in Figure 8 was taken after application of shake3 with acceleration amplitude 0.535g which shows a failure wedge that developed during the strong shaking.

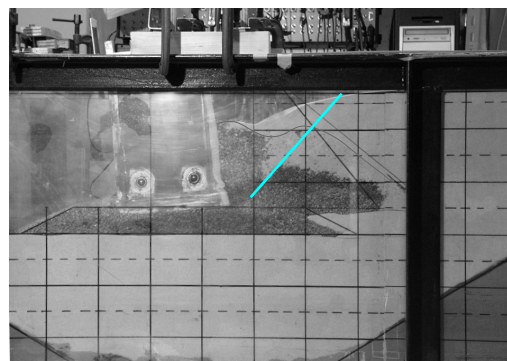
Figure 8: Displacement of caisson and deformation of backfill of test QW-01dry after shake3.

It was also observed that the vertical displacement of the quay wall during shake3 with acceleration amplitude 0.535g was not due to densification of the foundation sand but mainly due to distortion of the rubble mound which was placed loosely, tamped lightly and levelled before placing the quay wall. It should be noted that the rubble filter was also placed loosely and tamped lightly in all model tests. Visual observation of the deformed backfill and rubble filter revealed that a failure plane or shear band under the active soil wedge was oriented towards the direction of around 50-55° from the horizontal.

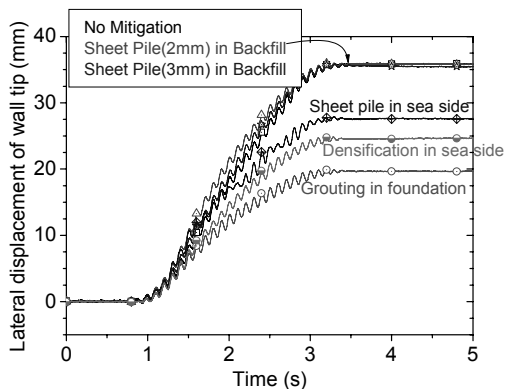
Figure 17: Time history of lateral displacement at top of quay wall.

The recorded time history of the lateral displacement at the top of the quay wall is plotted in Figure 17. It can be seen that the displacement obtained from the cases of a sheet pile wall in the backfill soil was as large as that in the case without mitigation. This implies that sheet pile mitigation behind a quay wall is not effective. A possible reason for this is that the dynamic earth pressure exerted by the backfill soil was not reduced by a sheet pile installed far behind the quay wall; there remained a big mass of soil between the sheet pile and the quay wall which generated a substantial magnitude of inertia force. Note that the installation of a sheet pile wall at a shorter distance is not practical because there is a filter zone made of large stones. Another reason is the overwhelming role played by the inertial force of the caisson wall. Evidently, this force was not mitigated by the sheet pile wall in the backfill, and hence, a significant wall distortion resulted.

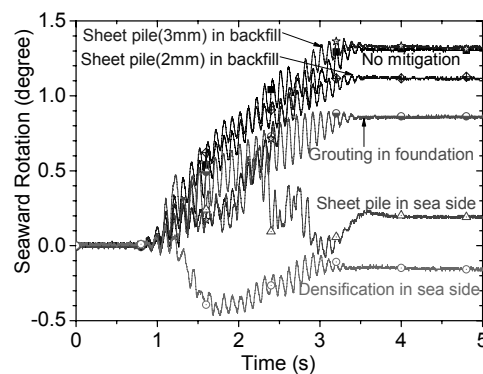
Figure 18: Time history of rotation of quay wall.

Figure 18 shows the time history of rotation of the quay wall for the different cases. It is seen that the rotation was maximal when no mitigation was taken, and that the installation of a sheet pile wall behind the quay wall was not effective. In contrast, the rotation was reduced by mitigation measures conducted in the foundation under the quay wall or in the sea side of the foundation. The observations in terms of lateral displacement (Figure 17) and rotation (Figure 18) are consistent. So grouting in the foundation soil, sheet pile in the sea side of the foundation, and densification in the sea side of the foundation were found to be effective for mitigation of the damage of quay wall systems.

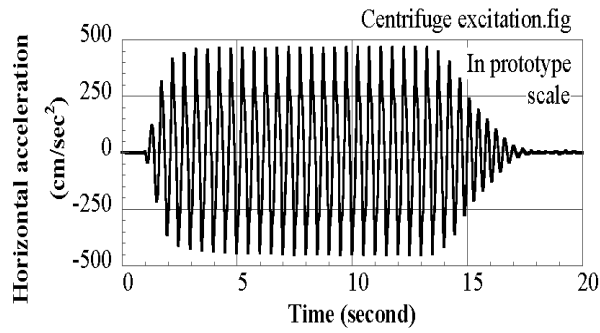
Figure 19: Time history of base excitation (prototype scale).

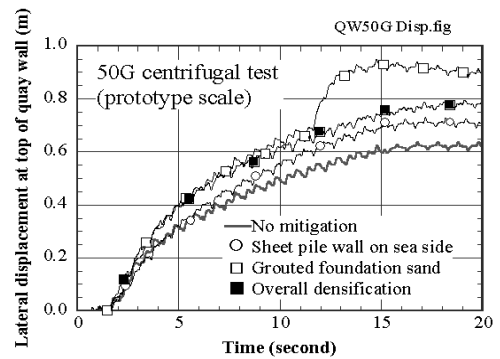
Figure 24: Time history of lateral displacement at top of quay wall.

Detailed information on lateral translation and tilting of a quay wall is presented in Figures 24 and 25. When no mitigation measure was taken (Figure 23), the quay wall model simply translated and subsided downwards, while tilting was very small. When the foundation soil was improved by grouting, on the other hand (Figure 25), more significant extent of tilting in the wall model occurred. Both tests developed significant subsidence in the surface of the backfill. As was suggested in previous figures, the case without mitigation developed smaller lateral displacement at the top of the quay wall, and the rotation was minimal in the case without mitigation. This unexpected finding may be interpreted by dividing the lateral displacement into components. Figure 26 shows shear strains in the foundation sand and in the rubble mound which were read from the displacement of embedded markers. The case without mitigation developed the greatest extent of shear deformation in the foundation sand, while the rubble mound exhibited less strain and rotation of the quay wall was negligible. On the other hand, cases with reinforced or solidified foundation developed more tilting of the quay wall while the strain in the foundation was smaller. The stabilized foundation soil increased the acceleration in the overlying structures and in consequence magnified the distortion of the rubble mound. Moreover, the inertial force, translation, and tilting of the quay wall were increased. Accordingly, the dynamic earth pressure exerted from the backfill became more significant.

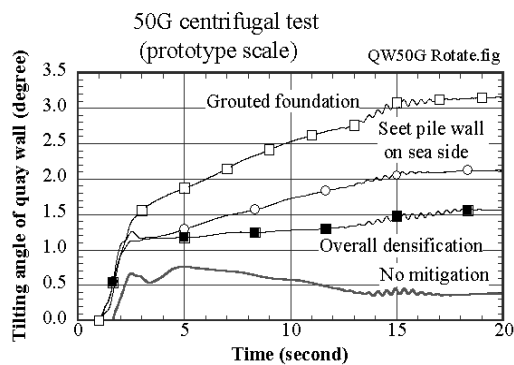
Figure 25: Time history of tilting angle of quay wall.
