BUILDING TYPOLOGIES AND FAILURE MODES OBSERVED IN THE 2015 GORKHA (NEPAL) EARTHQUAKE

**Dmytro Dizhur^{1,2}, Rajesh P. Dhakal³, Jitendra Bothara⁴ and
Jason M. Ingham⁵**

ABSTRACT

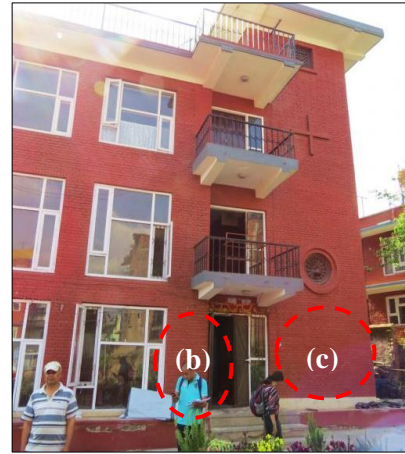
(a) Loadbearing URM building with rigid RC diaphragms

Figure 27: Compression damage of corner piers.

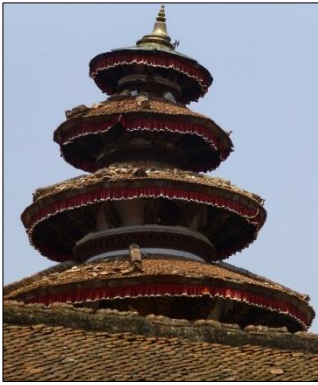
(b) Leaning of top portion of a Pagoda type temple

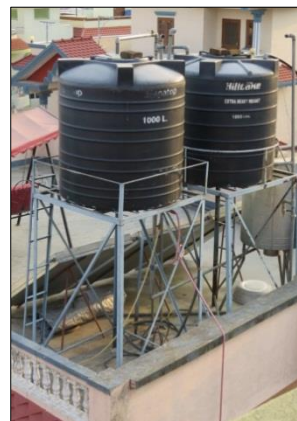
(c) Steel braced frame support frame
