## GENERAL OBSERVATIONS OF EFFECTS OF THE 30th SEPTEMBER 2009 PADANG EARTHQUAKE, INDONESIA

**Jitendra Bothara<sup>1</sup>, Dick Beetham<sup>2</sup>, Dave Brunson<sup>3</sup>, Mike Stannard<sup>4</sup>, Roger Brown<sup>5</sup>, Clark Hyland<sup>6</sup>, Warren Lewis<sup>7</sup>, Scott Miller<sup>8</sup>, Rebecca Sanders<sup>9</sup> and Yakso Sulistio<sup>10</sup>**

### SUMMARY

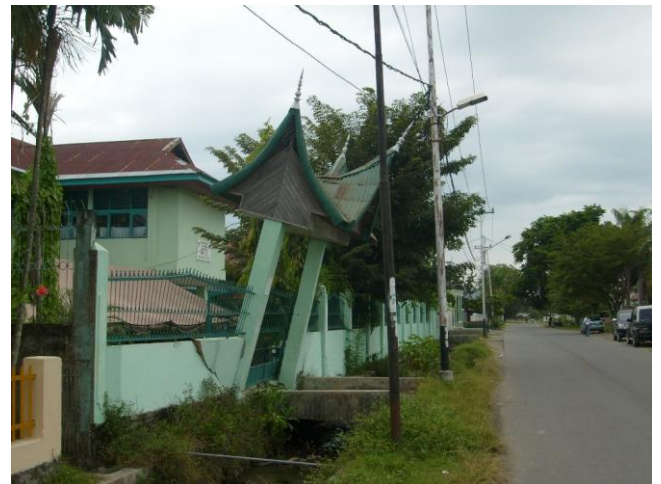
changed from stone masonry to concrete and there was no anchorage with the foundation. Figure 7.4b shows a leaning gate because of movement of the gate columns and the loose soil around the columns.

**b) Leaning towers at a gate.**
