# RECONNISSANCE REPORT ON GEOTECHNICAL AND GEOLOGICAL ASPECTS OF THE 14-16 APRIL 2016 KUMAMOTO EARTHQUAKES, JAPAN

**Gabriele Chiaro<sup>1</sup>, Gavin Alexander<sup>2</sup>, Pathmanathan Brabhaaran<sup>3</sup>, Christopher Massey<sup>4</sup>, Junichi Koseki<sup>5</sup>, Suguru Yamada<sup>6</sup> and Yudai Aoyagi<sup>7</sup>**

## ABSTRACT

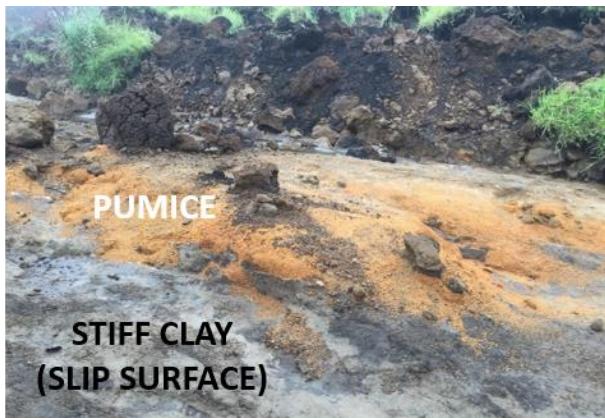
As shown in Photo 8, the slide surface was identified and traces of orange-coloured pumice soil were clearly noted on it. Two small trial pits (Figure 8) were excavated across the assumed slide surface and soil profile details are provided henceforward.

*Photo 8. Traces of pumice soil on the slide surface.*

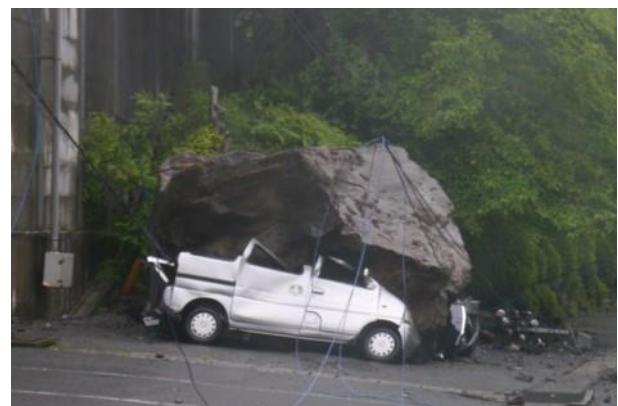
**Photo 20:** Cars crushed by rock fall near the Tochinokibaru hot spring (N 32.8711; E 131.9982).

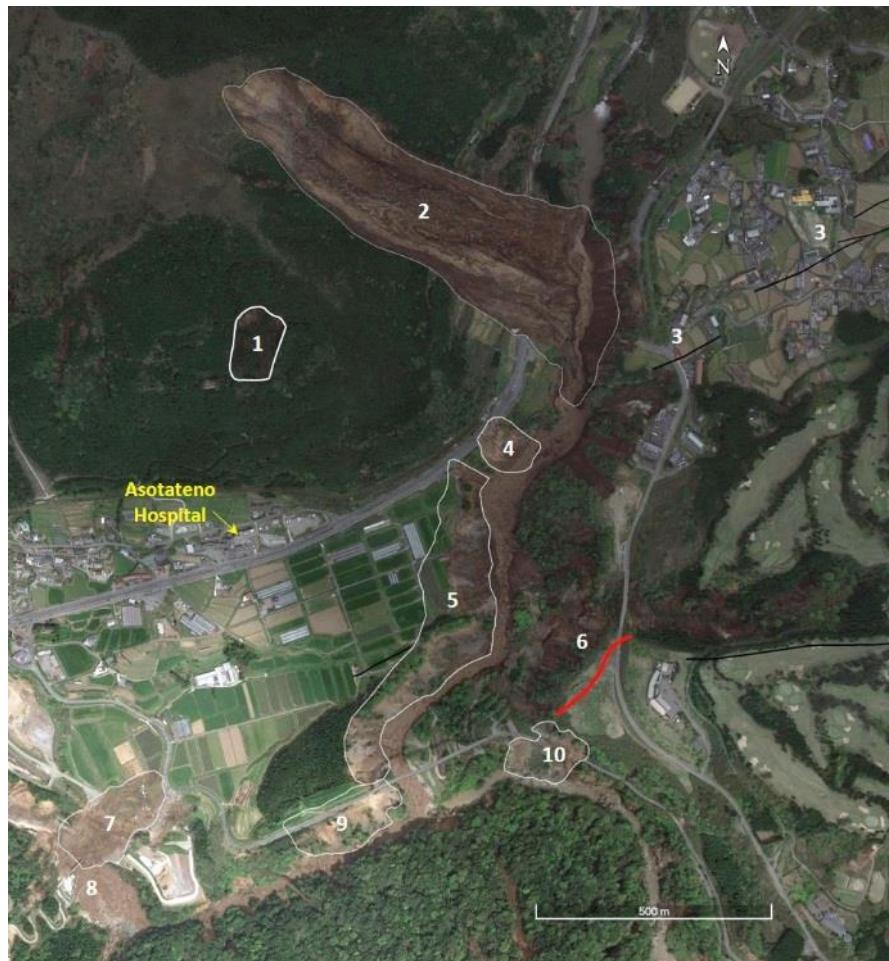
- 1: Debris flow threatening Asotateno Hospital
- 2: Debris avalanche destroyed highway and the Aso Ohashi Bridge (c.f. Photos 15 and 16)
- 3: Fault rupture severely damaged buildings (c.f. Photo 5)
- 4: Debris avalanche undercut highway making it impassable
- 5: Debris avalanche and cliff top recession and cracking destroyed the high voltage transmission line
- 6: Incipient landsliding severely impacts bridge making it impassable
- 7: Erath flow/slide destroyed railway line
- 8: Access to dam construction site destroyed
- 9: Incipient landsliding in rock and debris avalanches caused road bridge to settle (c.f. Photo 18)
- 10: Debris avalanche destroyed road bridge (c.f. Photo 17)

**Figure 20: Location of critical infrastructure concentrated along the main Shirakawa River valley at the natural break in the slopes forming the outer crater. Multiple hazards occurred in this area as a result of the earthquakes, active faulting and landslides, and as a result the main bridges were destroyed and power transmission lines across the river required interim replacement.**

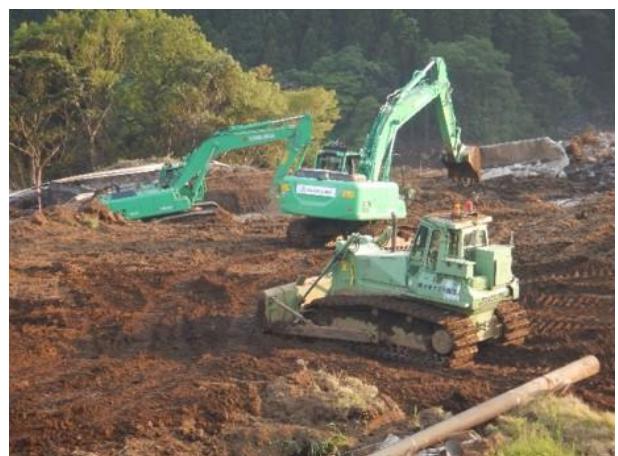
*Photo 53: Remotely-controlled machines used to rescue buried construction equipment (N 32.8776; E 130.9764).*
